Assessment of Steelhead Habitat and Migration Barriers within Watersheds Impacted by the Thomas, Whitter, and Topanga Wildfires

Pacific States Marine Fisheries Commission

California Department of Fisheries and Wildlife

September 10, 2019

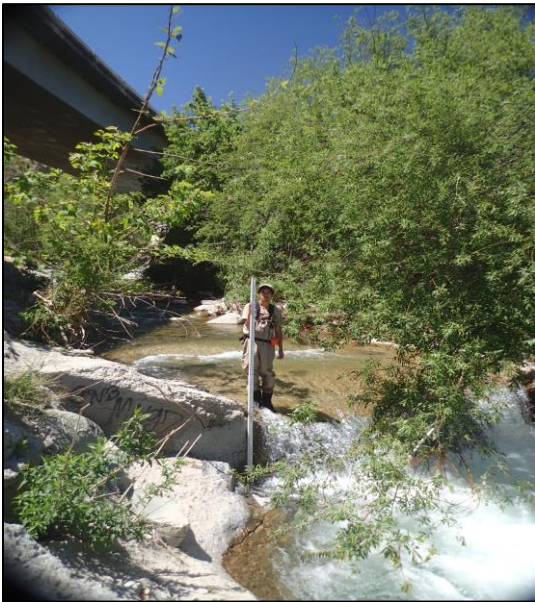
Two grade control structures were assessed to constrict *O. mykiss* upstream passage on Santa Paula Creek. The initial of these two structures (SPL_007_NR) consists of large chain linked boulder riprap and is located 5.1 stream miles from the Santa Clara River confluence. These boulders create numerous plunge and cascade points with a mean height of 4.1 ft. A large pool unit is located downstream of these boulders and when assessed on 3/28/19 the mean water depth below the plunge was 2.6 ft. A majority of the stream flow was directed through a cascade on river left. Under the conditions assessed a strong steelhead could likely make successful passage through this cascade, but the stream flow velocity would likely prevent all other *O. mykiss* life stages from gaining successful passage. The other grade control (SPL_008_R) constraining *O. mykiss* upstream passage on Santa Paula Creek is a concrete structure located 5.2 stream miles from the Santa Clara River confluence. This structure is located between concrete boulder riprap channel walls and beneath a highway 150 free spanning bridge. The structure creates a distinct plunge point with a mean height of 2.3 ft. When assessed on 4/23/19 the downstream pool unit had a mean water depth of 5 ft below the plunge. This plunge point water depth should allow steelhead to jump the grade control structure and gain passage, however it is unlikely resident *O. mykiss* life stages could successfully make the jump required for passage.

Figure 21. Concrete grade control below Hwy 150.

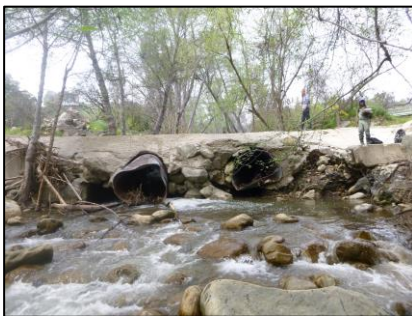
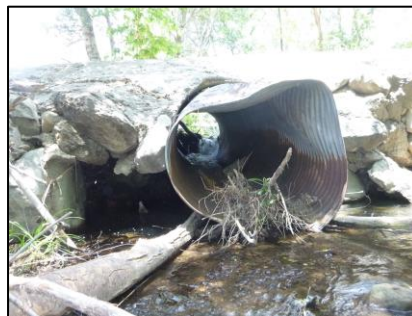
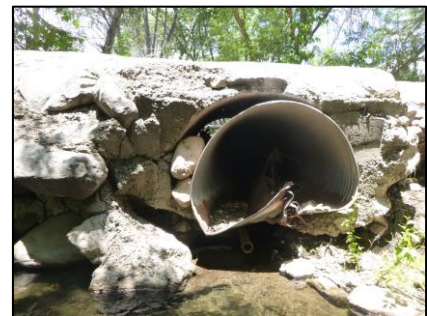
The next structure constraining *O. mykiss* passage on Sisar Creek was the Osborn Road low-water crossing located 2.1 stream miles from the Santa Paula Creek confluence. This crossing included two corrugated steel culverts running through the concrete crossing. Both culverts are moderately damaged and had partial vegetation debris blockage. The river left culvert was more severely damaged and streamflow was passing below this culvert instead of through it. FishXing modeling predicted a steelhead could potentially pass through the culvert between streamflow rates of 68 ft³/s and 309 ft³/s. These calculations were based off conditions within an undamaged and debris free culverts, so it is likely FishXing steelhead passage calculations are an over estimation, however due to FishXing indicating possible passage this structure was deemed to be a temporal and partial barrier. This crossing was previously assessed to be a partial barrier by Stoecker in 2005.

Figures 24 – 26. Osborn Road Crossing with damaged and debris filled culverts

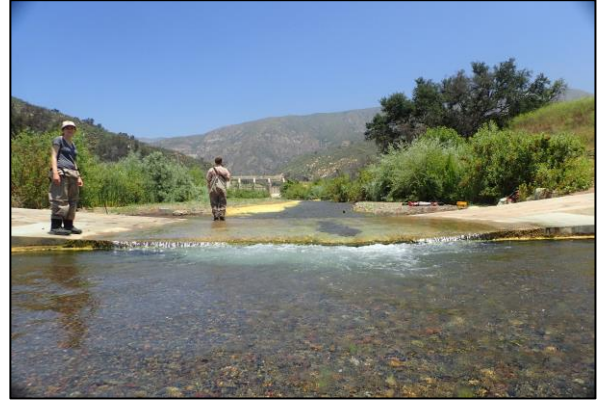
Figure 29. Concrete low-water crossing downstream of Robles diversion dam.

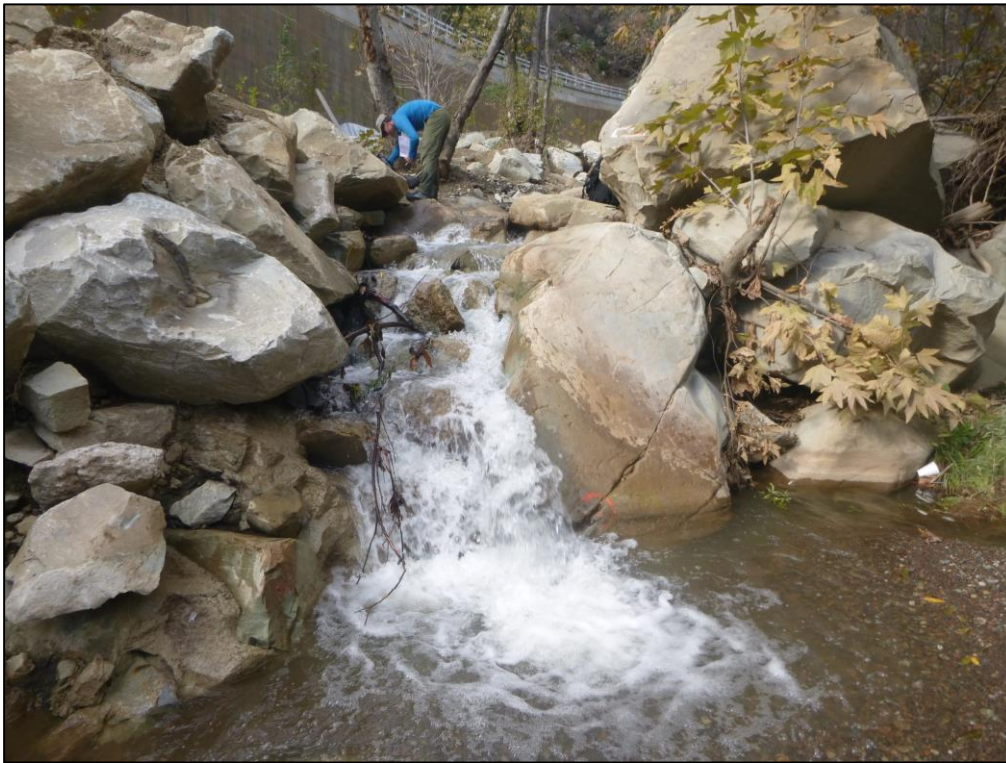
Figure 51. Downstream view of boulder riprap grade control on North Fork Matilija Creek.

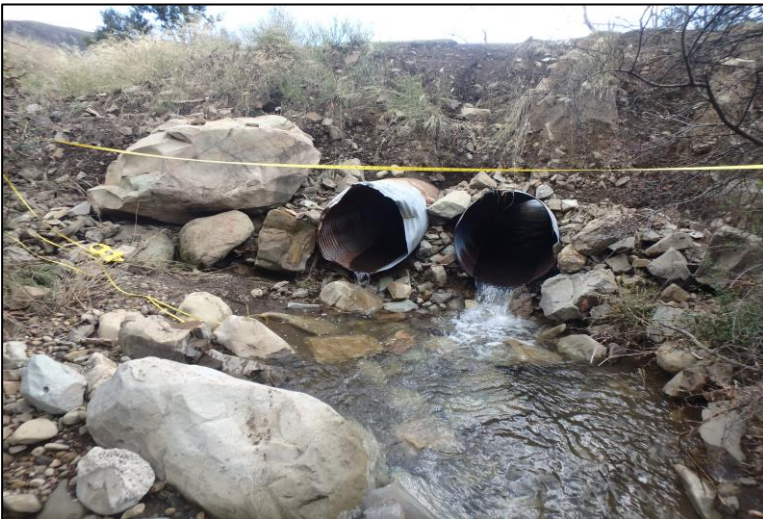
Figure 58. Outlet of culverts under forest service road on Cannon Creek.

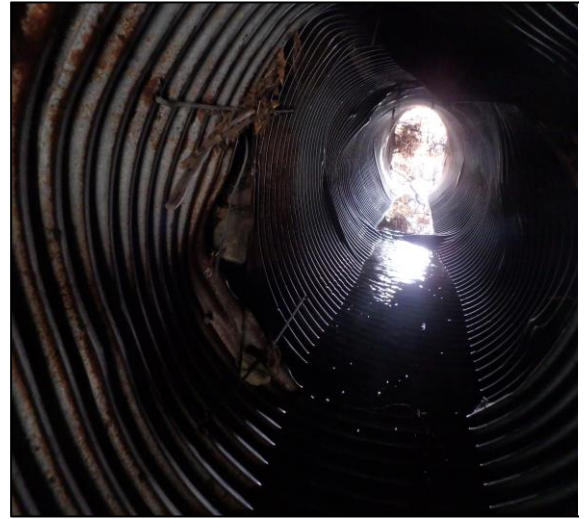
Figure 59. View of damage within river left culvert.

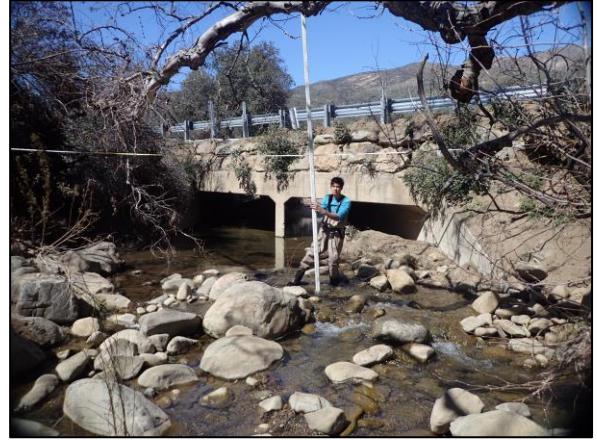
Figure 60. View of outlet at CAN_002_R Hwy 33 crossing.

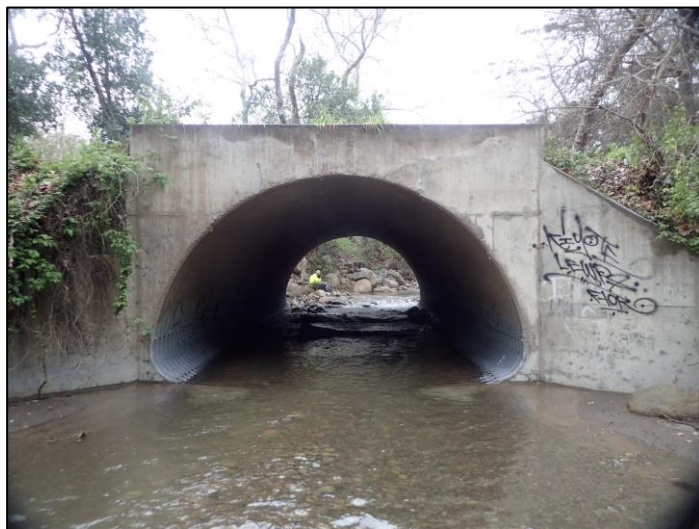
Figure 63. View of outlet of El Capitan State Beach Road crossing.

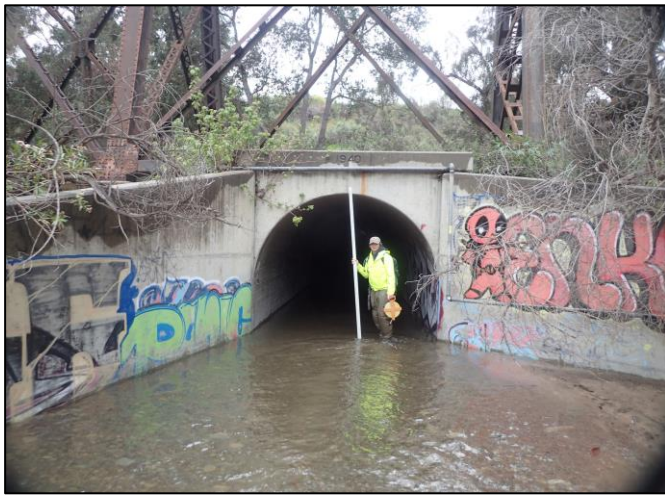
Figure 64. View of culvert outlet at Hwy 101 El Capitan Creek crossing.

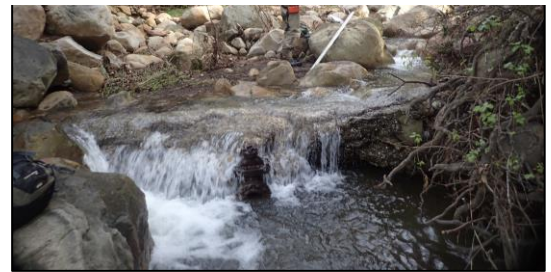
Figure 70. Downstream view of RAT_005_NR grade control on Rattlesnake Creek.

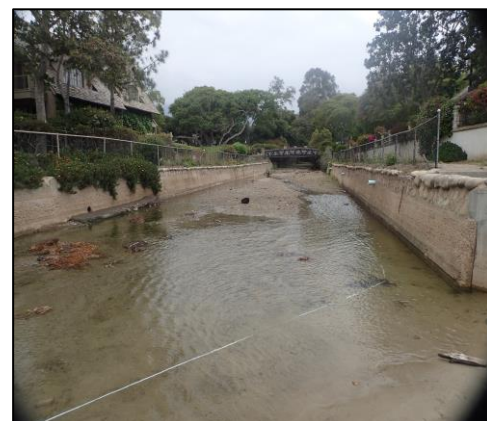
Figure 75. Flood control channel at mouth of Montecito Creek.

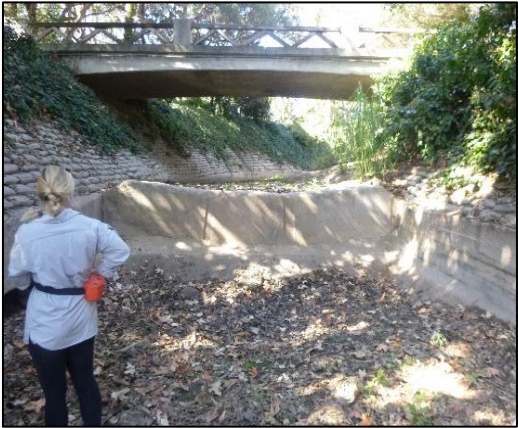
Barrier ID: MON_007_NR PAD ID: 706515	34.42329, -119.63567	Temporal	Temporal & Partial	Large segments of damaged concrete grade control. Mean height: 2.5 ft Mean breadth: 0.5 ft Mean cascade length: 2.6 ft Remediation score: 10.1

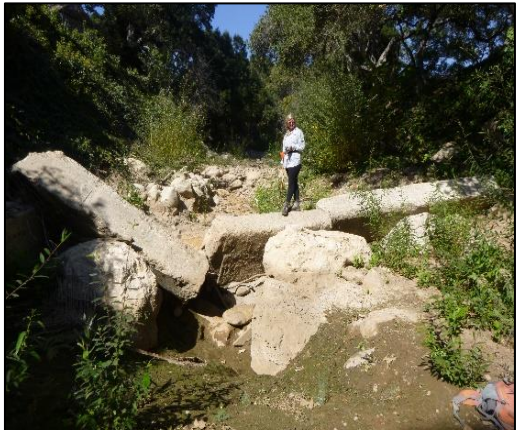
Barrier & PAD ID	Location	Previous Barrier Status	Current Barrier Status	Description, Dimensions, and Remediation Score	Picture
Barrier ID: MON_008_NR PAD ID: 706516	34.42367, -119.63586	Partial	Temporal & Partial	Concrete boulder riprap apron grade control. Mean height: 3.1 ft Mean breadth: 3.7 ft Mean cascade length: 4.8 ft Remediation score: 9.1

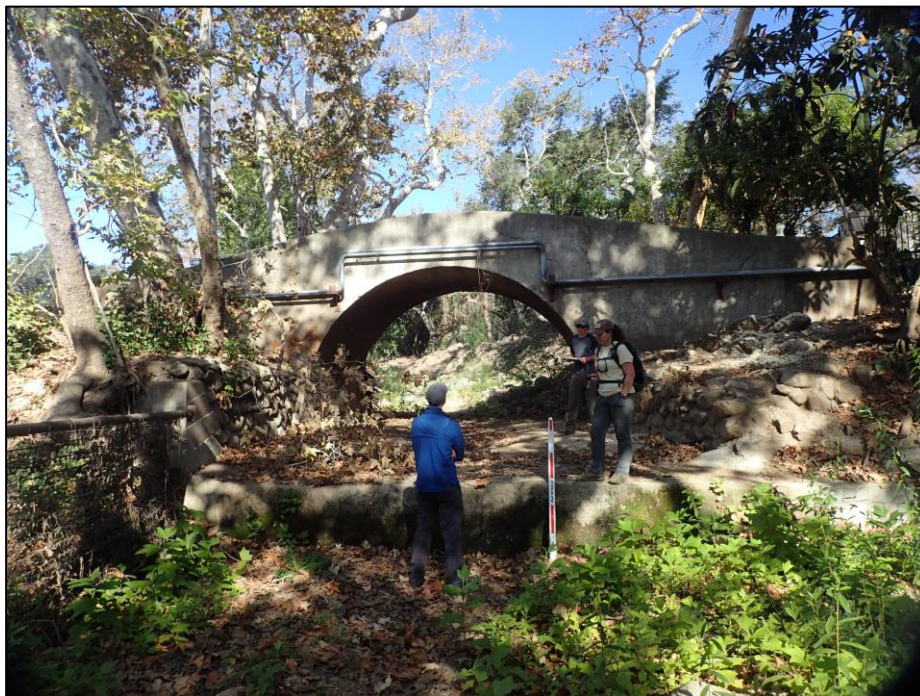
Figure 77. View of outlet at total barrier private road crossing/grade control on Montecito Creek.

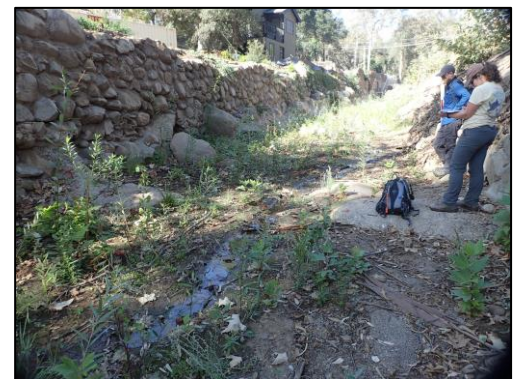
Figure 80. Remnants of MON_022_NR grade control structure.

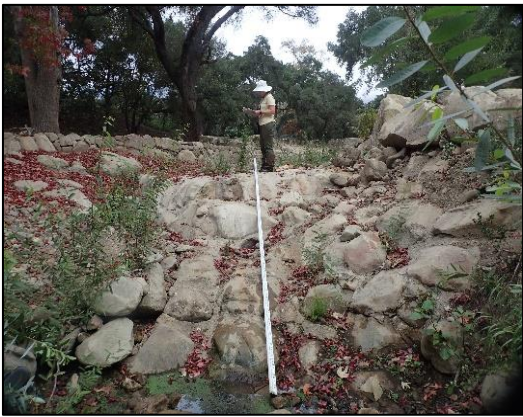
Barrier ID: HSP_003_NR PAD ID: None Assigned	34.44533, -119.64877	Unassessed	Temporal	Small and damaged concrete boulder riprap grade control. Mean height: 2.4 ft Mean breadth: 3.0 ft Mean cascade length: 3.5 ft Remediation score: 3.15

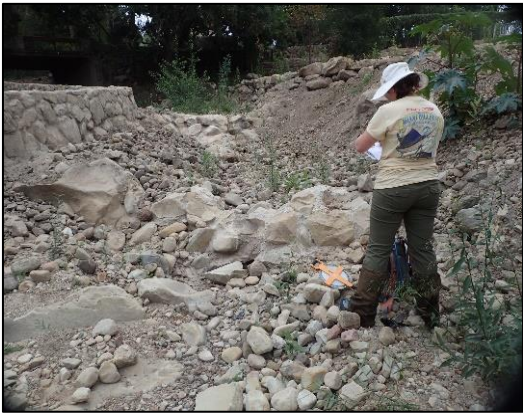
Barrier ID: HSP_004_NR PAD ID: None Assigned	34.44533, -119.6487	Unassessed	Temporal	Partially damaged concrete boulder riprap grade control. Mean height: 3.2 ft Mean breadth: 4.6 ft Mean cascade length: 6.6 ft Remediation score: 3.15

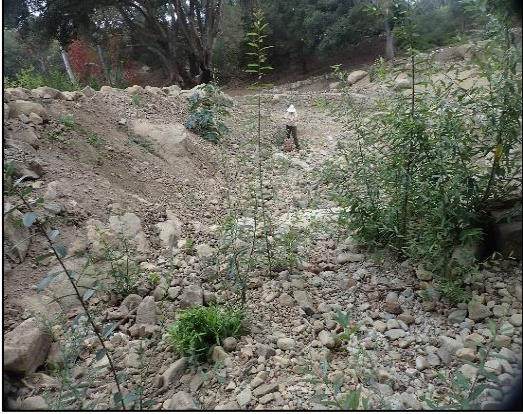
Barrier & PAD ID	Location	Previous Barrier Status	Current Barrier Status	Description, Dimensions, and Remediation Score	Picture
Barrier ID: HSP_006_NR PAD ID: None Assigned	34.44608, -119.64745	Unassessed	Temporal & Partial	Concrete grade control between wing walls with vertical plunge. Mean height: 2.5 ft Mean breadth: 0.8 ft Mean cascade length: 2.0 ft Remediation score: 4.05

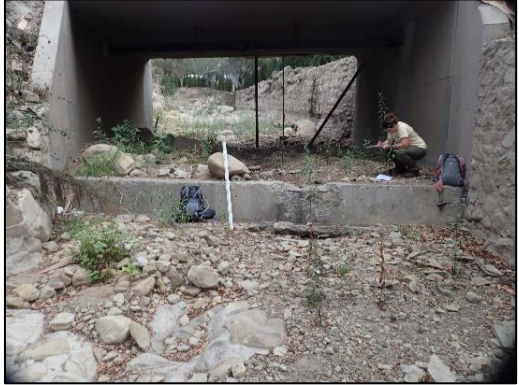
Barrier ID: HSP_010_NR PAD ID: None Assigned	34.44831, -119.64654	Unassessed	Total	Damaged concrete streambed channel lining grade control with vertical plunge. Mean height: 6.6 ft Mean breadth: 2.0 ft Mean cascade length: 7.2 ft Remediation score: 5.95

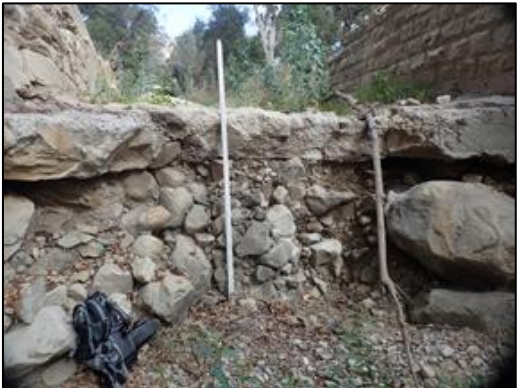
Barrier ID: HSP_011_NR PAD ID: None Assigned	34.44896, -119.64626	Unassessed	Temporal	Concrete boulder riprap grade control downstream of East Mountain Drive bridge crossing. Mean height: 5.6 ft Mean breadth: 14.7 ft Mean cascade length: 14.9 ft Remediation score: 5.4

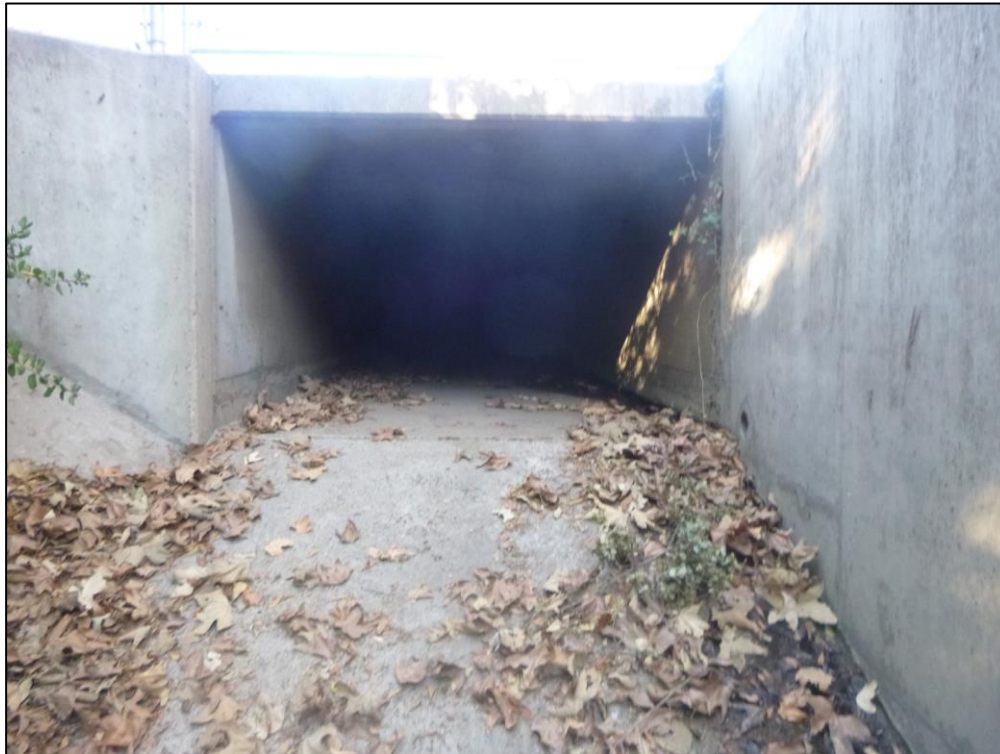
Figure 91. Outlet of extended total barrier box culvert on Oak Creek.

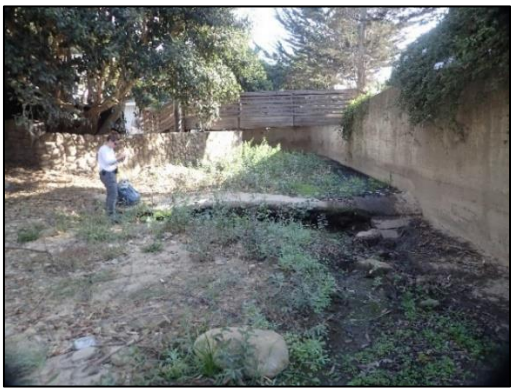
Barrier ID: ROM_002_NR PAD ID: None Assigned	34.42289, -119.61657	Unassessed	Temporal & Partial	Concrete grade control structure spanning width of stream channel. Mean height: 1.6 ft Mean breadth: 0.5 ft Mean cascade length: 2.0 ft Remediation score: 11.05

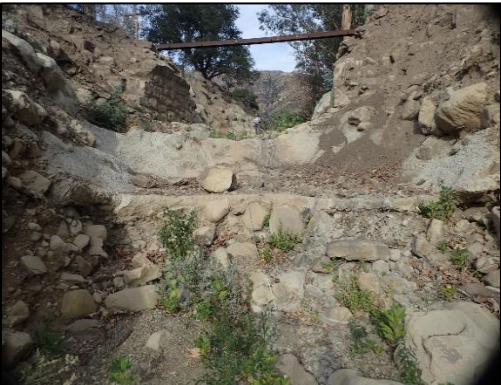
Barrier ID: ROM_016_NR PAD ID: None Assigned	34.44366, -119.59392	Unassessed	Total	Damaged concrete boulder riprap grade control with scour below plunge. Mean height: 4.3 ft Mean breadth: 2.2 ft Mean cascade length: 5.8 ft Remediation score: 6.1

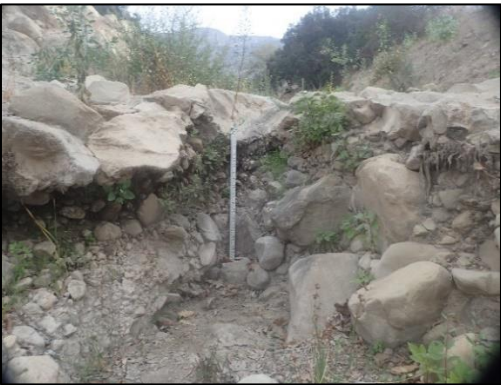
Barrier ID: ROM_017_NR PAD ID: None Assigned	34.44402, -119.59354	Unassessed	Temporal & Partial	Damaged concrete boulder riprap grade control with scour below plunge. Mean height: 6.5 ft Mean breadth: 3.4 ft Mean cascade length: 7.9 ft Remediation score: 5

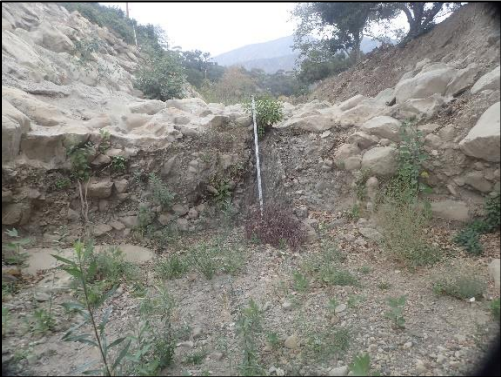
Barrier and PAD ID	Location	Previous Barrier Status	Current Barrier Status	Description, Dimensions, and Remediation Score	Picture
Barrier ID: ROM_018_NR PAD ID: None Assigned	34.44459, -119.59335	Unassessed	Temporal & Partial	Concrete boulder riprap grade control creating cascade. Mean height: 2.0 ft Mean breadth: 1.6 ft Mean cascade length: 3.1 ft Remediation score: 5

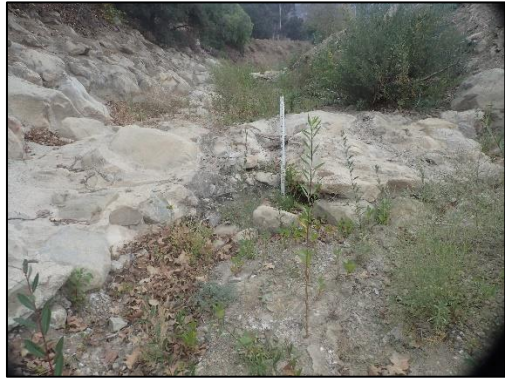
Barrier ID: ROM_021_NR PAD ID: None Assigned	34.44533, -119.59291	Unassessed	Temporal & Partial	Damaged concrete boulder riprap grade control with scour below plunge. Mean height: 4.0 ft Mean breadth: 1.2 ft Mean cascade length: 4.6 ft Remediation score: 4.9

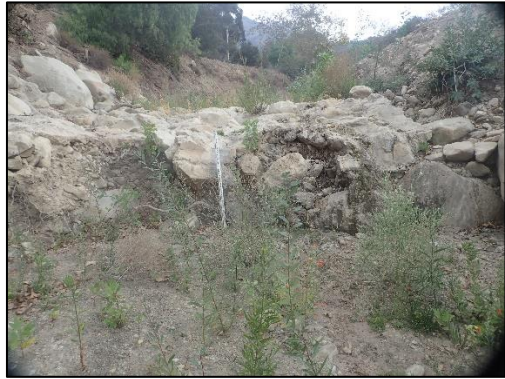
Barrier and PAD ID	Location	Previous Barrier Status	Current Barrier Status	Description, Dimensions, and Remediation Score	Picture
Barrier ID: ROM_022_NR PAD ID: None Assigned	34.44561, -119.59251	Unassessed	Temporal & Partial	Concrete boulder riprap grade control creating cascade and plunge point. Mean height: 3.8 ft Mean breadth: 2.5 ft Mean cascade length: 4.8 ft Remediation score: 4

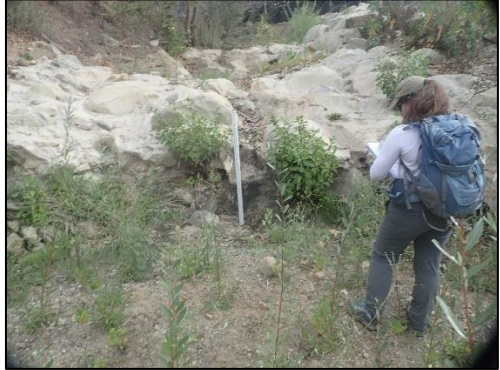
Barrier ID: ROM_024_NR PAD ID: None Assigned	34.45101, -119.59016	Unassessed	Total	Significantly damaged concrete boulder riprap grade control with scour below plunge. Mean height: 17.4 ft Mean breadth: 6.0 ft Mean cascade length: 17.7 ft Remediation score: 5.5

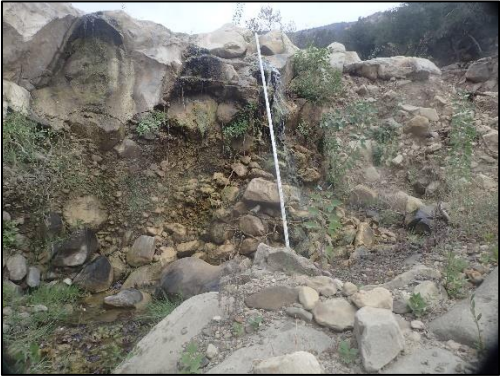
Barrier ID: ROM_025_NR PAD ID: None Assigned	34.4515, -119.59024	Unassessed	Total	Moderately damaged concrete boulder riprap grade control with some scour below plunge. Mean height: 9.0 ft Mean breadth: 4.0 ft Mean cascade length: 11 ft Remediation score: 5.4

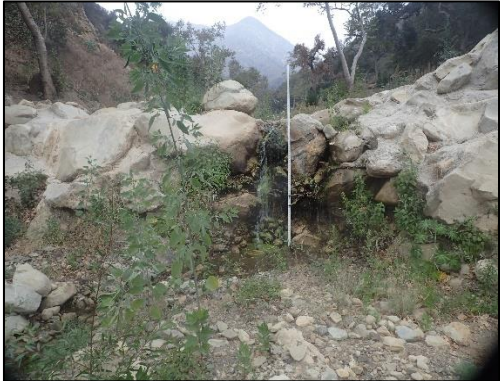
Barrier ID: ROM_026_NR PAD ID: None Assigned	34.45191, -119.59045	Unassessed	Total	Concrete boulder riprap grade control apron. Mean height: 7.0 ft Mean breadth: 11.5 ft Mean cascade length: 13.5 ft Remediation score: 5.4

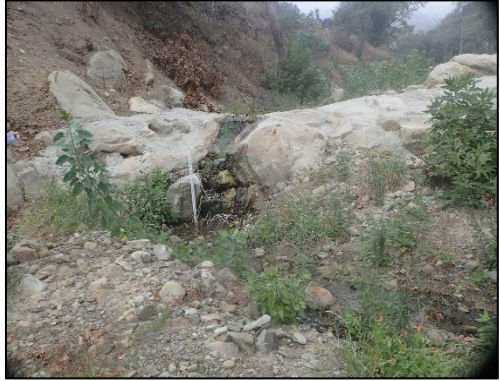
Barrier and PAD ID	Location	Previous Barrier Status	Current Barrier Status	Description, Dimensions, and Remediation Score	Picture
Barrier ID: ROM_027_NR PAD ID: None Assigned	34.45251, -119.59068	Unassessed	Total	Significantly damaged concrete boulder riprap grade control with scour below plunge. Mean height: 11.1 ft Mean breadth: 4.4 ft Mean cascade length: 12.3 ft Remediation score: 5.3

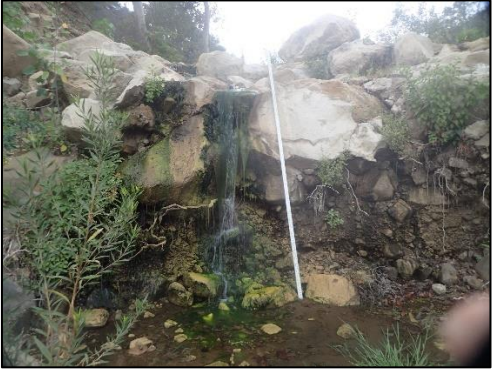
Barrier ID: ROM_028_NR PAD ID: None Assigned	34.45314, -119.59101	Unassessed	Temporal & Partial	Wide concrete boulder riprap grade control with eroded center. Mean height: 3.9 ft Mean breadth: 4.0 ft Mean cascade length: 6.0 ft Remediation score: 3.4

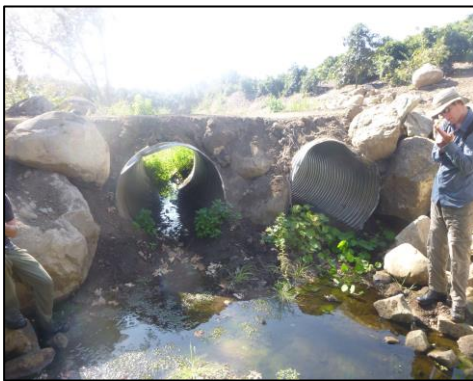
Figure 115. Inlet of culverts at AYP_005_R private road crossing.

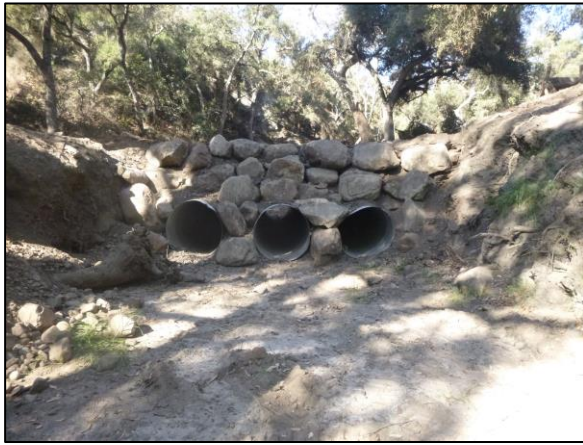
Figure 118. Outlet of Toro Canyon Park Road crossing culverts on Arroyo Paredon Creek..

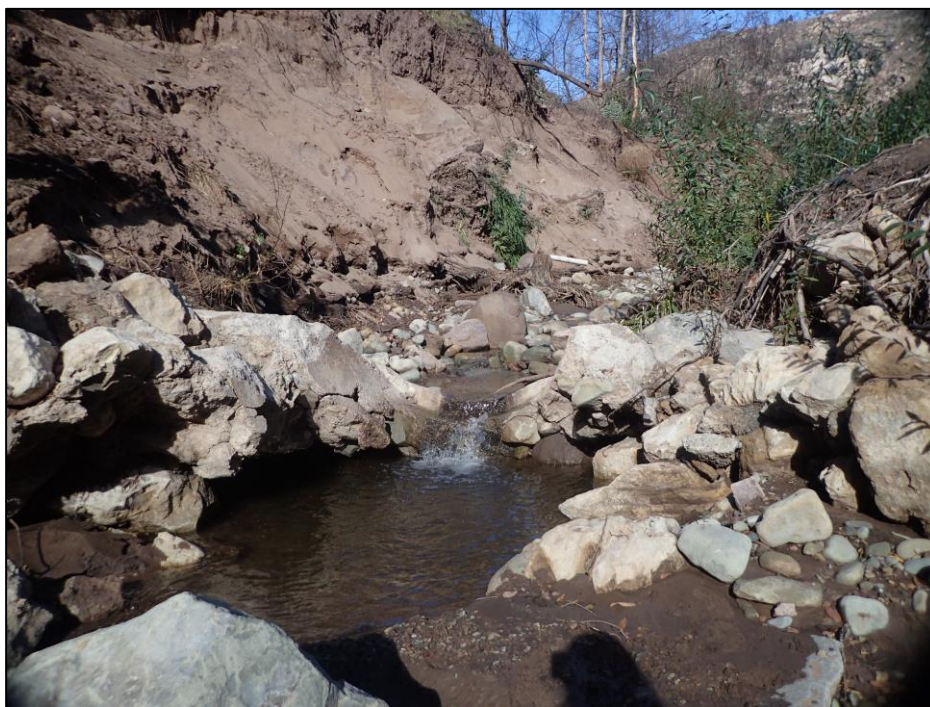
Figure 121. Downstream view of concrete debris basin remnants on Carpinteria Creek.

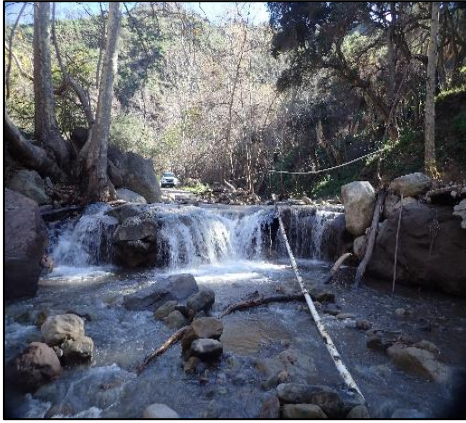
Barrier ID: RNC_013_R PAD ID: 706220	34.40673, -119.44547	Temporal	Total	Concrete low-water crossing with downstream scour and damage creating significant cascade over boulder and concrete from outlet. Outlet cascade height: 8 ft Outlet cascade length: 8.4 ft Water depth below cascade: 0.8 ft Road surface width: 12.9 ft Remediation score: 9.95

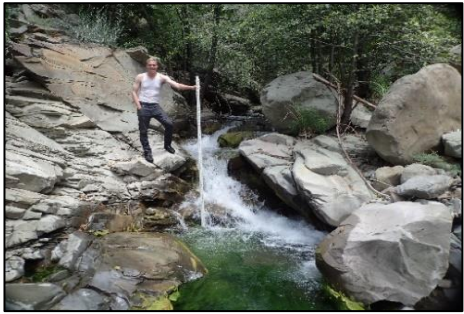
Barrier ID: EFSP_002_NR PAD ID: None Assigned	34.44866, -119.05621	Unassessed	Temporal & Partial	Cascade over bedrock. Cascade height: 6.8 ft Water depth below cascade 1.7 ft
