FINAL REPORT • APRIL 2015

# Cow Creek and Mill Creek Riparian Mapping and Conditions Assessment

Prepared for  
U.S. Fish and Wildlife Service Red Bluff USFWS Office 10950 Tyler Road, Red Bluff, CA 96080

Prepared by  
Stillwater Sciences 2855 Telegraph Ave., Suite 400, Berkeley, CA 94705  
Aerial Information Systems, Inc. 112 First Street, Redlands, CA 92373

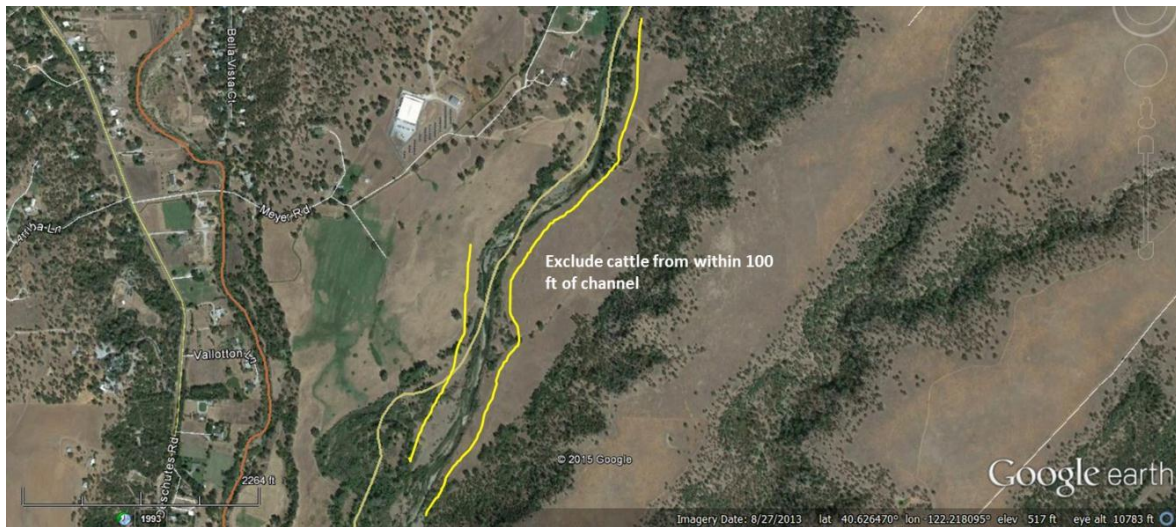
**Figure 6-2.** Condition reach 2a along Little Cow Creek. Recommended action is to exclude cattle from 100 ft buffer of channel.

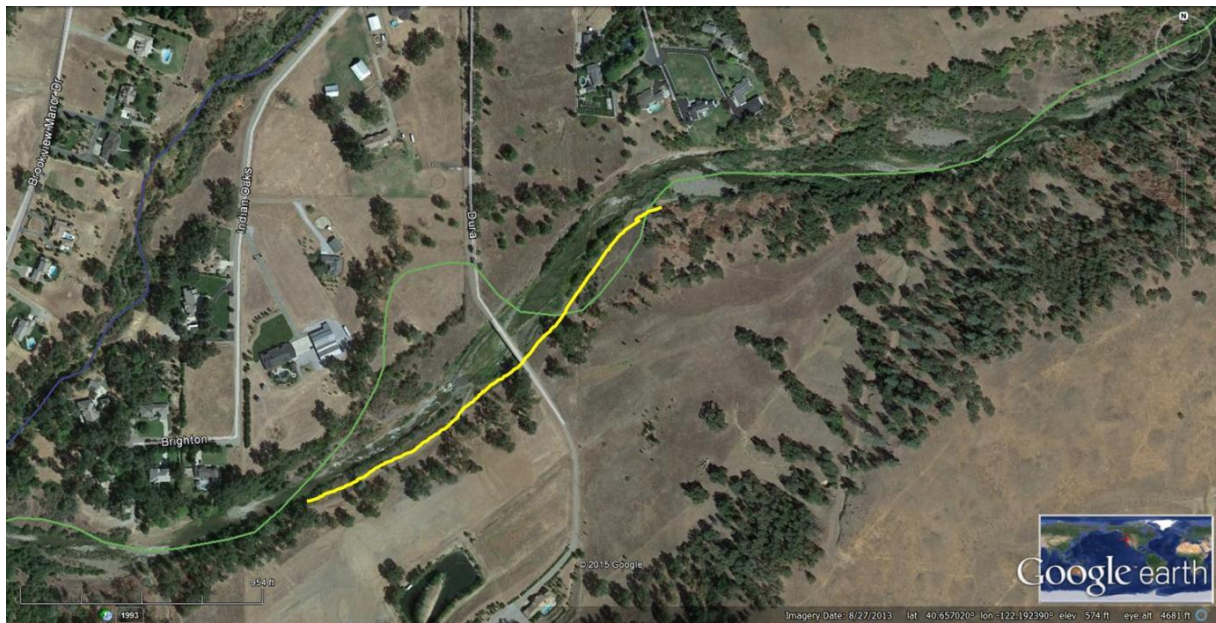
**Figure 6-3.** Condition reach 2c, site 1 along Little Cow Creek. Recommendation is to protect floodplain and banks and explore options to increase woody riparian cover along the south bank.

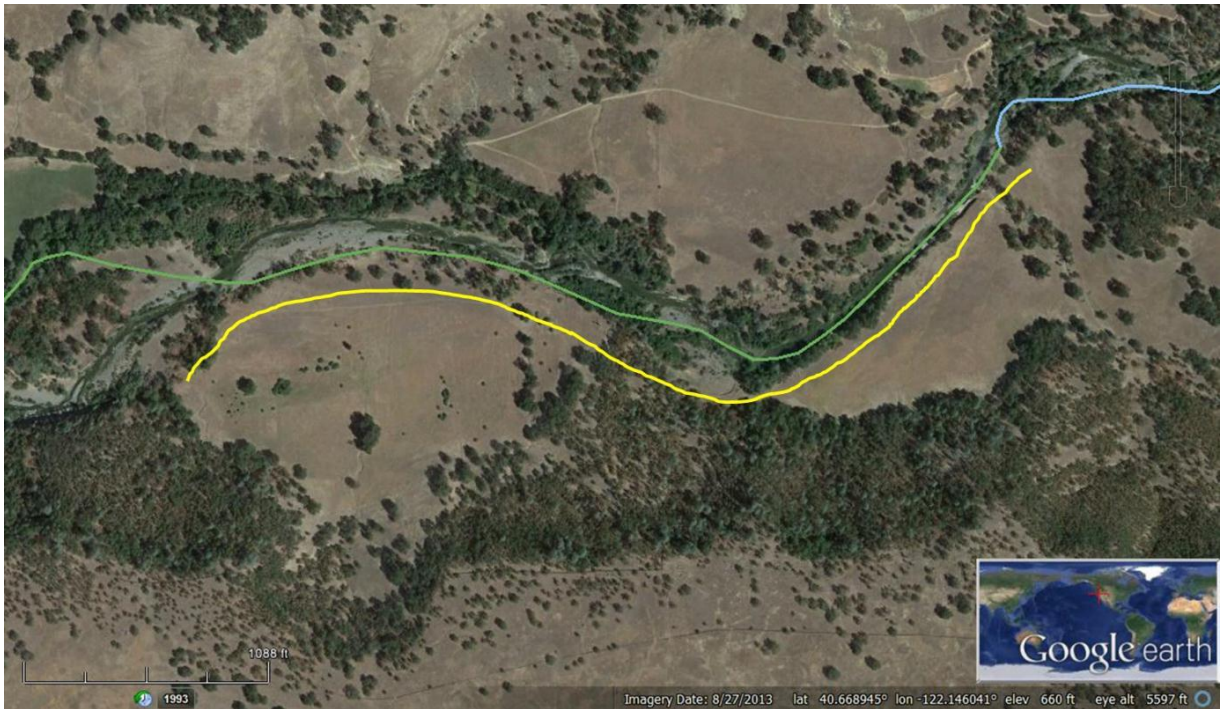
**Figure 6-4.** Condition reach 2c, site 2 along Little Cow Creek. Recommendation is to work with landowners to exclude cattle from within 100 ft of channel along south bank.

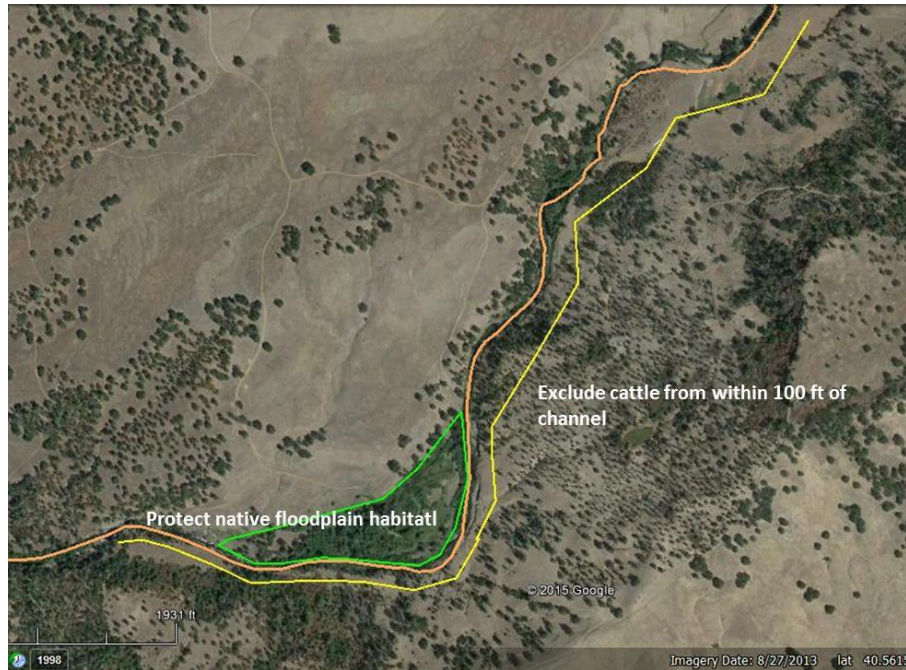
**Figure 6-5.** Condition reach 6a along lower Old Cow Creek. Recommendation is to exclude cattle from within 100 ft of channel on the river left (south side of channel) and to protect existing excellent floodplain habitat on a section of the river right.

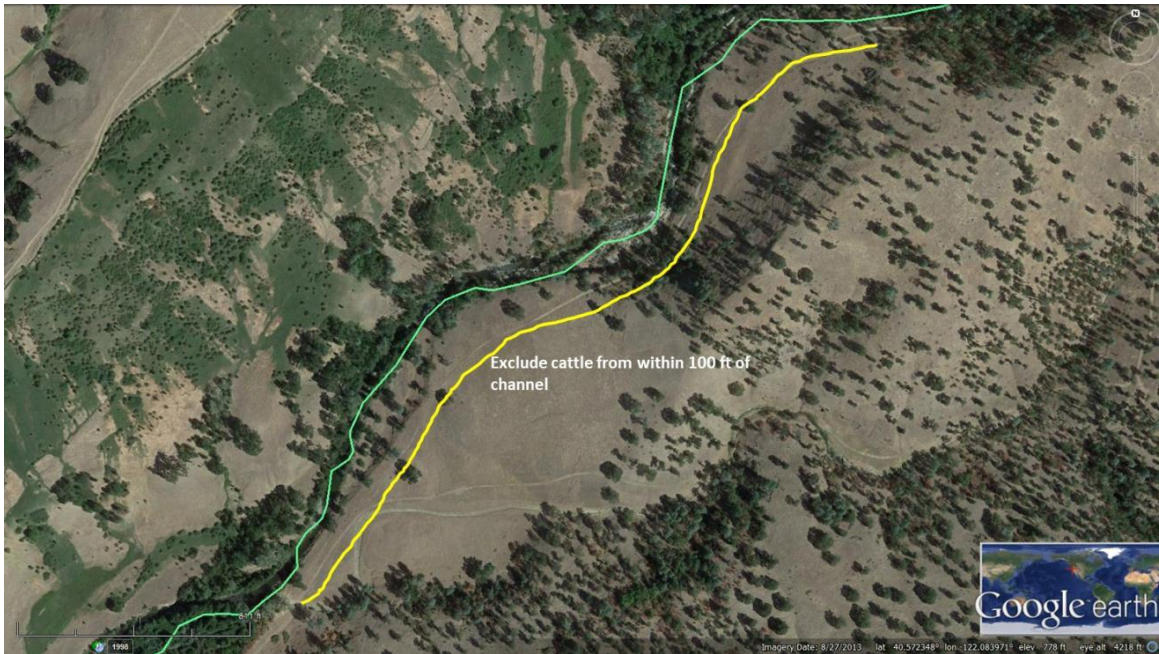
**Figure 6-6.** Condition reach 6b, site 1 along Old Cow Creek. Recommended action is to exclude cattle from 100 ft buffer of channel.

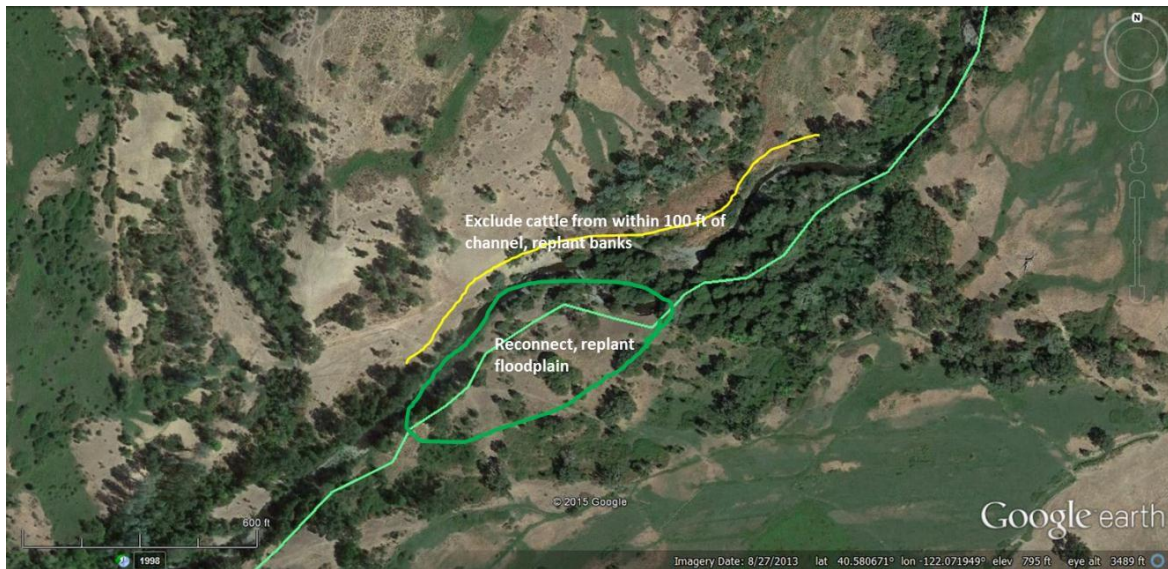
**Figure 6-7.** Condition reach 6b, sites 2 and 3 along lower Old Cow Creek. Management recommendations include excluding cattle from within 100 ft of the channel, replanting the banks with native riparian willows and oaks, and exploring options to increase floodplain connectivity along the river left.

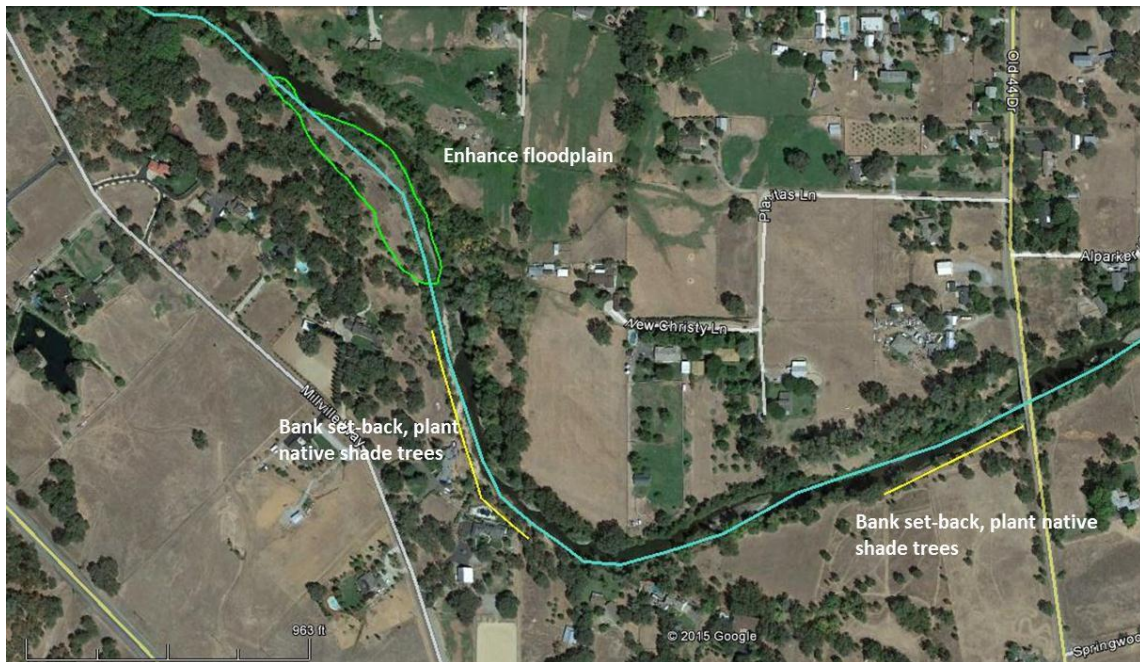
**Figure 6-10.** Condition reach 1a4 on South Cow Creek sites 2, 3, and 4 (left to right) recommended priority areas.

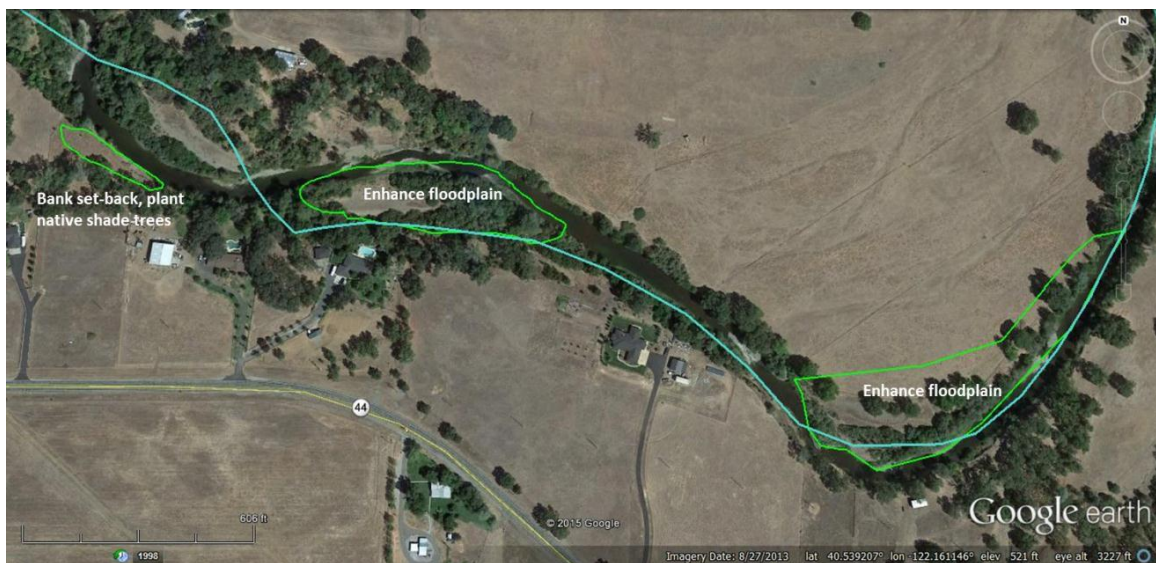
**Figure 6-11.** Condition reach 1a4 on South Cow Creek sites 5, 6, and 7 (left to right) recommended priority areas.

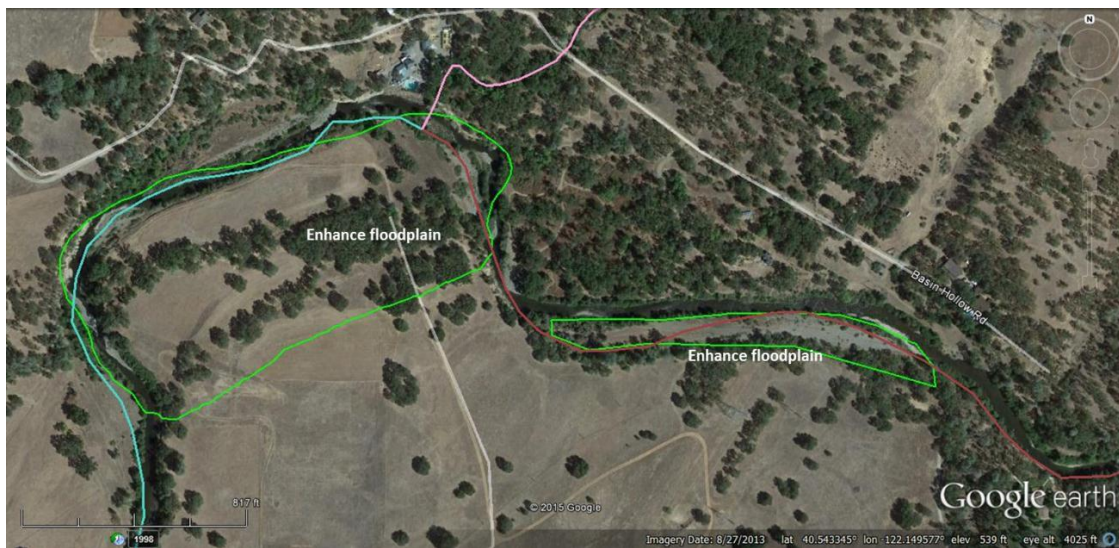
**Figure 6-12.** Condition reach 1a4 on South Cow Creek sites 8 and 9 (left to right) recommended priority areas.

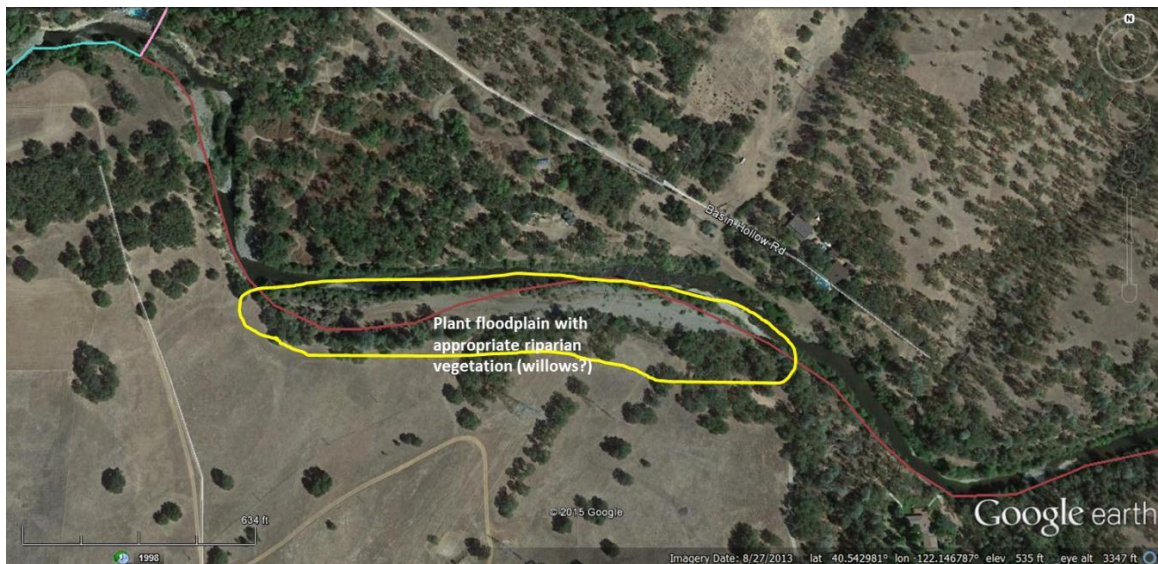
**Figure 6-13.** Condition reach 7a. Recommended priority management area along South Cow Creek below Old Cow Creek confluence.

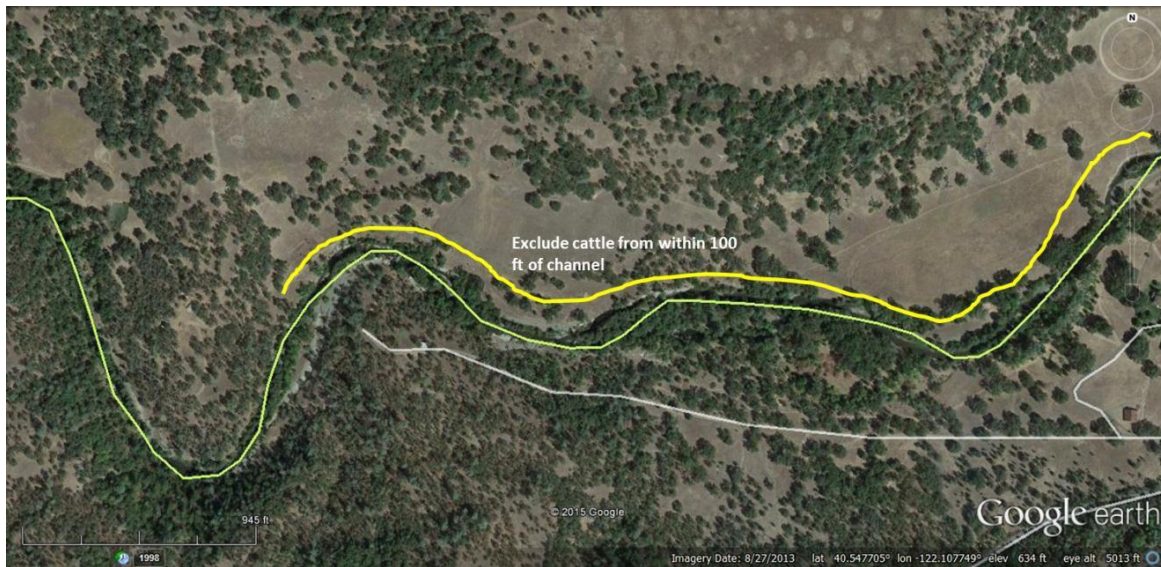
**Figure 6-14.** Condition reach 7b, site 1. Recommended priority management area along South Cow Creek: erect fencing to exclude cattle from within 100 ft of low flow channel on the north side of the channel to promote natural recruitment and growth of riparian trees (oaks).

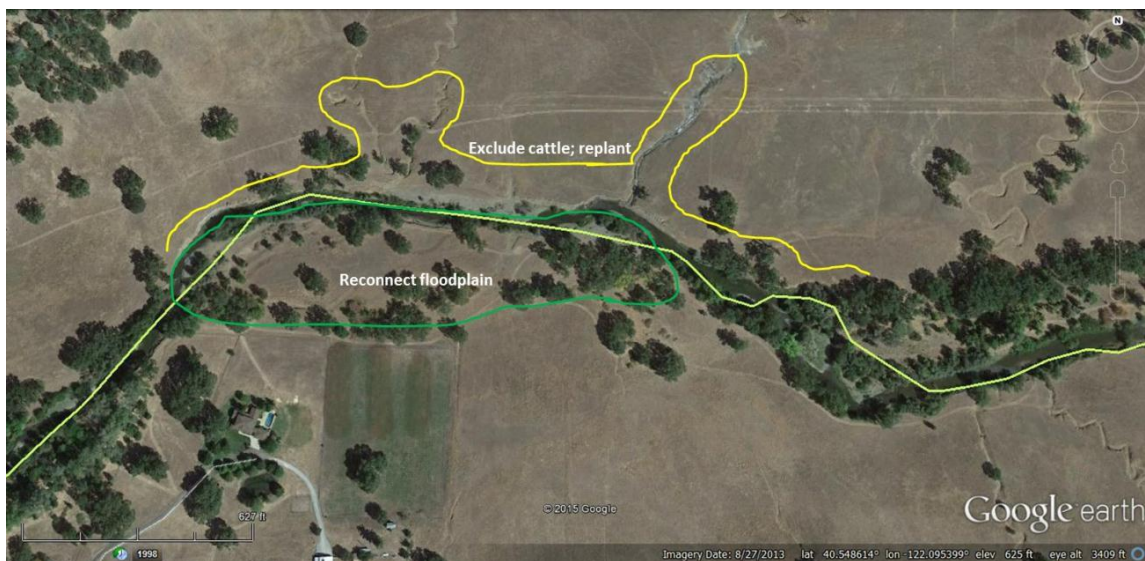
**Figure 6-15.** Condition reach 7b, site 2 along South Cow Creek upstream of Old Cow Creek Confluence. Recommended priority management actions include excluding cattle from within 100 ft of channel and exploring options to increase river left floodplain connectivity.

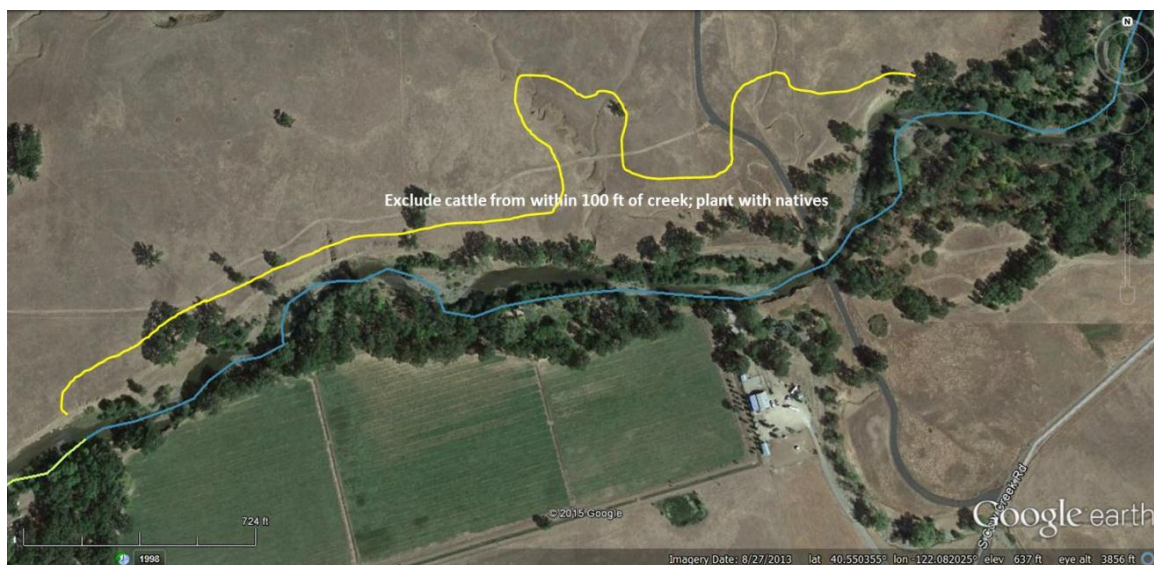
**Figure 6-16.** Condition reach 7c, site 1 along South Cow Creek above Old Cow Creek confluence. Recommended action is to exclude cattle from within 100 ft of channel on river right.

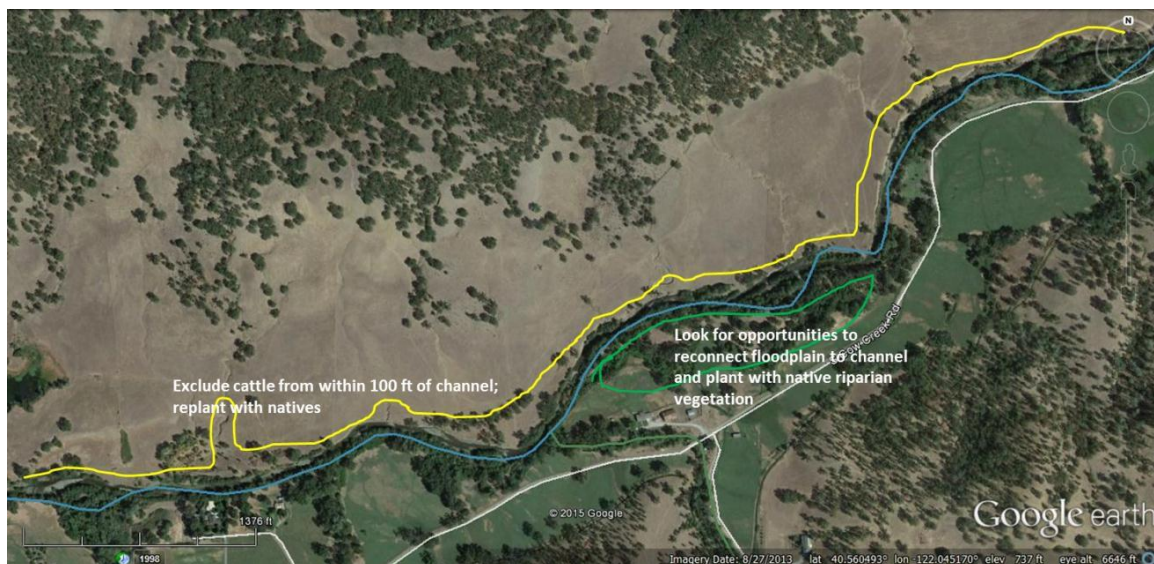
**Figure 6-17.** Upper condition reach 7c, site 2 along South Cow Creek above Old Cow Creek confluence. Recommended action is to exclude cattle from within 100 ft of channel on river right and explore opportunities to increase floodplain connectivity along river left.

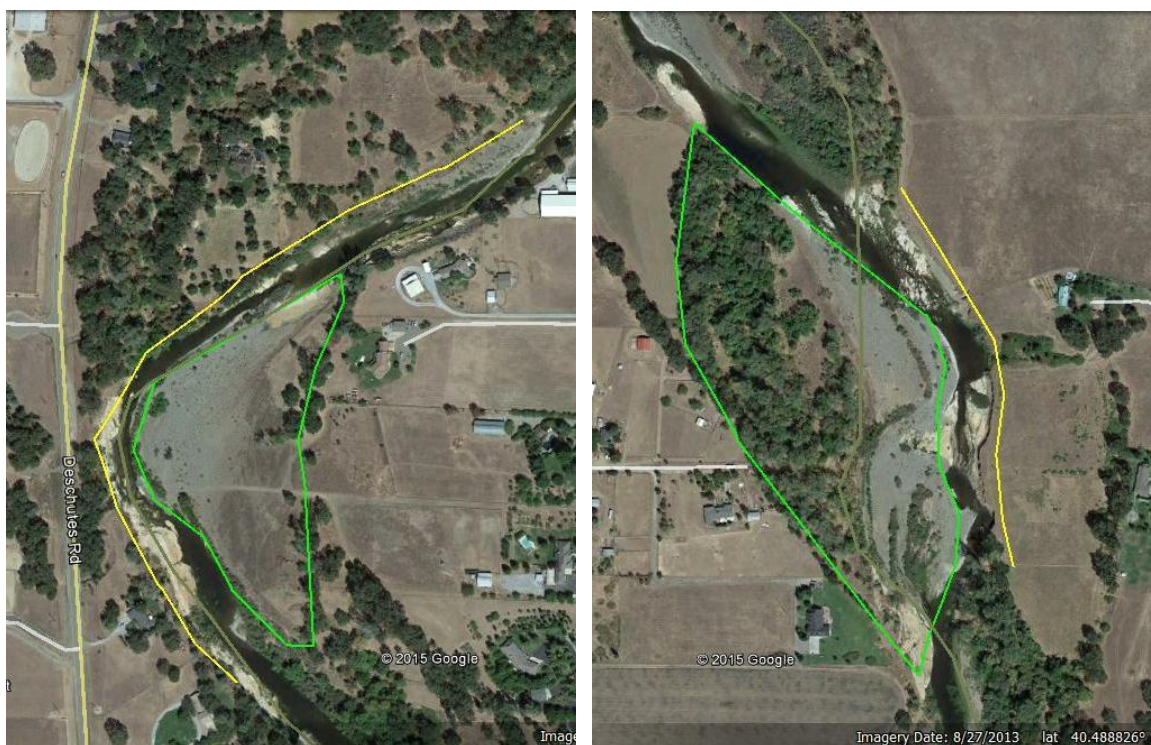
**Figure 6-18.** Condition reach 1a sites 3 and 4 (left), and 7 and 8 (right) along lower Mainstem Cow Creek. These are examples of areas where existing floodplains could be protected and enhanced, and eroding channel banks set back and or planted, according to findings on local processes and needs.

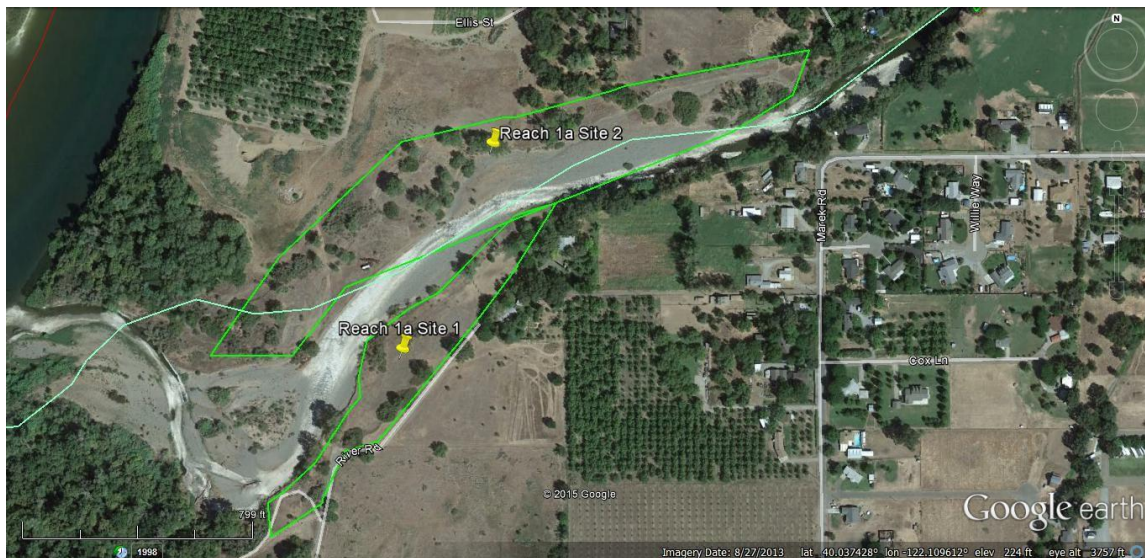
**Figure 6-19.** Mill Creek condition reach 1a sites 1 and 2 (lower and upper, respectively).  
(Google imagery date 8/27/2013)

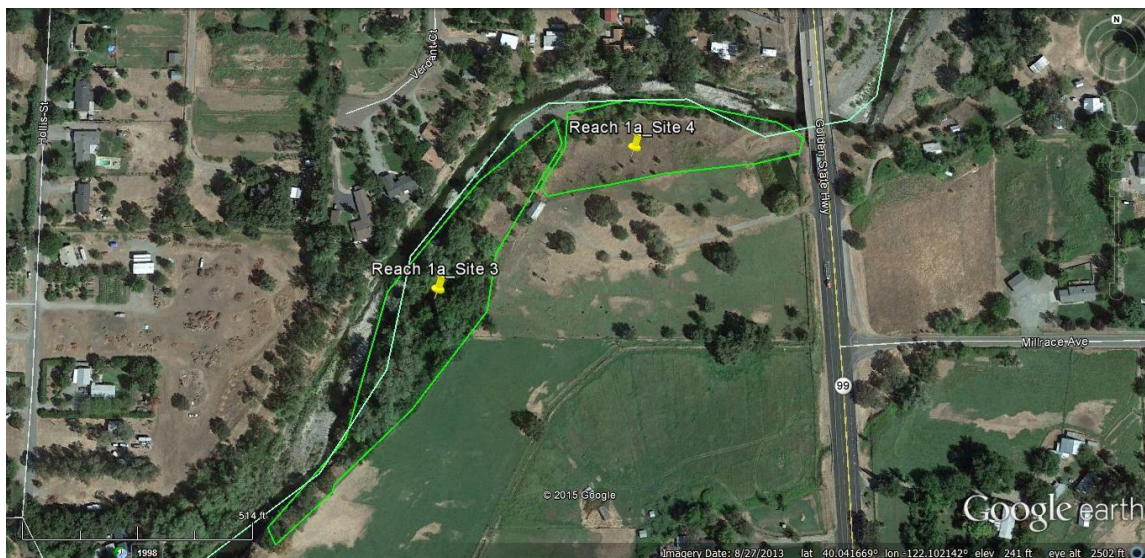
**Figure 6-20.** Mill Creek condition reach 1a sites 3 and 4 (lower and upper, respectively).  
(Google imagery date 8/27/2013)

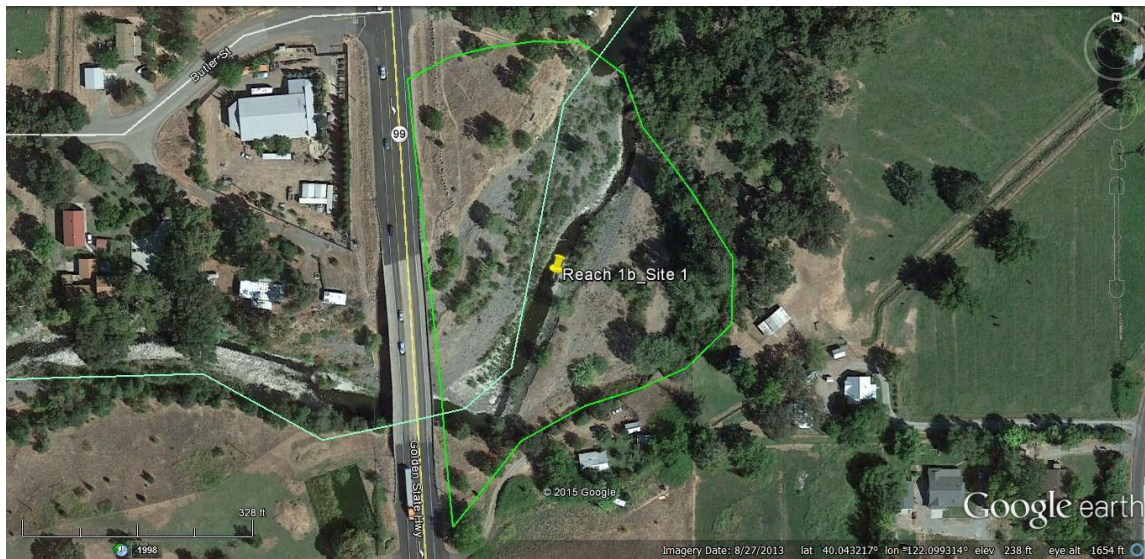
**Figure 6-21.** Mill Creek condition reach 1b site 1. *Arundo* eradication and enhancement of existing native riparian vegetation is recommended. (Google imagery date 8/27/2013)

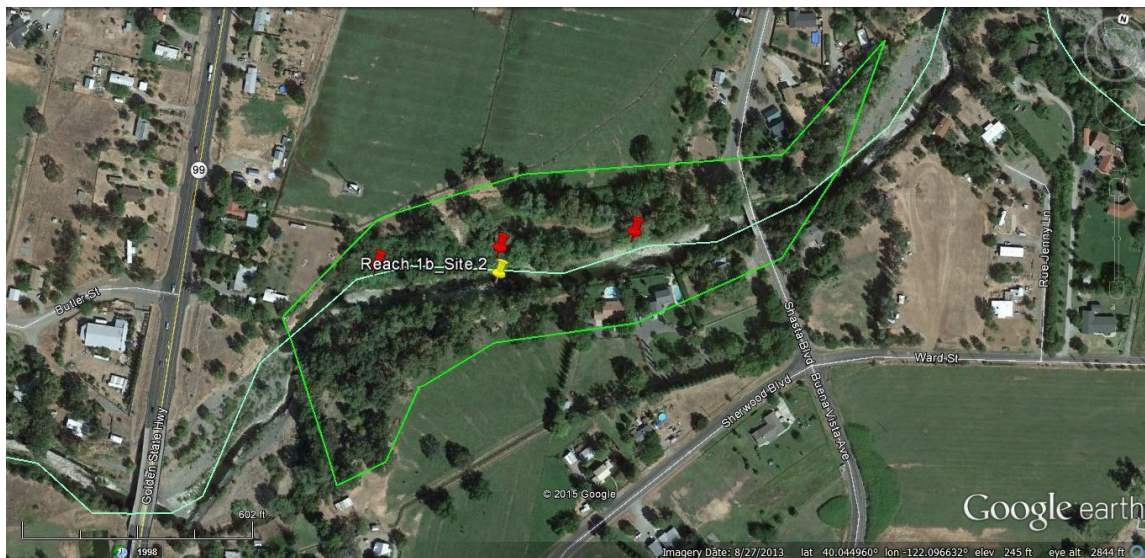
**Figure 6-22.** Mill Creek condition reach 1b site 2, with recommendations to enhance existing vegetation and to eradicate invasive weeds (*Arundo* locations shown with red pins). (Google imagery date 8/27/2013)

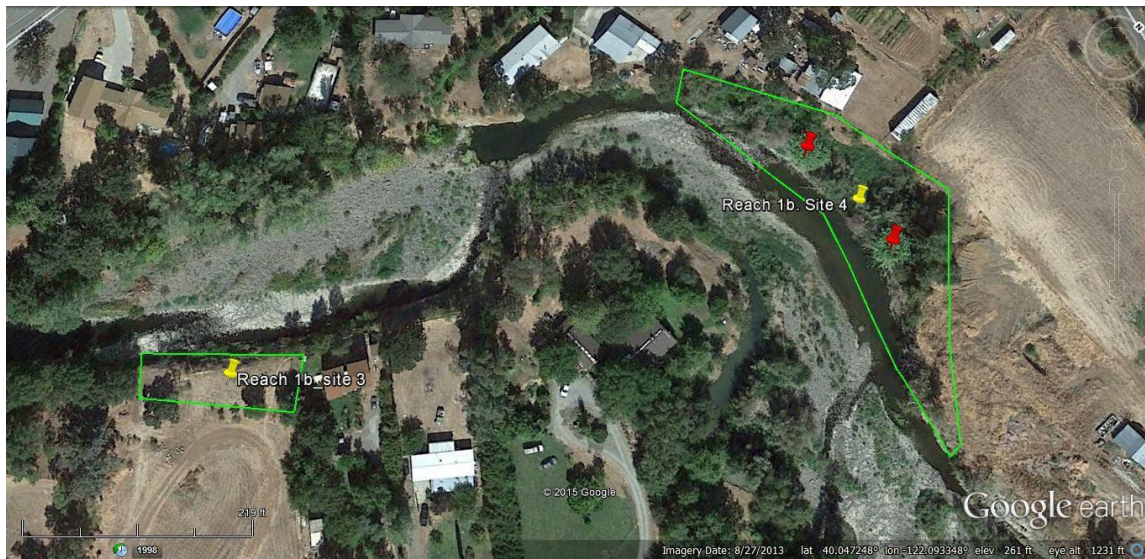
**Figure 6-23.** Mill Creek condition reach 1b sites 3 and 4 (left and right polygons, respectively). Planting native trees for shade recommended at site 3, and enhancement of existing native riparian vegetation recommended for site 4, including weed eradication (*Arundo* locations shown with red pins). (Google imagery date 8/27/2013)

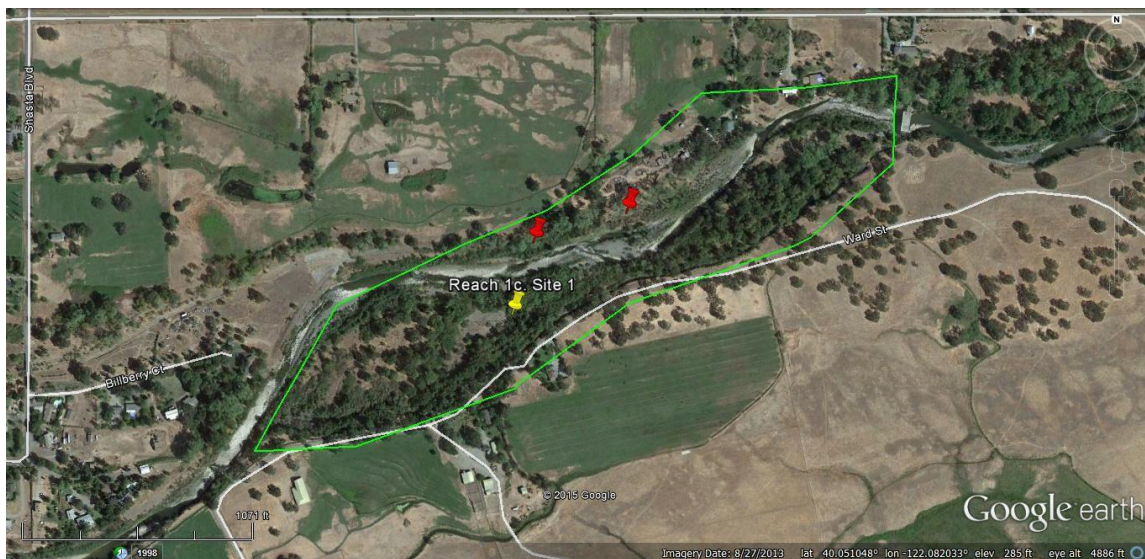
**Figure 6-24.** Mill Creek condition reach 1c site 1, with recommendations to enhance existing vegetation and to eradicate invasive weeds (*Arundo* locations shown with red pins). (Google imagery date 8/27/2013)

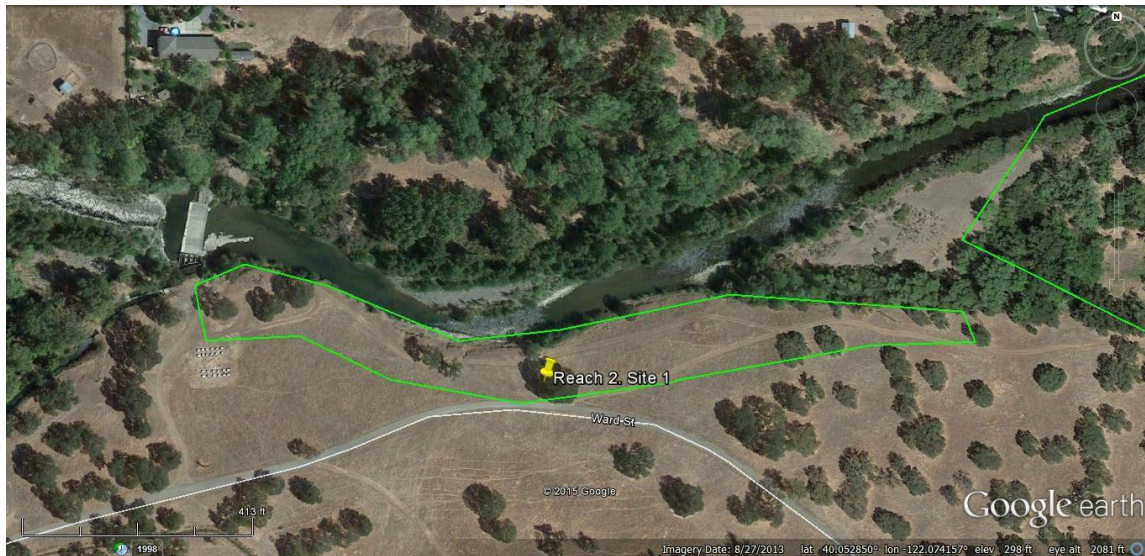
**Figure 6-25.** Mill Creek condition reach 2 site 1, with recommendations to enhance existing vegetation, work with the landowner to exclude grazing from within 100 ft of the channel edge, and to plant shade trees along the southern channel bank. (Google imagery date 8/27/2013)

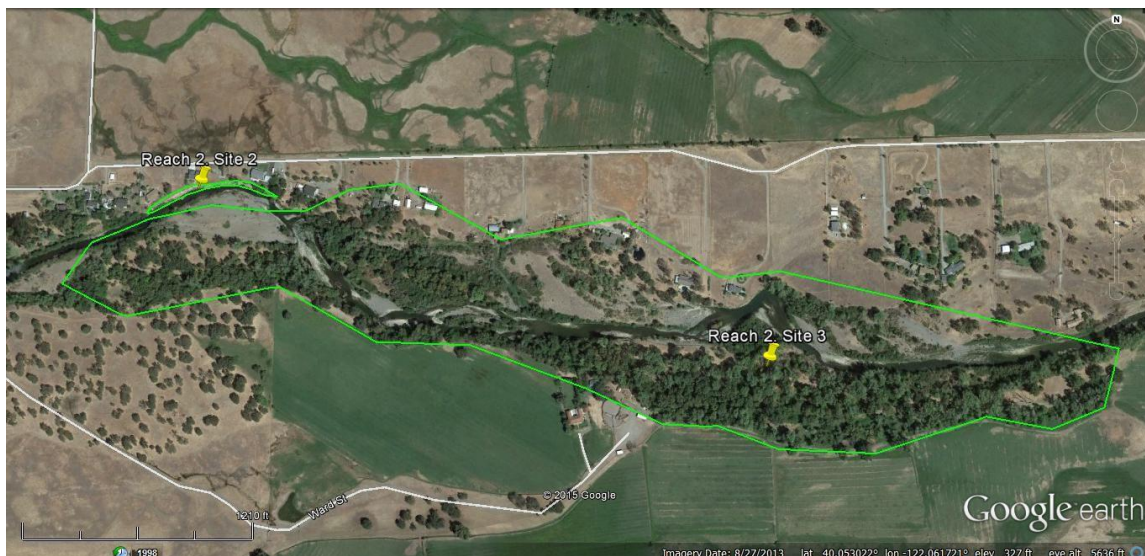
**Figure 6-26.** Mill Creek condition reach 2 sites 2 and 3 with recommendations to enhance existing vegetation. (Google imagery date 8/27/2013)

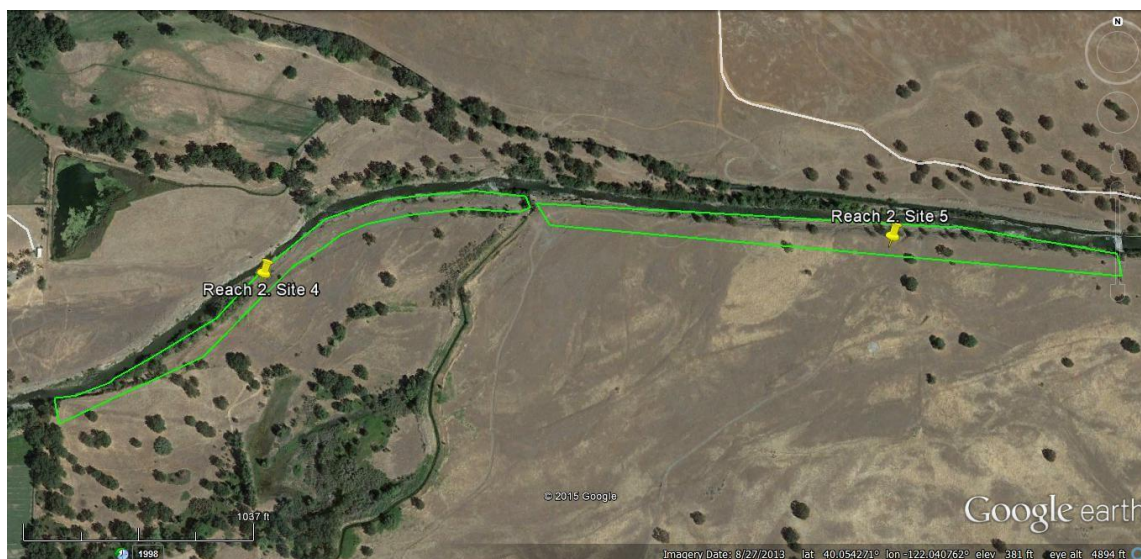
**Figure 6-27.** Mill Creek condition reach 2 sites 4 and 5, with recommendations to enhance existing vegetation, work with the landowner to exclude grazing from within 100 ft of the channel edge, and to consider planting shade trees along the southern channel bank. (Google imagery date 8/27/2013)

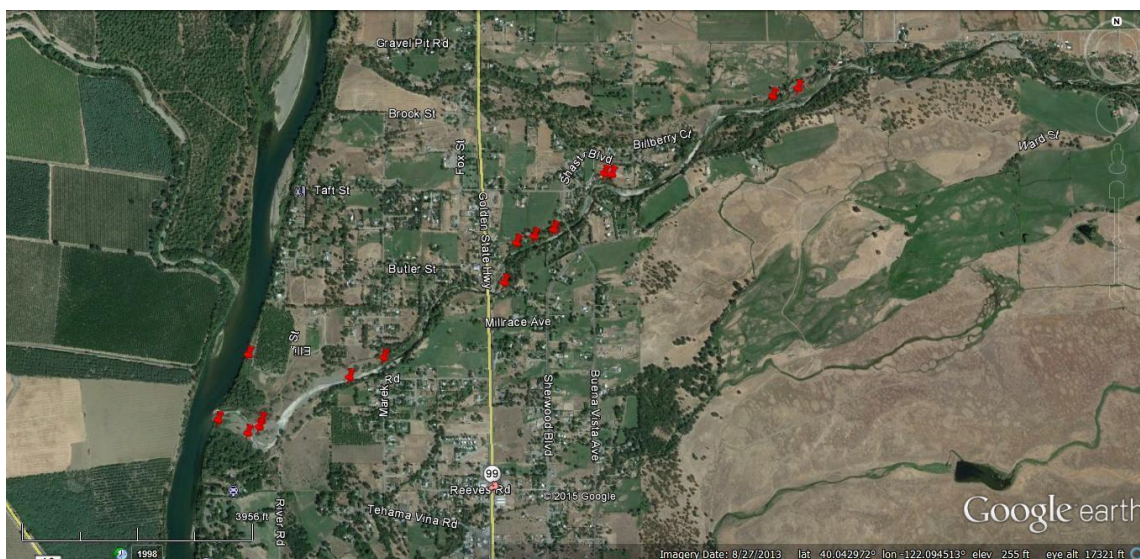
**Figure 6-28.** Observations of *Arundo* along Mill Creek from the upper end of condition reach 1c (where North Mill Creek distributary diverges from the mainstem) to the confluence and banks of the Sacramento River. (Google imagery date 8/27/2013)

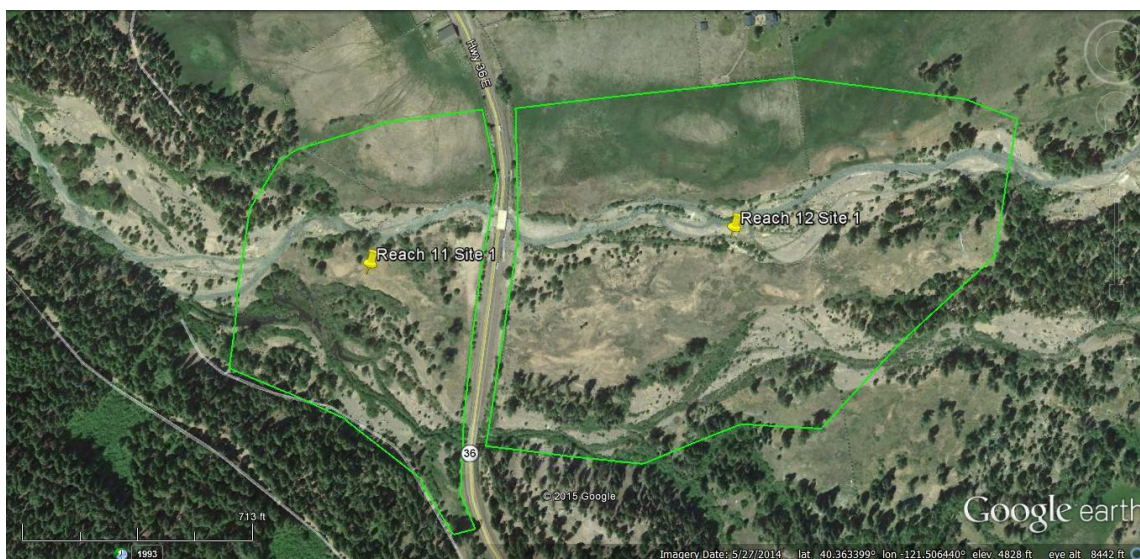
**Figure 6-29.** We recommend a closer review of the geomorphic, hydrologic and vegetation conditions along the stream channel and meadows above and below highway 36; part of condition reach 11 (below 36 to the left) and 12 (above 36 to the right).
