Dual-Frequency Identification Sonar (DIDSON) and Adaptive Resolution Imaging
Sonar (ARIS) monitoring of southern California steelhead in Santa Barbara and
Ventura Counties

2016 Annual Report for the California Department of Fish and Wildlife

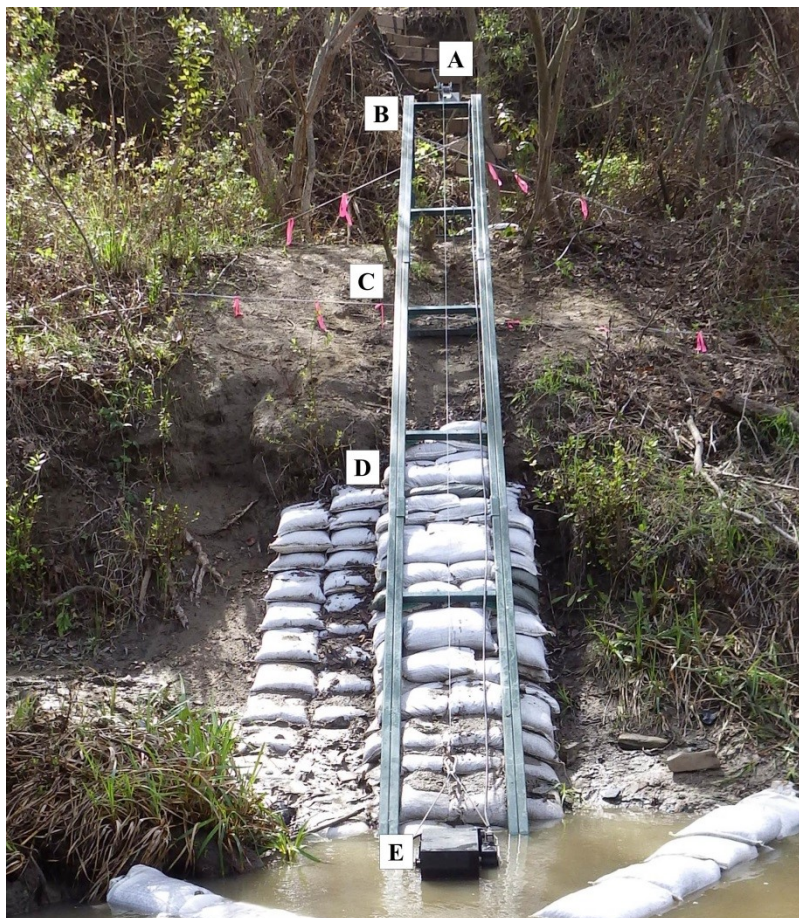
FIGURE 2. Salsipuedes Creek DIDSON deployment track system as seen during its last deployment in 2014 with key features labeled. (A) winch; (B) track; (C) cross-bracing cables; (D) gravel bag berm; (E) DIDSON/X₂/sled assembly.

A standard DIDSON unit was assigned to this site and a previously established track/sled system designated as the camera mount (FIGURE 2). The track is 30 feet in length and follows the bank's profile at a shallow angle. The track is mounted to steel legs that have been set into the bank at a depth of at least 3 feet. Further stability is achieved by cross-bracing the structure with aircraft cable. The space between the track and bank below has been blocked with gravel bags to prevent fish from passing below or behind

the camera. The DIDSON is affixed to an X₂ pan and tilt rotator. The X₂ is controlled by the DIDSON topside software, allowing for remote aiming of the DIDSON. The DIDSON and X₂ are mounted to an aluminum sled using hardware produced by Sound Metrics. The sled is then placed on the track where it can be raised and lowered by a winch tethered to the sled by aircraft cable. This allows for the camera height to be adjusted as needed without having to physically enter the stream when conditions may be unsafe.

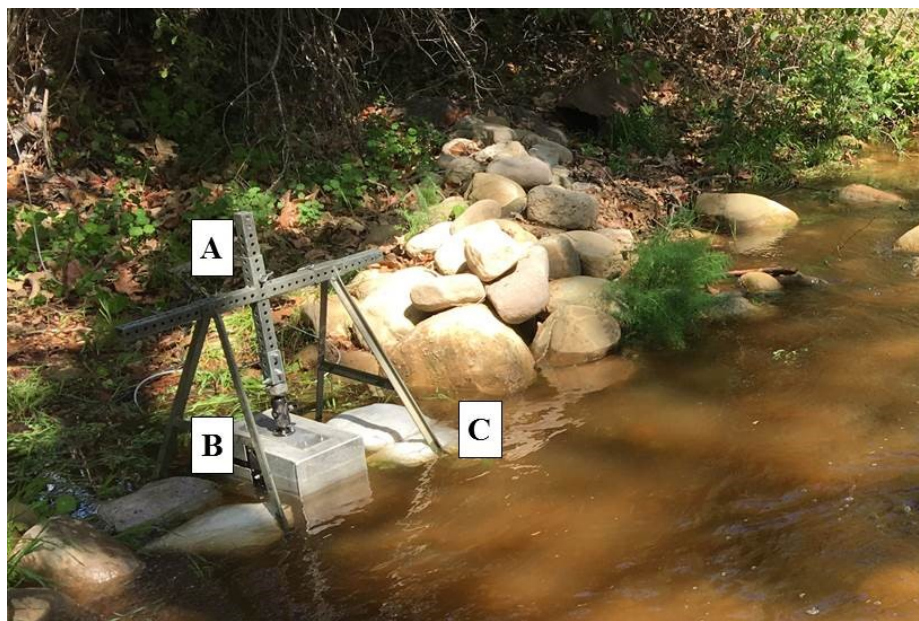
FIGURE 3. Carpinteria Creek DIDSON deployment infrastructure with key features labeled. (A) A-frame; B) DIDSON housed in a debris box and silt box; (C) gravel bags anchoring sled feet.

A long range DIDSON 300 m unit operating in high frequency mode (1.2 MHz) was used for all deployments in Carpinteria Creek. The long range model operates at a lower resolution than the standard model when in high frequency mode; however, imagery produced was sufficient to monitor fish passage as *O. mykiss* is the only extant fish species in the basin making fine detail unnecessary for species determination. The camera was positioned along the bank, facing perpendicular to flow and set at

shallow angle to allow for complete ensonification of the stream channel contained within the sonar's field of view (Pipal 2010). The camera was housed in a Sound Metrics manufactured siltbox as well as a custom aluminum "debris box" to prevent sediment accumulation on the lens and to provide a measure of protection from debris flows. The housings were then secured with a padlock. The camera was attached to a steel, sled foot "A- frame" mount using a RAM double socket ball joint as described by Larson et al. 2013. The sled was anchored using gravel bags and by an aircraft cable tether running from the housing's padlock to a large nearby tree. The cable served as both a safeguard against equipment being swept away and theft. The mount was flanked by berms composed of native cobbles and positioned to direct fish to an optimal distance from the lens (~1.25 m) while preventing fish passage behind the camera. The DIDSON was connected to topside electronics via a 60 m cable assembly.

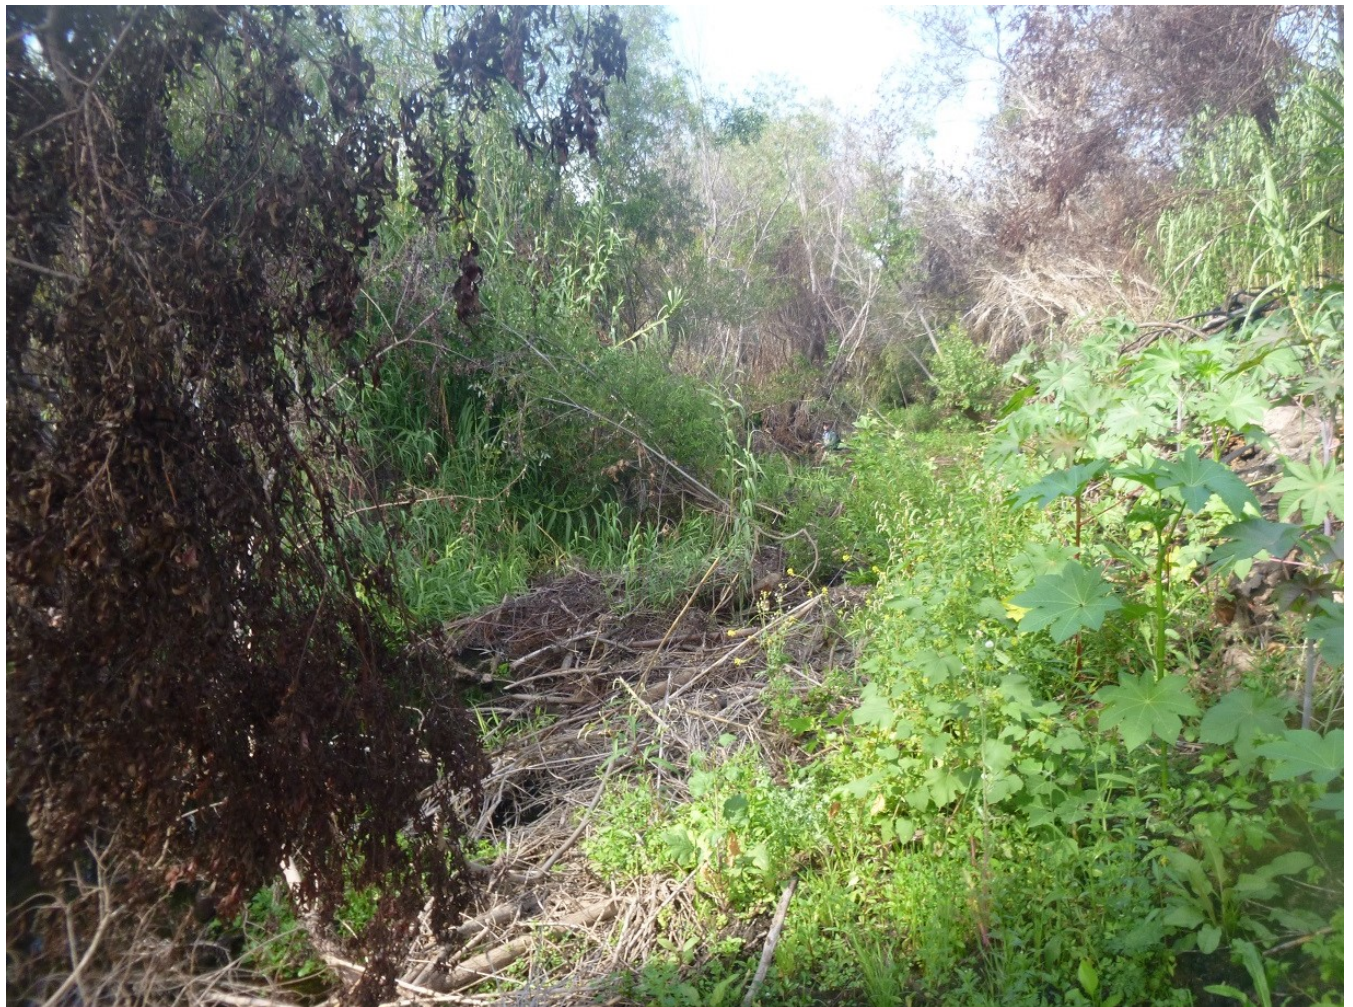
FIGURE 5. A channel spanning low flow fish passage barrier composed of woody debris and vegetation in the lower Ventura River.

Flow regimes in southern California are expected to be highly episodic, but persistent drought effects combined with another year of below normal rainfall (FIGURE 6) have exacerbated this condition. As a result deployment opportunities were extremely limited and short in duration (FIGURE 7). In the Ventura River, sequential drought years have allowed instream vegetation, normally removed by seasonal flushing, to proliferate and form channel spanning mats. This vegetative material combined with displaced woody debris to form temporal fish passage barriers. These barriers restricted potential fish movement in the lower watershed and were a contributing factor in limiting deployment duration (FIGURE 5).
