Southern California Steelhead Monitoring: Santa Ynez River, Conception Coast,  
and Ventura River 2013–2015

**Report for the California Department of Fish and Wildlife  
Fisheries Restoration Grants Program (Project Number: P1250012)**

Pacific States Marine Fisheries Commission

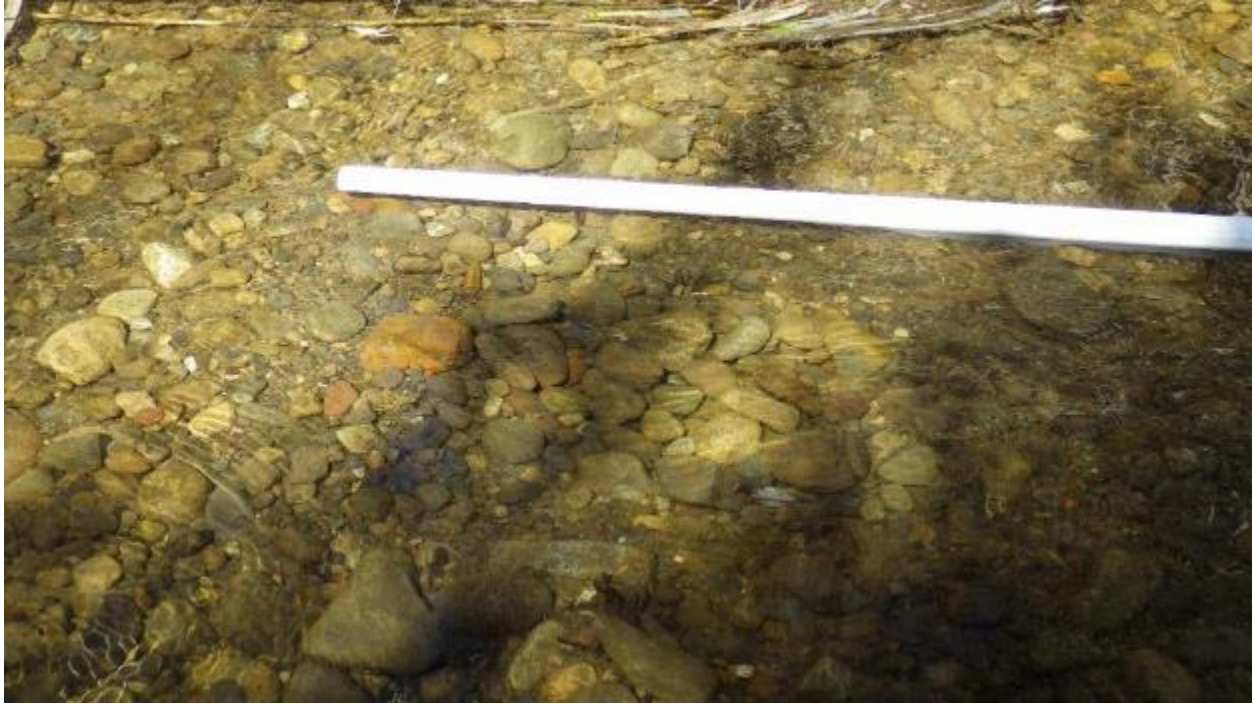
**Figure 147.** Observed redd in San Antonio Creek March 17, 2014.

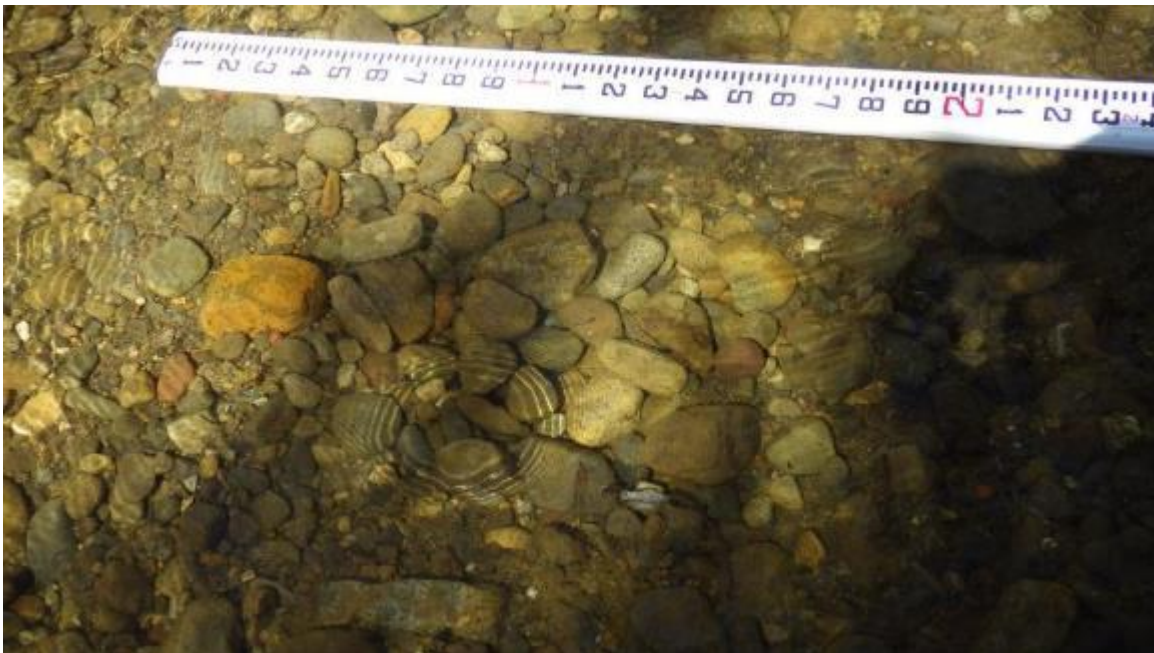
**Figure 154.** Observed redd in San Antonio Creek Reach 1, March 17, 2014, that later became dry.

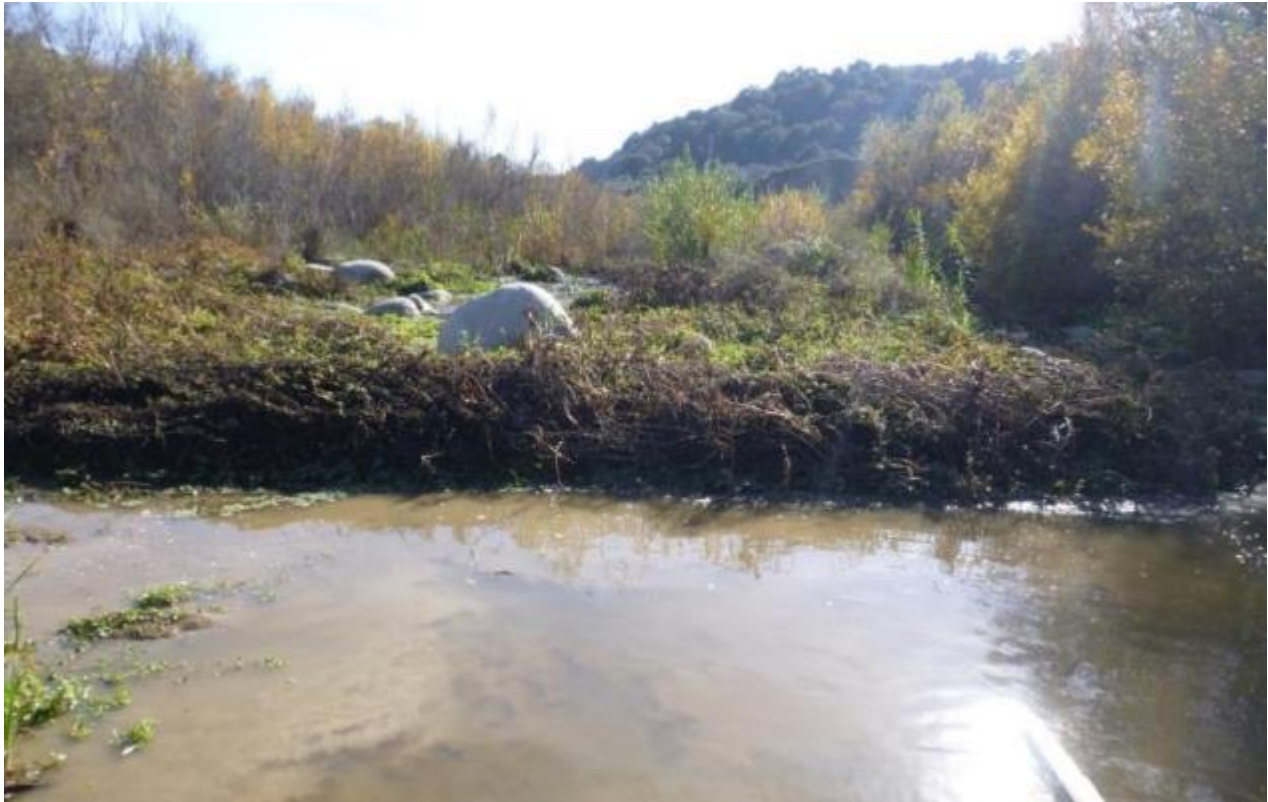
**Figure 161.** Invasive primrose formed barrier observed on the lower Ventura River main stem on January 13, 2015. This barrier was 1 m in height and spanned the entire wetted channel.
