Assessment of Steelhead Habitat and Migration Barriers within Watersheds Impacted by the Thomas, Whitter, and Topanga Wildfires

Pacific States Marine Fisheries Commission

California Department of Fisheries and Wildlife

September 10, 2019

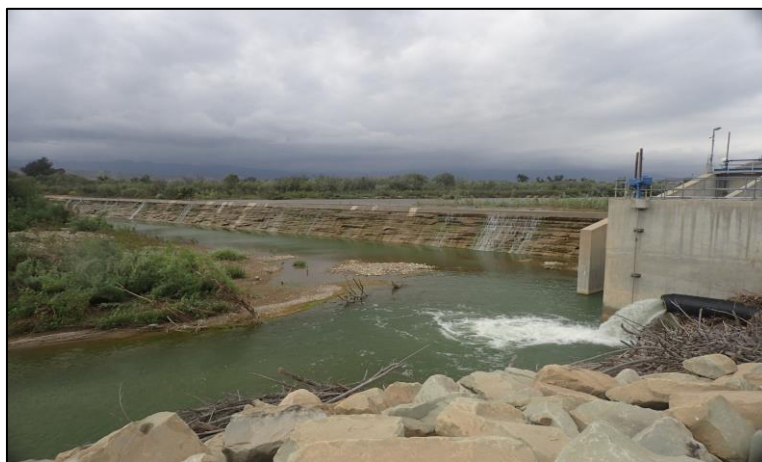
Figure 16. Downstream view of Freeman Diversion Dam

Santa Clara River Watershed - Santa Clara River - Vern Freeman Diversion Dam						
Barrier ID	PAD ID	Location	Previous Barrier Status	Current Barrier Status	Remediation Score	Figures
SCL_005_NR	70025	34.29891, -119.10867	Partial	Partial	17.8	16 - 17

Over the 22.25 stream miles of the Santa Clara River surveyed between the Pacific Ocean and the Sespe Creek confluence the only structure assessed to contain passage constraints was the Vern Freeman diversion dam, which is owned and operated by the Bureau of Reclamation and the United Water Conservation District. Located 10.7 stream miles from the Pacific Ocean the Vern Freeman diversion dam spans 1200 feet across the river channel and a height of roughly 25 feet. The dam contains a Denil fishway and when streamflow permits operates at a 35 ft³/s to 100 ft³/s flowrate. When the dam was assessed for this project the fishway was operating. Successful steelhead passage through the fishway has been documented although not since 2012. Currently a video camera and DIDSON sonar camera are being used to document occurrences of fish passage. Streamflow not passing through the fishway primarily cascades over and down the face of the dam. Some streamflow is directed through a separate passageway for *O. mykiss* smolts migrating downstream. In previous passage assessments NOAA personnel identified insufficient fishway attraction flows as a potential limiting factor for upstream migrating steelhead (CDFW PAD). Debris blockage and strong flow velocities are other possible passage issues with the Denil fishway at this site. When the fishway is operating the Vern Freeman diversion dam should be considered a partial barrier. However, when the

fishway is not operational the dam is a total barrier. United Water is currently in the process of evaluating several possible alternative engineering designs to improve fish passage. A recent court decision (Wishtoyo et al. vs. United 2018) has mandated that a preferred design alternative be selected and submitted as a component within a draft Habitat Conservation Plan by June 2020.

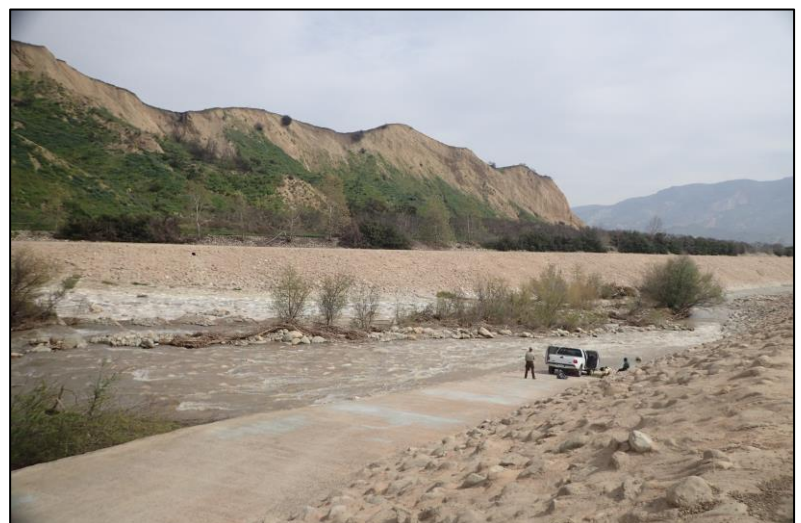
Santa Clara River Watershed - Santa Paula Creek - Army Core of Engineers Flood Control Stream Modifications						
Barrier ID	PAD ID	Location	Previous Barrier Status	Current Barrier Status	Remediation Score	Figure
None Assigned	723741	34.35152, -119.04864	Not a Barrier	Not a Barrier	NA	18
SCL_003_NR	72342	34.37555, -119.0561	Total	Unknown	19.6	18

To provide flood control for the city of Santa Paula, roughly 1.6 miles of the lowest 1.8 miles of Santa Paula Creek has been modified by the U.S. Army Core of Engineers (USACE). These modifications include concrete and boulder rip rap flood control channelization (PAD ID: 723741) and a concrete grade control structure (PAD ID: 723742). The flood control channel contained a natural streambed substrate and was assessed to be free of passage constraints. However, the confined channel was primarily void of vegetation and lacked channel complexity. 96.9 percent of the flood control channel was assessed as shallow riffle habitat with few areas likely suitable for migrating *O. mykiss* to spawn or rest. The 277-foot long grade control structure rises roughly 23 feet and is located at the upstream extent of the concrete flood control channel. A concrete steel reinforced weir and pool fishway is located in the center of the structure. Conditions within the fishway did not appear favorable to *O. mykiss* passage as all weirs were degraded and each bay contained sediment and vegetative debris accumulation causing shallow turbulent streamflow conditions. Additionally, a minimal portion of the streamflow was flowing through the fishway at the time of assessment (3/19/19), despite a streamflow rate of roughly 70 ft³/s (USGS). Considering the conditions encountered at the time of assessment this structure is likely a total barrier, but due to complexities of streamflow hydraulics in the fishway a definitive barrier status for the structure was not able to be determined. Total barrier status was assigned when this structure and fishway was previously assessed in 2005 following historic streamflow levels and flooding (Stoecker 2002).

Figure 18. USACE grade control and flood control channel on Santa Paula Creek.

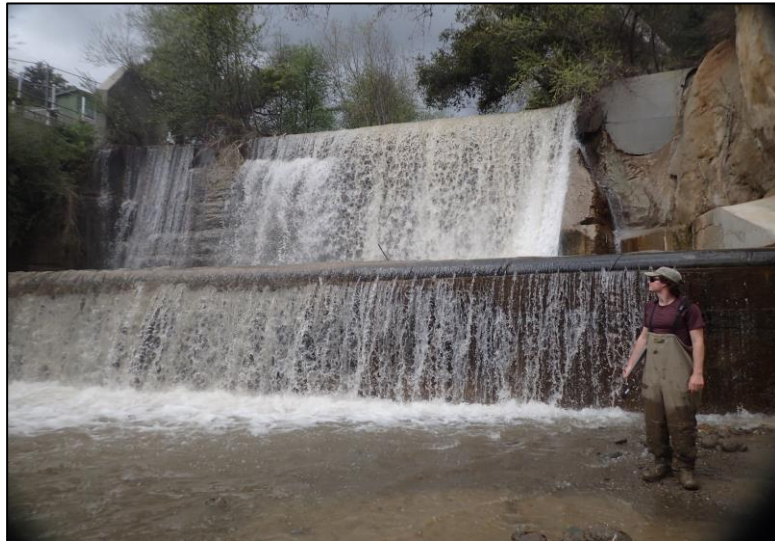
Santa Clara River Watershed - Santa Paula Creek – Harvey Diversion Dam						
Barrier ID	PAD ID	Location	Pervious Barrier Status	Current Barrier Status	Remediation Score	Figures
SPL_005_NR	705338	34.39557, 119.07605	Total	Total	18.6	19 - 20

The Harvey Diversion Dam is located 3.6 miles upstream from the Santa Clara River confluence. The dam has two significant plunge points and a concrete fishway. The dam was assessed on 3/21/19 and 3/25/19. During the initial first pass assessment no water was passing through the fishway and the each fishway bay contained excessive sediment. During the follow up assessment water was passing through the fishway, but the entrance of the fishway appeared inaccessible to upstream migrating *O. mykiss*. The height to the entrance bay of the fishway was measured to be 4.2 ft. At the time of assessment the water depth below the entrance was only 1.8 feet with turbulent conditions as shown in figure 20. Under these conditions *O. mykiss* are unable to access the fishway and the dam was assigned a total barrier status. Caltrout has received funding to conduct a fish passage restoration project at the Harvey diversion dam in which the dam will be partially removed and the downstream channel stabilized with grade control structures (Caltrout).

Figure 19. Downstream view of Harvey Dam plunge points.

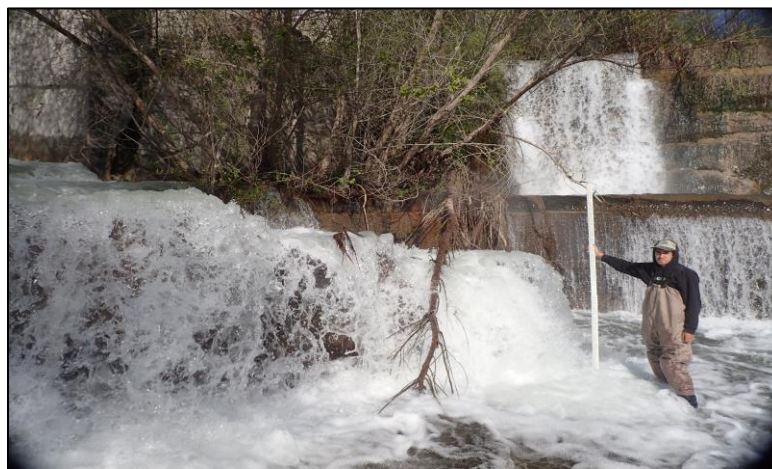
Figure 20. Harvey Dam fishway entrance (3/25/19.)

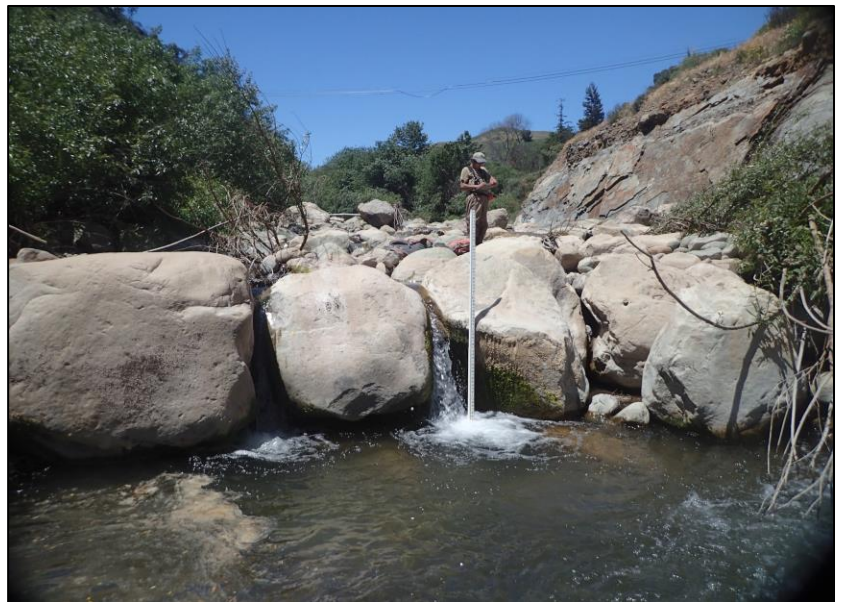
Santa Clara River Watershed - Santa Paula Creek – Grade Control Structures						
Barrier ID	PAD ID	Location	Previous Barrier Status	Current Barrier Status	Remediation Score	Figures
SPL_007_NR	None Assigned	34.42621, -119.08852	No Status	Partial	13.95	22
SPL_008_R	723744	34.42651, -119.08941	Partial	Partial	15.6	21

Figure 22. Boulder rip rap grade control downstream of Hwy 150 bridge.

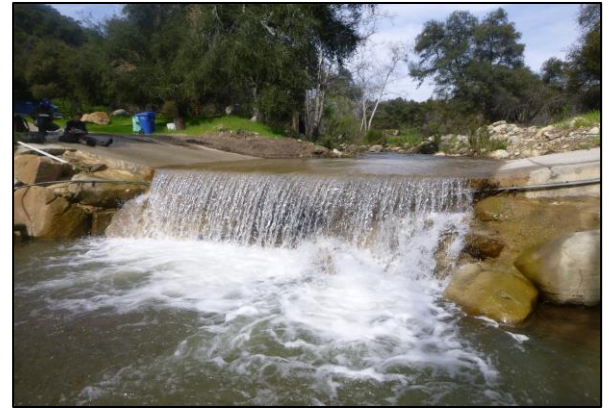
Santa Clara River Watershed - Sisar Creek – Private Road Low-Water Crossing						
Barrier ID	PAD ID	Location	Previous Barrier Status	Current Barrier Status	Remediation Score	Figure
SIS_006_R	None Assigned	34.42842, -119.11304	No Status	Unknown	16.5	23

The first structure encountered with passage constrains in assessing Sisar Creek is a private concrete low-water crossing located 1.4 stream miles from the confluence with Santa Paula Creek. When the first pass assessment was performed on 3/19/19 streamflow was shallow as it flowed over the crossing and plunged 4.8 feet to the downstream pool. A detailed 2nd pass assessment was unable to be performed due to access restrictions associated with the private property this structure is located on. A definitive barrier status determination was unable to be made due to the limited data collected at this crossing, however it is likely this structure is a temporal and partial barrier passable only at high rates of stream flow to the strongest anadromous steelhead.

Figure 23. Private road low-water crossing on Sisar Creek.

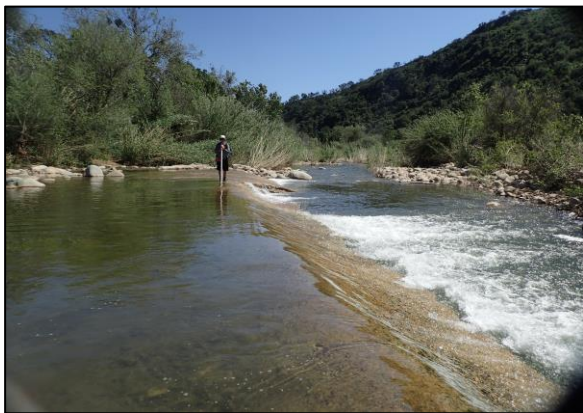
Foster Park Diversion Dams	Mean Depth Below Plunge (ft)	Mean Height of Structure (ft)	Mean Cascade Length (ft)	Mean Breadth (ft)
Downstream Dam	2.5	2.1	7.0	6.2
Upstream Dam	7.0	2.0	2.2	1.0

Figure 27. Downstream Foster Park diversion dam.

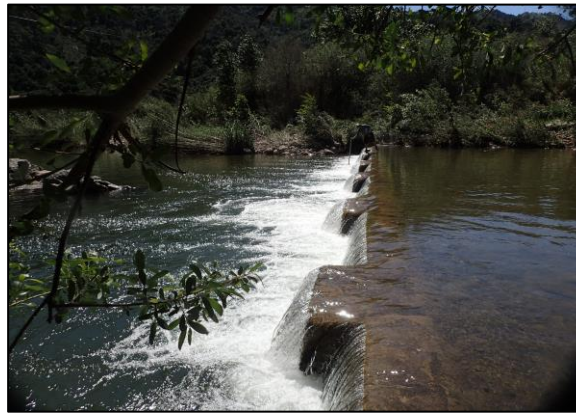
Figure 28. Upstream Foster Park diversion dam.

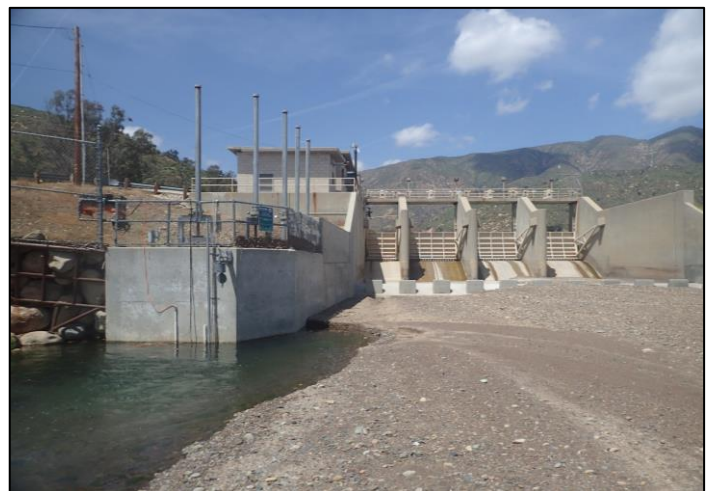
Ventura River Watershed – Ventura River – Robles Diversion Dam						
Barrier ID	PAD ID	Location	Previous Barrier Status	Current Barrier Status	Remediation Score	Figure
VEN_011_NR	713886	34.46454, -119.29061	Remediated, fish response unconfirmed	Partial	16.1	30

The Robles Diversion Dam is located roughly 14.35 stream miles upstream from the Pacific Ocean. The dam was originally constructed in 1958 and diverts water from the Ventura River Lake Casitas reservoir. The dam was eventually retrofitted with a fish passage facility following the listing of the southern California steelhead DPS under the Endangered Species Act, but this facility did not operate to allow for upstream *O. mykiss* migration until 2006 (Casitas Municipal Water District, 2017). The current fishway facility is designed to operate at a 50 ft³/s flowrate when streamflow permits and anadromous steelhead have been documented to successfully pass upstream through the fishway, but not since 2010 (Casitas Municipal Water District, 2011). Documentation of resident *O. mykiss* life stages passage through the facility have only occurred for downstream smolts. It is unlikely a resident *O. mykiss* could pass upstream through the facility fish ladder. The dam is listed in PAD with a barrier status of “remediated, fish response unconfirmed.” This status was provided following several alterations made to improve the fish passage through the facility. Considering no *O. mykiss* have been documented passing upstream through facility since these improvements were made it was determined that the dam presents as a partial barrier.

Figure 30. Downstream view of Robles Diversion Dam. Fish ladder entrance is located at the left of image, in the wetted portion of channel.

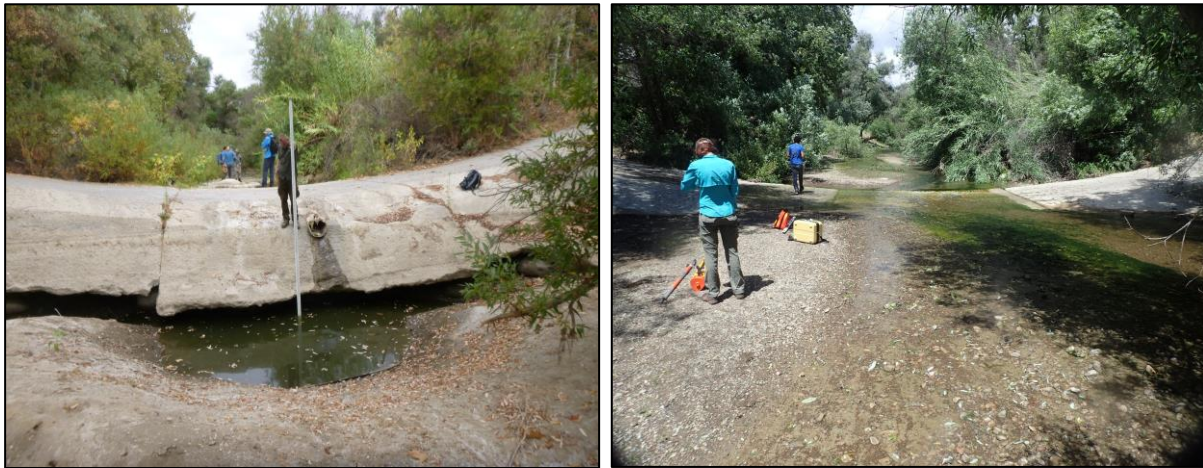
San Antonio Creek is a tributary to the Ventura River with a confluence located 8 stream miles upstream from the Ventura River mouth at the Pacific Ocean. Five low-water crossings were assessed over the course of San Antonio Creek, but only two of these crossings were assessed to constrict *O. mykiss* upstream movement. Two of the other three crossings passed through the natural streambed substrate of the stream. The Fraser Street low-water crossing (SNT_008_R) was initially assessed to contain passage constraints during first pass assessments due to a significant plunge at its outlet on 10/15/18, but when surveyed for a detailed assessment on 5/16/19 the downstream pool unit had been completely filled in with sediment and the crossing was assessed to no longer constrict upstream *O. mykiss* movement. Figures 31 and 32 depicts the change due to this sediment filling.

Figures 31 & 32. Fraser Street low-water crossing prior to (left) and after sedimentation (right).

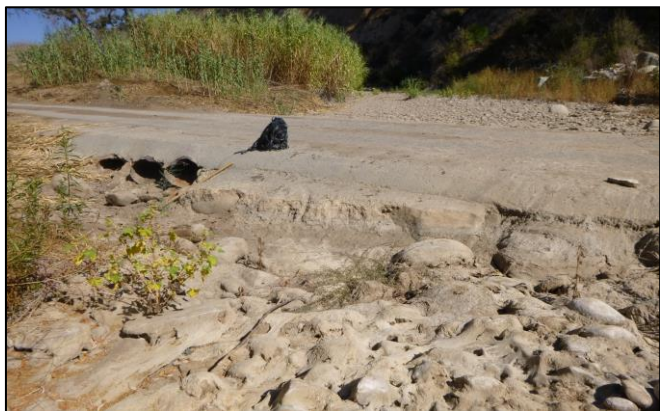
The two low-water crossings on San Antonio Creek assessed to contain passage constraints did not have PAD records indicating previous barrier status. The initial of these two low-water crossings (SNT_009_R) is located 3.2 stream miles upstream of the Ventura River confluence. Unfortunately, this crossing is private and permission to conduct a detailed assessment was not received. Without a detailed assessment being performed a definitive barrier status was not assigned. The concrete crossing contained three small cylindrical culverts encased just below the road surface, but each was completely embedded under sediment and not visible at the inlet. Due to the minimal plunge from the road surface at the outlet

this crossing is likely only a temporal barrier. The Hermitage Road crossing (SNT_027_R) is the other low-water containing passage constraints and is located at the confluence of Gridley Creek, Senior Creek, and San Antonio Creek, 9.74 stream miles upstream of the Ventura River confluence. This crossing also marks the upstream extent of San Antonio Creek. This concrete crossing also contains a single cylindrical culvert beneath the road surface. At the time of assessment this culvert was also fully embedded under sediment at its inlet. A 1.02 ft plunge was measured from the road surface outlet to the downstream unit. FishXing analysis estimated this crossing would be passable to steelhead at streamflows greater than 164 ft³/s, but deemed it unpassable to resident adult *O. mykiss*, thus resulting in this crossing being designated as a temporal and partial barrier.

Figure 33. SNT_009_NR low-water crossing on San Antonio Creek.

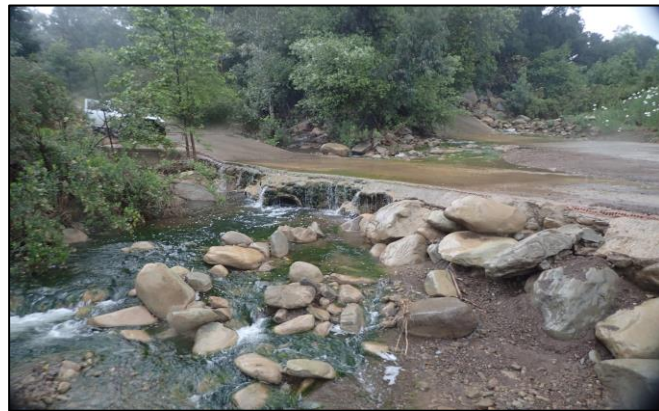
Figure 34. Hermitage Road low-water crossing on San Antonio Creek.

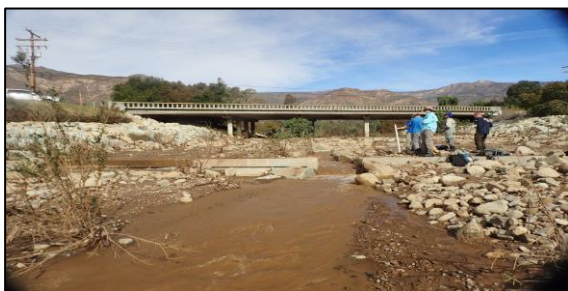
Two concrete grade control structures with 4 ft wide notches at their centers were assessed downstream of the Grand Avenue bridge crossing or 8.15 stream miles upstream of the Ventura River confluence. Each grade control extends across the entire width of the stream channel, which is lined with boulder riprap on both banks. Each grade control was also partially embedded within the channel substrate. The initial grade control (SNT_019_NR) had a mean height of 1.0 ft and the next grade control (SNT_020_NR) had a mean height of 0.7 ft. Both grade controls were assigned a temporal barrier status due to the likelihood of all *O. mykiss* life stages requiring specific streamflow rates to successfully gain passage.

Figure 35. Downstream notched grade control with Grand Avenue bridge in background.

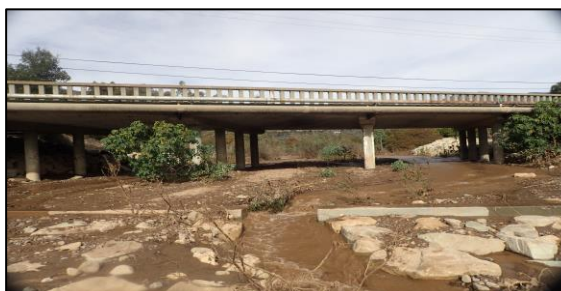
Figure 36. Upstream notched grade control with Grand Avenue bridge in background.

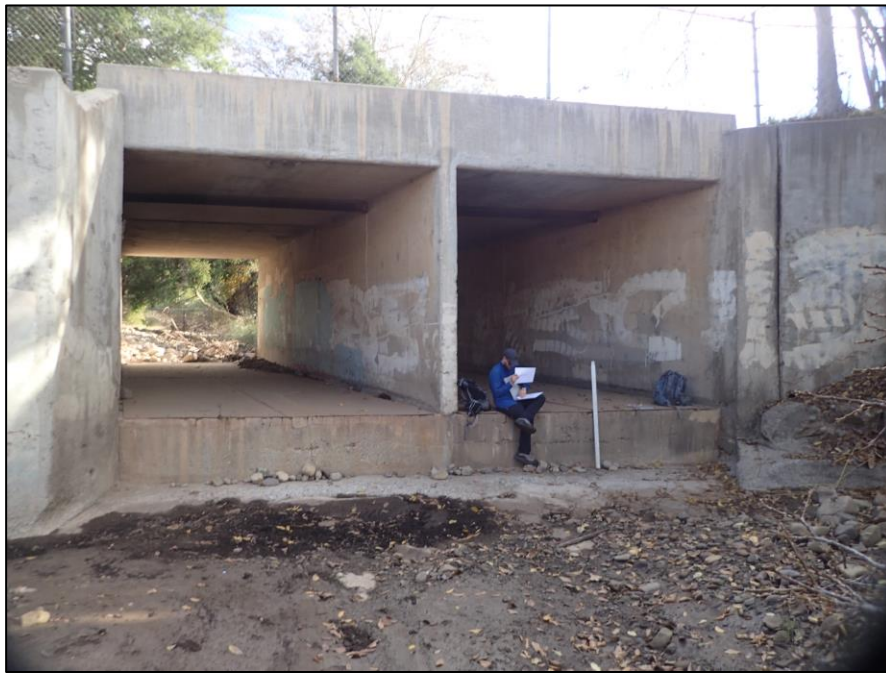
Thacher Creek is a tributary to San Antonio Creek with a confluence located 7.3 stream miles from the San Antonio Creek and Ventura River confluence. The first barrier assessed on Thacher Creek was a large set of concrete box culverts at the Boardman Road crossing half a mile upstream from the San Antonio Creek confluence. These culverts were separated with a concrete divider and each culvert base was lined with steel plates. Each culvert also had a vertical plunge point onto a concrete outlet apron. The plunge had a uniform height of 2.5ft. The presence of the outlet apron had appeared to largely prevent the occurrence of scour in the downstream unit. As a result, the max water depth within the downstream unit was only 0.6ft when a detailed assessment was conducted at the crossing on 3/5/19. FishXing analysis estimated this lack of downstream depth would prevent all life stages of *O. mykiss* from successfully jumping over the outlet plunge and gaining passage. The total barrier status assigned matched the existing barrier status assigned to the crossing by the Ventura County Planning Division in 2004.

Figure 37. View of Boardman Road crossing culvert outlets.

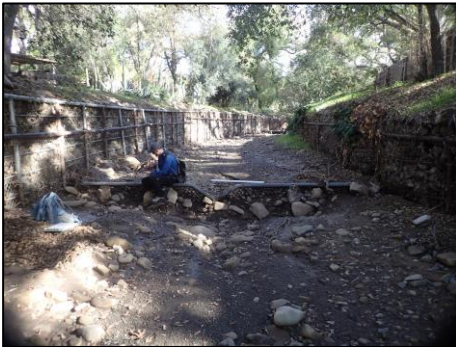
Figure 38. Downstream view of THC_002_NR.

Four grade control structures were assessed on Thatcher Creek. Three of these structures consisted of center notched steel crossbars extending across the width of a chain linked fence lined stream channel (THC_002_NR, THC_003_NR, and THC_004_NR). These three grade control structures were located within close succession of each other 0.7 stream miles from the San Antonio confluence. The mean height of these three grade control structures was 1.3ft, 1.2ft, and 0.6ft. At the time of assessment (12/20/18) no streamflow was present, however the uniform distribution of streambed substrate upstream and downstream of these three grade likely results in long shallow riffle units. Due to the lack of stream water depth that likely occurs in this part of Thatcher Creek during low rates of streamflow these three grade control structures were assigned a temporal barrier status.

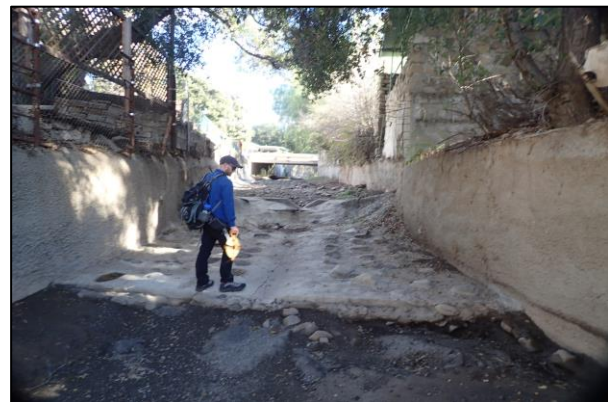
Figure 41. Downstream view of THC_006_NR.

The fourth grade control on Thatcher Creek is a cemented boulder riprap apron structure (THC_006_NR) located 0.8 stream miles from the San Antonio Confluence. The structure expands the width of the channel which is lined with vertical cement walls. The center of structure inlet has a small “V” shaped notch. The structure was assessed to be 29ft in length and have a mean height of 2.4ft. Successful passage of the structure would likely be challenging for all *O. mykiss* life stages, however due to the narrow constricted nature of the channel at this location high rates of streamflow may create deep laminar flow conditions conducive to *O. mykiss* passage. Due to the perceived possible passage a temporal and partial barrier status was assigned to the structure.

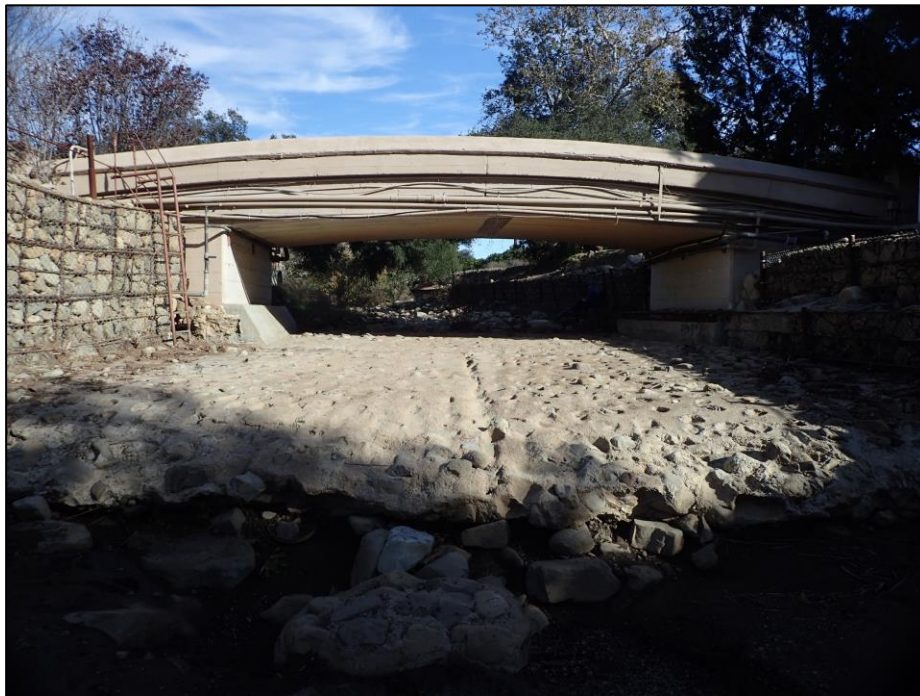
A private free spanning ranch bridge with a concrete cobble riprap apron below it was documented during first pass surveys located 1.7 stream miles from the San Antonio Creek confluence. Unfortunately access for a follow up detailed assessment was not granted and without such an assessment being performed a definitive barrier status could not be determined. During the first pass survey the length of the apron was estimated to be roughly 20 ft and the outlet of the apron was 2.7ft above the downstream substrate. At the time of this survey (12/20/18) no streamflow was present at this crossing, but lack of scour in the streambed downstream of the apron outlet suggests a lack of water depth at the plunge point when streamflow is present. This likely makes this private crossing and apron beneath it passable to only the strongest *O. mykiss* lifestages and only at high rates of streamflow.

Figure 42. Downstream view of private crossing and apron below it on Thacher Creek.

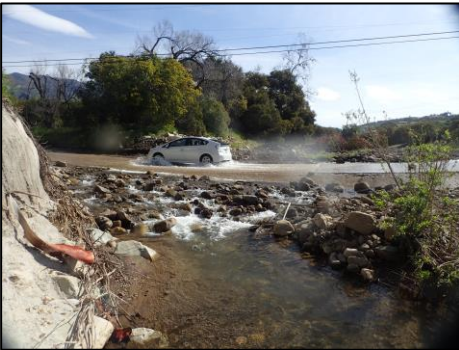
Three low-water road crossings were assessed on Thacher Creek to present as barriers to *O. mykiss*. The McNell Road crossing (THC_011_R) is located 2.1 stream miles from the San Antonio Creek confluence and was the initial low-water crossing assessed. This crossing has a short concrete outlet apron measured to have a length of 5.9ft and a height of 1.63ft. At the time of assessment (3/22/19) riffle units were present immediately upstream and downstream of the crossings, which contribute to an increased difficulty of *O. mykiss* passage. FishXing analysis estimated an anadromous steelhead life stage *O. mykiss* would be able to successfully gain passage once stream flows were above 173 ft³/s, but also estimated the adult resident life stage would not be able to pass the crossing under any rate of stream flow. Due to this the crossing was assigned a temporal and partial barrier status. The Ventura County Planning Division had assigned the crossing a partial barrier status in 2004. The Grand Avenue crossing (THC_013_R) is located 2.8 stream miles from the San Antonio Creek confluence was the other low-water crossing assessed on Thacher Creek. The Grand Avenue crossing has a significant concrete boulder riprap outlet apron which was assessed to have a length of 121ft and a height of 25.6 ft. This outlet apron makes this crossing impassible by all life stages of *O. mykiss* over all rates of streamflow as indicated by FishXing analysis. This also matches the barrier status assigned by the Ventura County Planning Division in 2004. Finally, the Thacher Road crossing (THC_015_R) passes through the natural substrate of the streambed and is located 3.7 stream miles from the San Antonio Creek confluence. Substantially sized boulders appeared to have been placed downstream of the crossing outlet to serve as foundation for the crossing. These boulders created a cascade downstream of the crossing that was measured to be 32 ft in length and 9.3 ft in height. FishXing analysis estimated the crossing would be passable to steelhead lifestage *O. mykiss* at streamflow rates greater than 229.5 ft³/s, but not passable to resident adult *O. mykiss* lifestages. This led to a temporal and partial barrier status being assigned to the crossing.

Figure 43. Downstream view of McNell Road low-water crossing on Thacher Creek.

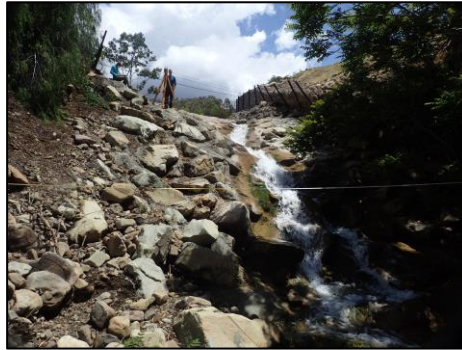
Figure 44. Downstream view of significant outlet apron at Grand Avenue crossing on Thacher Creek.

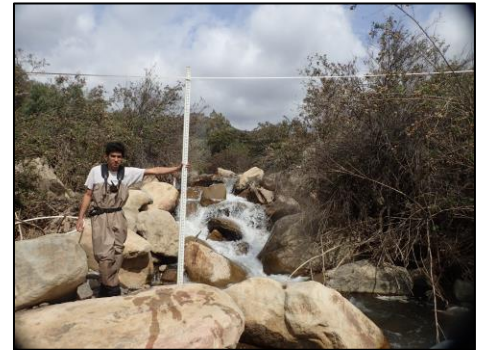
Figure 45. Boulder cascade downstream of the Thacher Road low-water crossing on Thacher Creek.

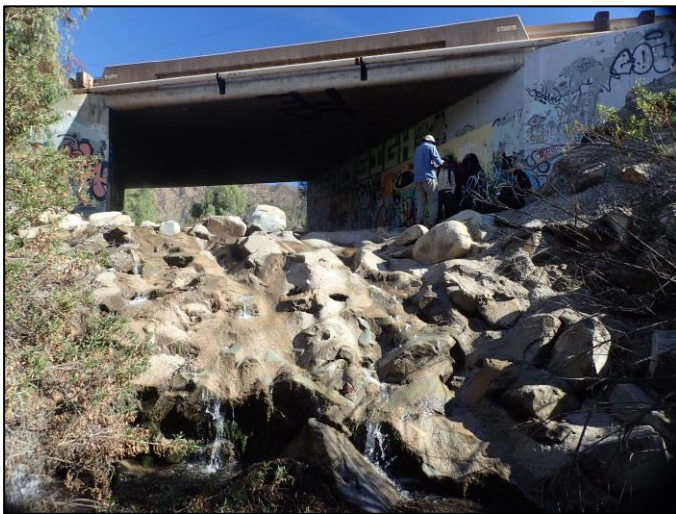
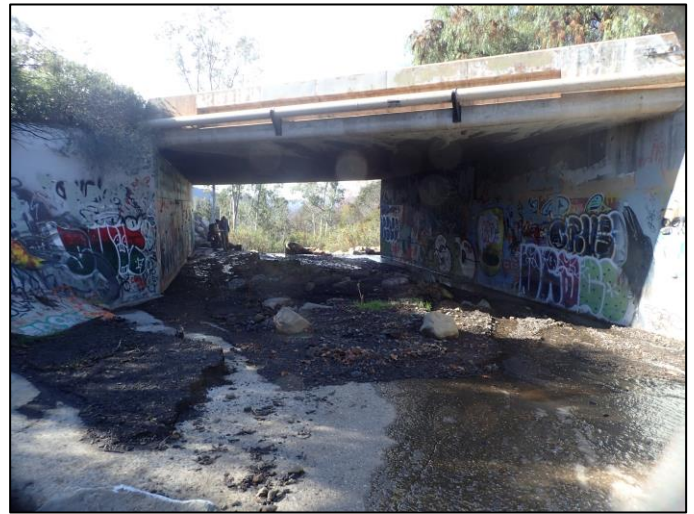
The McAndrew Road crossing is a free spanning bridge over a fully concrete lined channel. The concrete lining extends downstream to include a significant concrete boulder riprap apron which has a length of 33.4 ft and a height of 7.9 ft. A cascade over boulders is present at the outlet of this apron and has a height of 5.4 ft to the downstream pool unit. Additionally, the concrete lining extends upstream of the crossing to form an inlet apron measured to have a length of 25.3 ft and a height of 1.75 ft. The crossing is located 3.4 stream miles from the San Antonio Creek confluence and FishXing analysis estimated this crossing to be unpassable by all life stages of *O. mykiss* over all rates of streamflow. The total barrier status assigned from this analysis differs from the partial barrier status previously assigned to the crossing by the Ventura County Planning Division in 2004.

Figure 46. Downstream view of concrete boulder riprap outlet apron at the McAndrew Road crossing.

Figure 47. Upstream view of concrete lined inlet apron at the McAndrew Road crossing.

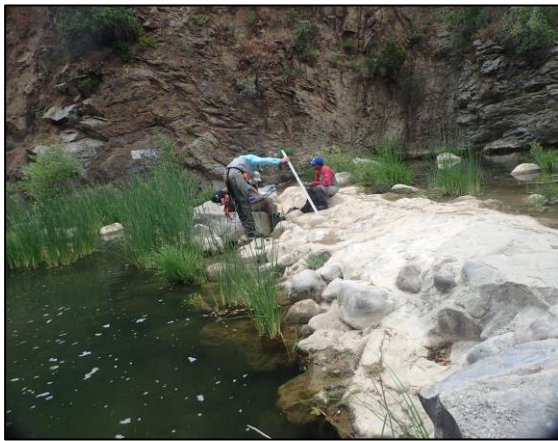
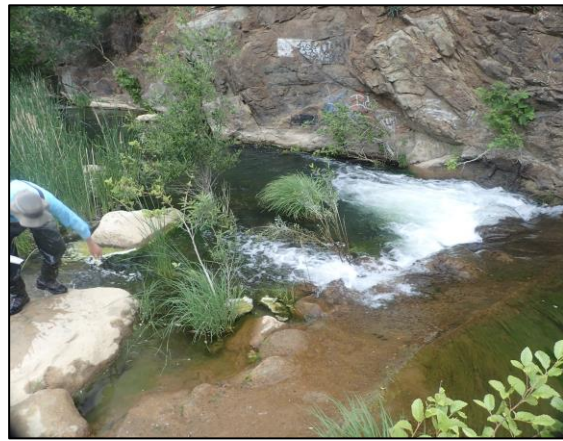
Matilija Creek begins at the upstream extent of the Ventura River and the confluence point with the North Fork of Matilija Creek. A concrete boulder riprap grade control and weir gauging station is located 0.2 miles upstream of this confluence point. Moderately deep pool units are located immediately downstream and upstream of the structure which should allow strong steelhead *O. mykiss* life stages to successfully jump this structure given the gauging station record indicates perennial flow occurs at this location. All other life stages of *O. mykiss* likely would have difficulty making an upstream passage of this structure due to the moderate cascade length (6.2 ft) and breadth (5ft). Our assessment concludes that this structure continues to present as a partial barrier to *O. mykiss*.

Figure 48. Matilija Creek concrete boulder riprap grade control structure.

Figure 49. Low flow cascade point over Matilija Creek grade control structure.

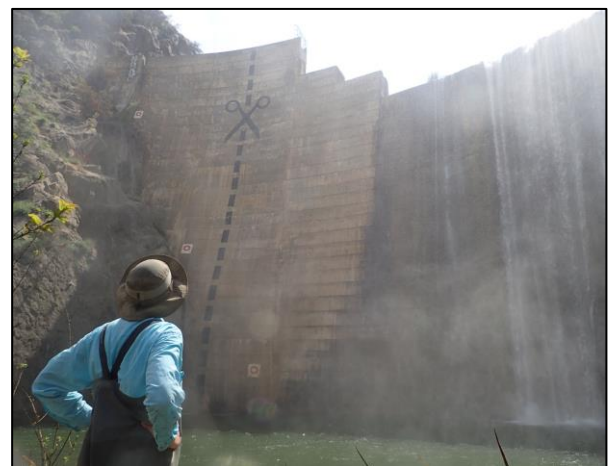
The defining structure on Matilija Creek is the Matilija Dam, which was constructed in 1947, and is a total barrier to all *O. mykiss* life stages. The dam has been considered obsolete for decades and aspirations to remove it led all vested parties and agencies to adopt a removal plan in 2016 (O,Neal 2016). The date in which actions begin to physical remove the dam is dependent on various removal preparation steps and funding. 17 stream miles of *O. mykiss* spawning, rearing, and foraging habitat will be reopened once the dam is finally removed as the only manmade barrier listed in PAD on Matilija Creek upstream of the dam is an low-water crossing through natural substrate with a temporal barrier status. The Matilija Dam also marks the upstream extent of Matilija Creek survived for this report.

Figure 50. Downstream view of Matilija Dam.

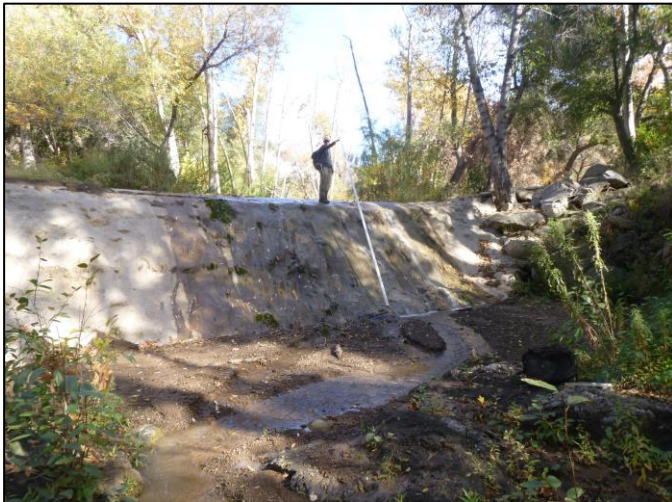
Figure 52. NFM_013_R Wheeler Gorge Campsite low-water crossing.

The next set of barriers an upstream migrating *O. mykiss* would encounter on North Fork Matilija Creek are a set of concrete low-water crossings located within the Wheeler Gorge Campground. The initial low-water crossing (NFM_013_R) is located 4.3 stream miles from the Ventura River confluence and contains a significant cascade down a steep concrete boulder riprap outlet apron. This outlet apron is 16.7 ft in length and 9.6 ft in height. The downstream unit was a shallow pool with a mean water depth of 2.6 ft. FishXing analysis indicated the crossing to be impassable to all *O. mykiss* life stages over all rates of streamflow. This corresponds with the existing total barrier status assigned to the crossing. The 2nd low-water crossing in Wheeler Gorge Campground (NFM_014_R) is located 4.6 stream miles from the Ventura River confluence and also contains a concrete boulder riprap outlet apron. This outlet apron has a shorter length (10.2 ft) and height (2.48 ft) than the outlet apron of the initial low-water crossing. FishXing analysis estimated that a steelhead life stage *O. mykiss* would be able to pass the crossing at streamflows greater than 190 ft³/s. FishXing analysis also projected that a resident life stage *O. mykiss* would not be able to gain upstream passage of the crossing under any rate of streamflow. Due to this and the higher flows required for steelhead to successfully gain passage a temporal and partial barrier status was assigned. A partial barrier status had previously been assigned to this crossing by Entrix Incorporated in 2003. Fortunately, funding was awarded in 2018 to Earth Island Institute through the CDFW Fisheries Restoration Grant Program (FRGP) to create mitigation designs for these low-water crossing barriers (CDFW FRGP Proposal Funding Summaries).

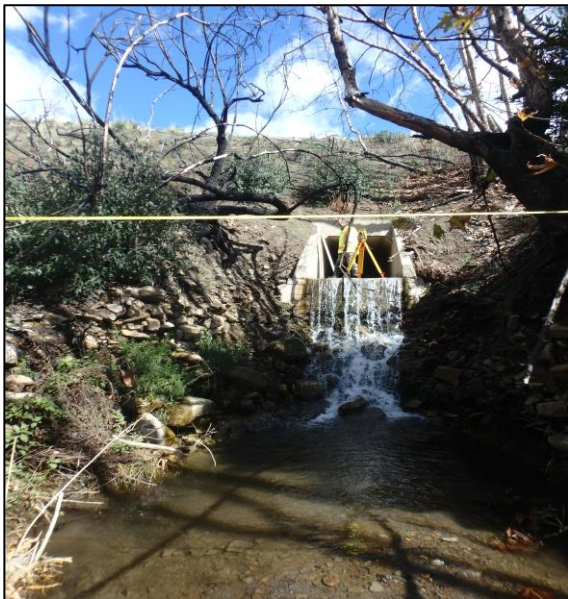
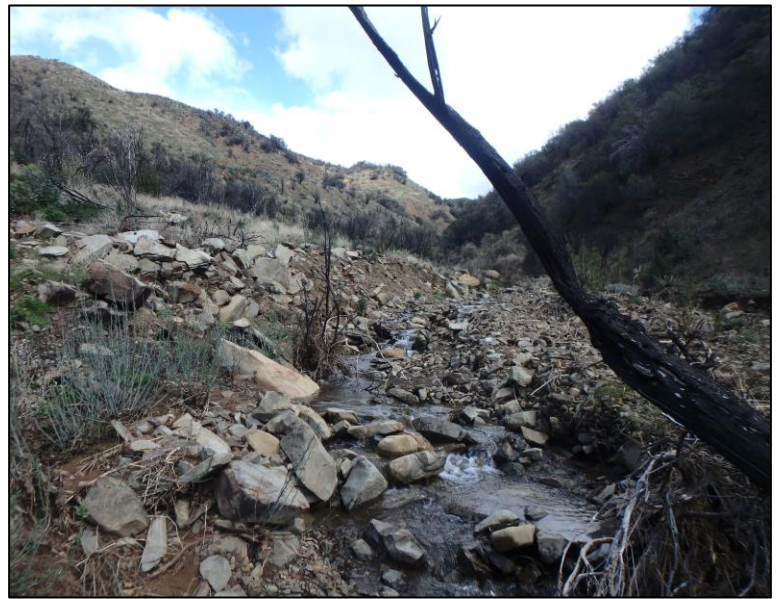
California state highway 33 crosses North Fork Matilija Creek ten times. All of these crossings are free spanning bridges over natural streambed substrate assessed to be free of passage constraints, except the most upstream crossing. This highway 33 crossing consists of significant sediment fill with a moderately sized fully lined concrete box culvert running through it. The culvert was assessed to have a slope of 5.2° and a vertical plunge from the outlet apron to a shallow downstream pool unit of 10.3 ft. FishXing analysis assessed the crossing to be a total barrier to all *O. mykiss* life stages, which matches the pervious assessment status made by the Ventura County Flood Control District in 2006. Additionally, this crossing marked the upstream extent of surveys conducted for North Fork Matilija Creek due to the total barrier status and poor quality of *O. mykiss* habitat visible upstream of the crossing as shown in figure 55.

Figure 54. Downstream view of plunge at outlet of Hwy 33 culvert crossing.

Figure 55. Low quality *O. mykiss* habitat visible upstream of Hwy 33 culvert crossing.

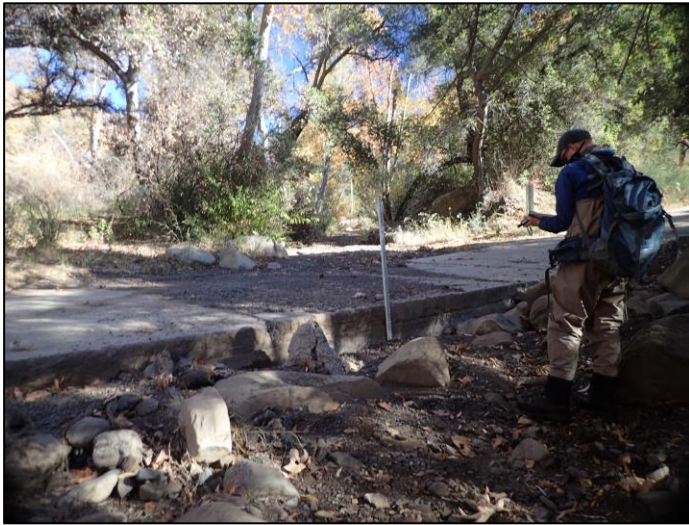
Bear Creek is a tributary to North Fork Matilija Creek and its confluence is located within the Wheeler Gorge Campground. Within the campground there are two concrete low-water crossings across Bear Creek. These low-water crossings are located 160 ft and 329 ft from the North Fork Matilija Creek confluence. The initial low-water crossing (BER_001_R) has a 2.1 ft vertical plunge point from the road surface to the downstream substrate and FishXing analysis predicted it to be passable by steelhead life stage *O. mykiss* at streamflow rates above 60.1 ft³/s. The other low-water crossing (BER_002_R) has a concrete boulder riprap outlet apron with a length of 9.8 ft and a height of 3.6 ft. FishXing analysis predicted the this low-water crossing to be passable by steelhead above streamflow rates of 152.9 ft³/s. Both of these low-water crossings were predicted to be impassable to resident *O. mykiss* life stages over all rates of streamflow. Temporal and partial barrier statuses were assigned to both of these low-water crossings. Both crossings had previously been assigned partial barrier status by the USFS in 2001.

Figure 56. Downstream view of initial low-water crossing (BER_001_R) on Bear Creek.

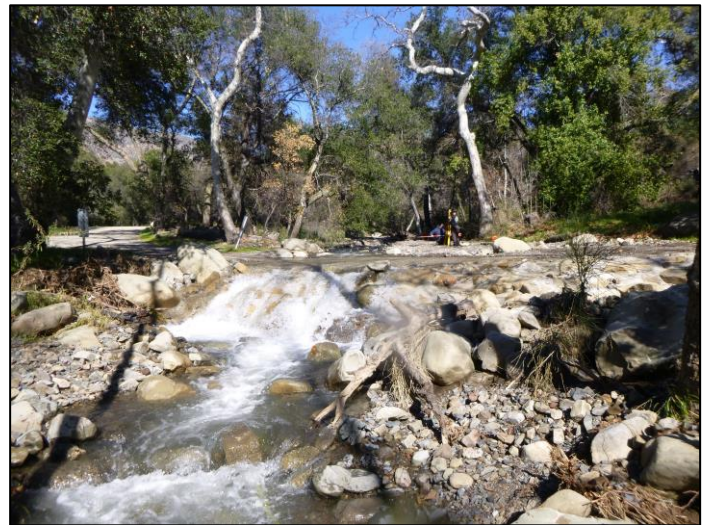
Figure 57. Downstream view of BER_002_R low-water crossing on Bear Creek.

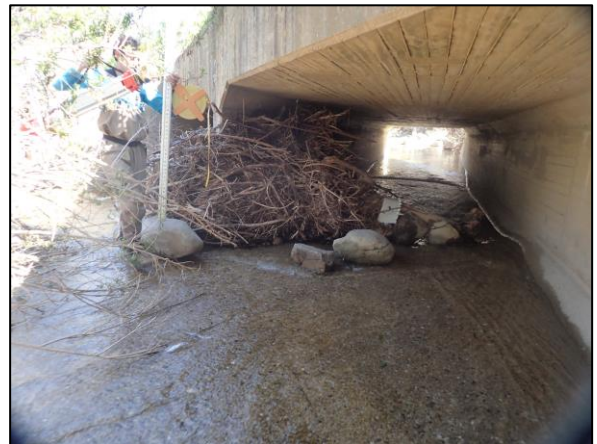
Figure 61. Debris at inlet of CAN_002_R Hwy 33 crossing.

California state highway 33 crosses Cannon Creek in two locations. Side by side concrete lined box culverts with inlet and outlet aprons between wingwalls are present at both crossings. The initial of these two crossings (CAN_002_R) is located 0.7 stream miles from the North Fork Matilija Creek confluence. At the time a detailed assessment was conducted on this crossing (3/13/19) the downstream half of both culverts was partially embedded with gravel substrate. This build up of substrate extended past the outlet and caused stream water to pool within the downstream portion of each culvert. Additionally, at the inlet the center divider of the culverts had a small buildup of woody debris. The length of the river right culvert is 55.4 ft and the length of the river left culvert is 47.4 ft. FishXing analysis estimated this crossing to be passable for the steelhead *O. mykiss* life stage at streamflow rates greater than 160.2 ft³/s, but not passable for the adult resident life stage. As a result this crossing was assigned a temporal and partial barrier status. The other highway 33 crossing of Cannon Creek (CAN_003_R) is located 1.0 stream miles from the North Fork Matilija confluence. The length of the river left culvert is 42 ft and the length of the river right culvert is 44.6 ft. A small plunge with a mean height of 1.6 ft was present below the outlet apron. FishXing analysis estimated this crossing to be passable for the steelhead at streamflow rates greater than 130 ft³/s, but not passable for the adult resident life stage. As a result this crossing has also been assigned a temporal and partial barrier status.

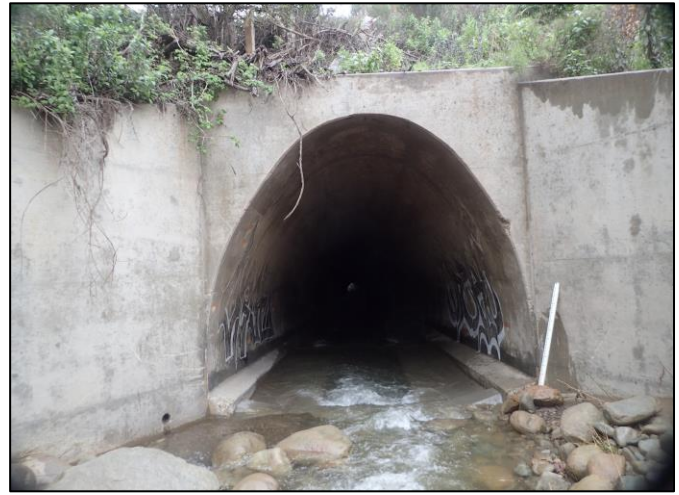
Figure 65. View of culvert inlet and weir at Hwy 101 El Capitan Creek crossing.

A long concrete pipe arched culvert with inlet and outlet wingwalls runs under the highway 101 crossing located 0.4 stream miles from the Pacific Ocean. The culvert has a mean width of 11.5 ft and the height at the inlet is 13 ft and 8.3 ft at the outlet. The bottom of the culvert contains concrete center notched weirs throughout its length, which according to the crossings PAD listing were installed in 2007 to provide more favorable conditions for *O. mykiss* passage. All weir bays contained gravel and cobble sediment at the time of assessment. The culvert was previously assessed by CDFW in 2009 and a “remediated, fish response unconfirmed” status was assigned. No records of successful steelhead passage were obtained in the research conducted for this report. The sediment filling documented within the weir bays appeared to have reduced the capacity for the weirs to create conditions conducive to allowing successful *O. mykiss* passage. Turbulent streamflow was present throughout the culvert and lack of water depth within the weir bays diminished possible resting areas for any *O. mykiss* attempting to gain passage. Unfortunately, due to the complexities of streamflow hydraulics occurring between weirs within this culvert FishXing analysis could not be used and a definitive barrier status was not determined. The passage constraints documented under the conditions assessed during the first pass assessment likely limit or possibly prevent *O. mykiss* passage abilities.

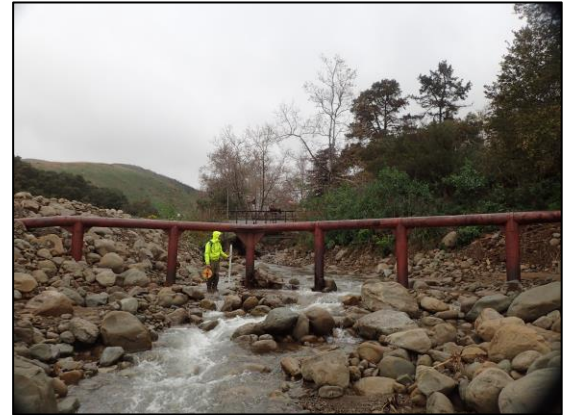
Figure 66. Remediated grade control structure on El Capitan Creek.

Two PAD listings on El Capitan Creek and one PAD listing on the West Fork of El Capitan Creek were assessed and confirmed to no longer constrict *O. mykiss* upstream movement. The initial of the two PAD listings on El Capitan Creek was a for a grade control structure which also supports a metal crossbar pipe over the stream channel (PAD ID: 706441). This structure is still present within the stream, but its base appeared to be buried within the streambed substrate and therefore is no longer a barrier. The PAD listing for this grade control structure indicates that it received barrier remediation treatment in 2007. As future high flow events shift streambed sediments over time the base of this grade control structure could potentially become exposed again and present as a barrier. The other PAD listing confirmed to no longer constrict *O. mykiss* movement is the El Capitan Canyon Resort road crossing (PAD ID: 706642). This crossing is a free spanning bridge over natural streambed substrate, which replaced a concrete low-water crossing in 2008. The PAD listing on the West Fork of El Captian Creek assessed to no longer be a barrier is for a culvert located under an abandoned gravel road (PAD ID: 706332). This culvert and the road it was located under was found to be completely blown out. Remnants of the culvert and road fill were present, but the stream now flows unobstructed at this location.

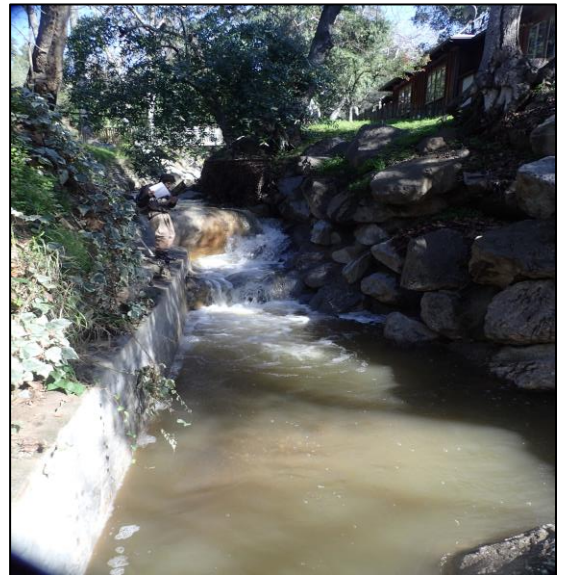
Figure 71. Downstream view of RAT_005_NR grade control on Rattlesnake Creek.

Three grade control structures were assessed to contain passage constraints on Rattlesnake Creek. The first of these structures was the initial barrier assessed on Rattlesnake Creek located just 150 feet from the confluence with Mission Creek. This grade control (RAT_001_NR) was a concrete structure and extended across the width of the stream channel. The plunge height is 3.7 ft and at the time of assessment (2/6/19) the water depth below the plunge was 4 ft. Considering streamflow was likely above average for Rattlesnake Creek at the time of assessment successful passage for resident *O. mykiss* life stages is unlikely. Due to the water depth below the plunge steelhead likely would be able to successfully jump this structure. As such a partial barrier status was assigned which matches the previous barrier status assigned to the structure. The 2nd grade control structure (RAT_005_NR) is also a concrete structure, but is located within a short and narrow 11 ft wide section of stream channel that is lined by concrete and boulder riprap for flood control. The structure is located 0.3 stream miles from the Mission Creek confluence and has a total height of 4.9 ft consisting of two plunge points creating a total cascade length of 13 ft. The water depth below the structure at the time of assessment was 4 ft. The main factor likely limiting *O. mykiss* passage of this structure is the constricted nature of the stream channel as it causes a significant increase in the turbulence and velocity of streamflow over the structure. Additionally, the water depth between the two plunge points was only 0.9 ft which also increases the difficulty of passage for upstream migrating *O. mykiss*. Due to these factors it is unlikely any life stage of *O. mykiss* could successfully pass this structure at any rate of streamflow. The total barrier status assigned matches the previously assigned barrier status. The 3rd grade control structure is also concrete structure and had a plunge height of 1.3 ft. The water depth below the plunge was 1.5 ft. This structure is located 0.7 stream miles from the Mission

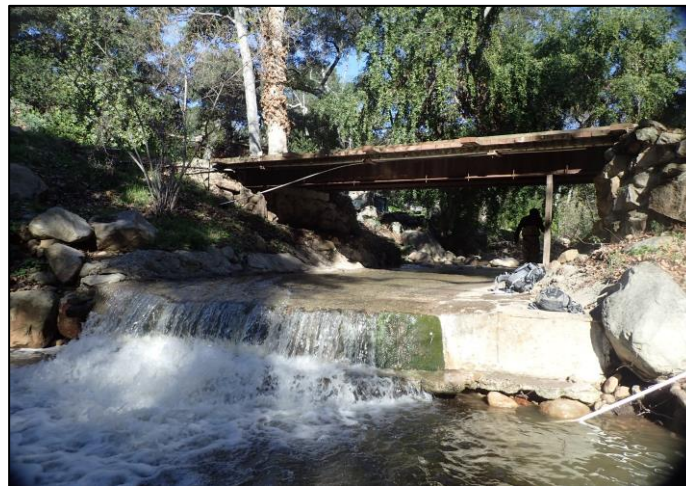
Figure 71. Downstream view of private road crossing on Rattlesnake Creek.

The next barrier assessed on Rattlesnake Creek is located 0.4 stream miles from the Mission Creek confluence and is a private road crossing bridge with a concrete apron under it. The outlet of the apron had a plunge point with a height of 2.6 ft and at the time of assessment (2/6/19) the water depth below the plunge was 2.2 ft. Permission to conduct a detailed assessment was not received from the private owner of the crossing. Due to the shallow and accelerated stream flow occurring over the apron it is believed resident *O. mykiss* life stages would not be able to gain upstream passage of this crossing. Steelhead *O. mykiss* life stages potentially could successfully gain passage, but likely only under specific stream flow rates. Due to this assessment the crossing was assigned a temporal and partial barrier status which matches the status assigned in 2002 by Stoecker Environmental Consulting.

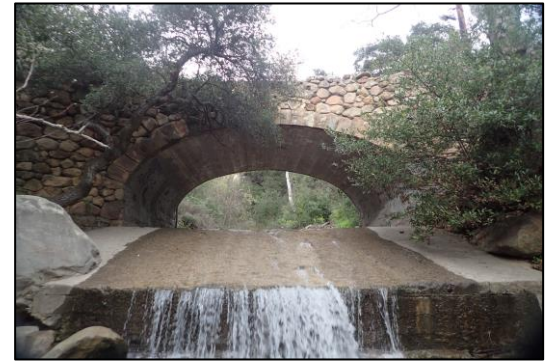
Figure 72. View of outlet apron and plunge point at Las Canoas Road crossing on Rattlesnake Creek.

The Las Canoas Road crossing is located 1.1 stream miles from the Mission Creek confluence and is a free spanning bridge over a fully concrete lined channel with a steep 26 ft long outlet apron containing a 3.8 ft plunge point at its base. At the time of assessment (2/12/19) the water depth below the plunge was 3.1 ft. The concrete streambed lining also extends 14 ft upstream from the inlet of bridge. The road crossing is located 1.1 stream miles from the Mission Creek confluence. FishXing analysis of this crossing indicated the structure is not passable to any *O. mykiss* life stages at any rate of streamflow. The total barrier status assigned to the crossing structure matches its previously assigned barrier status.

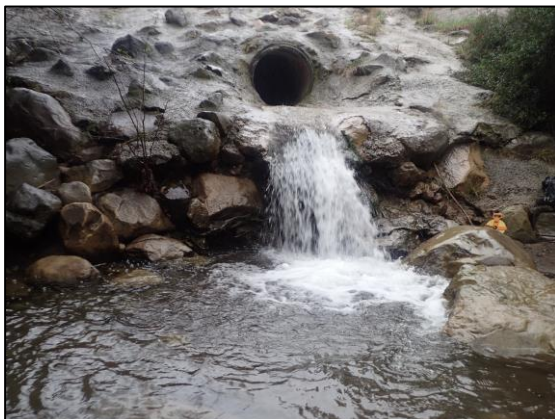
Figure 73. View of outlet culvert at debris basin dam on Rattlesnake Creek.

Two dam structures were assessed on Rattlesnake Creek. A concrete boulder riprap debris basin dam (RAT_014_NR) is located 1.3 stream miles from the Mission Creek confluence. A small culvert with a diameter of 4 ft is located at the outlet of the dam. Stream water flows out of this covert and onto a concrete apron which has a plunge point of 7.5 ft and at the time of assesses (2/27/19) water depth below the plunge was 1.3 ft. Due to this height of the plunge and stream flow velocities occurring at the outlet culvert and apron this dam is a total barrier to all *O. mykiss* life stages. This matches the previous barrier status assigned to the dam. The other dam (RAT_016_NR) assessed on Rattlesnake Creek consists of remnants from a dam constructed in the early 1800's that provided water to the Santa Barbara Mission. The structure is located 1.5 stream miles from the Mission Creek confluence. The center of the dam has been blown out, but a significant plunge with a height of 12.2 ft remains. The depth below this plunge was measured to be 3.3 ft. Due to the height of the plunge and turbulent stream flow channeled through it the structure remains a total barrier to all *O. mykiss* life stages.
