Assessment of Steelhead Habitat and Migration Barriers within Watersheds Impacted by the Thomas, Whitter, and Topanga Wildfires

Pacific States Marine Fisheries Commission

California Department of Fisheries and Wildlife

September 10, 2019

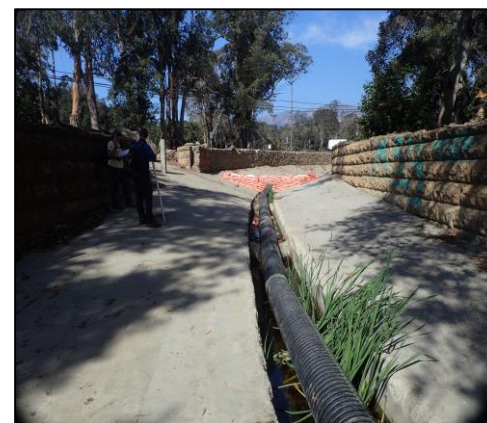
Figure 76. Flood control channel upstream of debris basin with center notch.

The initial structure assessed to contain passage constraints to *O. mykiss* on Montecito Creek is a fully concrete lined flood control channel (MON_025_R) which begins just 380 feet from the mouth of the creek at the Pacific Ocean. This concrete lining extends 756 ft upstream and has a mean width 64 ft. To assess passage conditions the structure was modeled within FishXing as a box culvert. This analysis estimated steelhead could successfully gain passage through structure at stream flow rates of 221 ft³/s or greater, but also estimated resident life stages of *O. mykiss* would not be able to gain passage over any rates of streamflow. A temporal and partial passage state was assigned to the structure as a result of FishXing estimations. The structure had previously been assigned a partial barrier status. The other portion of Montecito Creek converted to a fully lined concrete flood control channel (MON_018_NR) begins immediately upstream of a debris basin and 1.0 stream miles upstream from the Pacific Ocean. The concrete lining extends upstream within the channel for 723 ft. A 2.6 ft wide notch which is also fully lined with concrete is located at the center of the channel and runs the length of the structure. The depth of the notch varies and occasional small weirs are present within the lower portion of the notch. It is likely this notch is intended to improve passage conditions for *O. mykiss*. The presence of the notch and weirs within it significantly add to the complexities of stream flow hydraulics occurring through this flood control channel. Due to this FishXing was not able to model this structure and perform passage analysis. As a result, a definitive passage status could not be determined for this structure. A partial barrier status was previously assigned to the structure. Excessive water velocities likely occur through this flood control channel during the occurrence of stream flow rates conducive to steelhead migration resulting in very difficult passage for even the strongest steelhead.

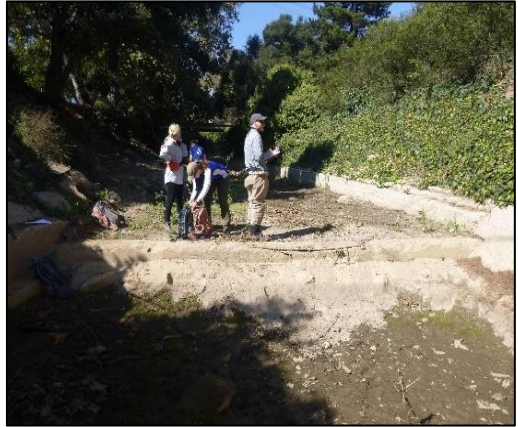
Barrier & PAD ID	Location	Previous Barrier Status	Current Barrier Status	Description, Dimensions, and Remediation Score	Picture
Barrier ID: MON_004_NR PAD ID: 706250	34.42303, -119.63485	Temporal	Temporal & Partial	Small concrete grade control between concrete channel walls. Mean height: 2.3 ft Mean breadth: 3.3 ft Mean cascade length: 3.8 ft Remediation score: 12.1

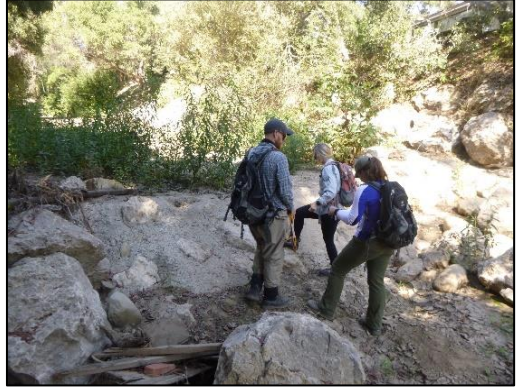
Barrier & PAD ID	Location	Previous Barrier Status	Current Barrier Status	Description, Dimensions, and Remediation Score	Picture
Barrier ID: MON_008_NR PAD ID: 706516	34.42367, -119.63586	Partial	Temporal & Partial	Concrete boulder riprap apron grade control. Mean height: 3.1 ft Mean breadth: 3.7 ft Mean cascade length: 4.8 ft Remediation score: 9.1

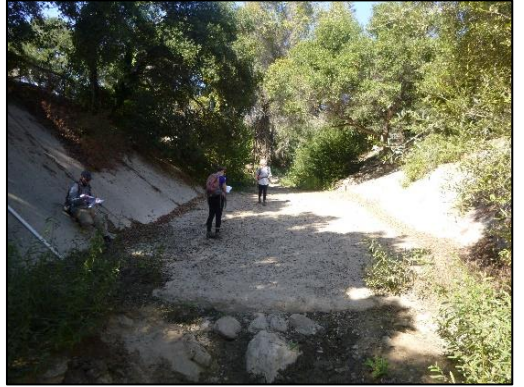
Barrier ID: MON_009_NR PAD ID: None Assigned	34.42382, -119.63599	Unassessed	Temporal & Partial	Long concrete grade control between concrete walls. Mean height: 3.3 ft Mean breadth: 48.3 ft Mean cascade length: 48.6 ft Remediation score: 9.1

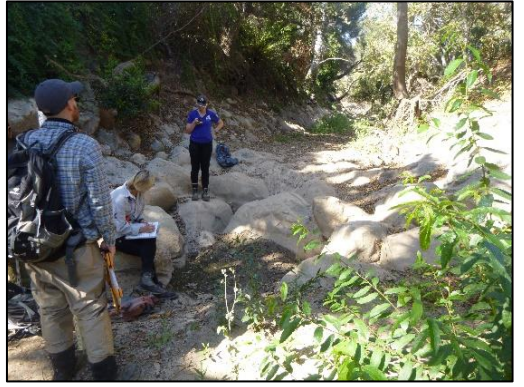
Barrier ID: MON_010_NR PAD ID: 706517	34.4244, -119.63633	Partial	Temporal	Concrete boulder riprap grade control. Mean height: 3.1 ft Mean breadth: 3.2 ft Mean cascade length: 4.6 ft Remediation score: 7.4

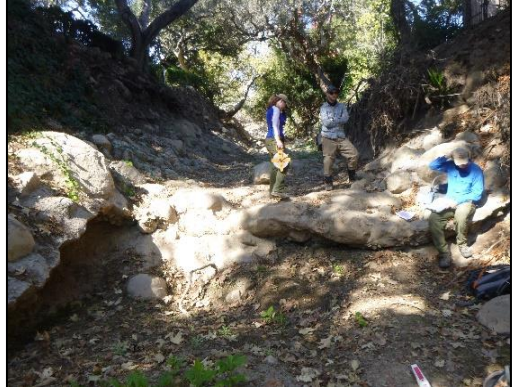
Barrier ID: MON_011_NR PAD ID: 706518	34.42477, -119.63644	Partial	Temporal & Partial	Concrete boulder riprap grade control. Mean height: 3.1 ft Mean breadth: 4.7 ft Mean cascade length: 6.2 ft Remediation score: 7.4

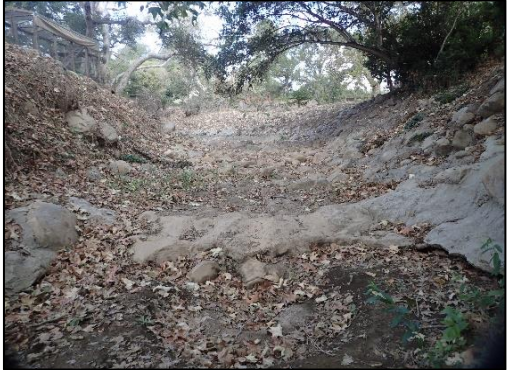
Barrier & PAD ID	Location	Previous Barrier Status	Current Barrier Status	Description, Dimensions, and Remediation Score	Picture
Barrier ID: MON_012_NR PAD ID: 706519	34.42541, -119.63667	Partial	Temporal	Small concrete boulder rip rap grade control Mean height: 2.5 ft Mean breadth: 4.4 ft Mean cascade length: 4.5 ft Remediation score: 5.4

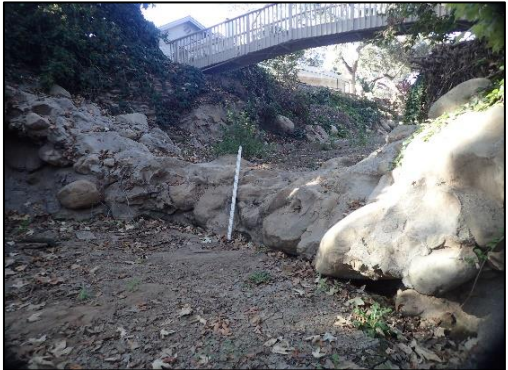
Barrier ID: MON_013_NR PAD ID: 706520	34.42567, -119.63742	Partial	Temporal & Partial	Concrete boulder riprap grade control. Mean height: 3.8 ft Mean breadth: 3.8 ft Mean cascade length: 7.0 ft Remediation score: 5.4

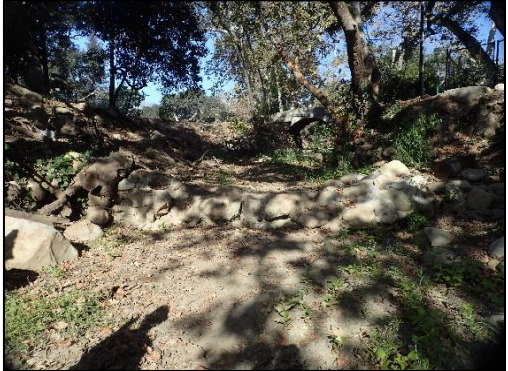
Barrier ID: MON_014_NR PAD ID: 706521	34.42571, -119.63815	Partial	Temporal & Partial	Small concrete boulder rip rap grade control. Mean height: 2.5 ft Mean breadth: 1.0 ft Mean cascade length: 2.6 ft Remediation score: 4.4

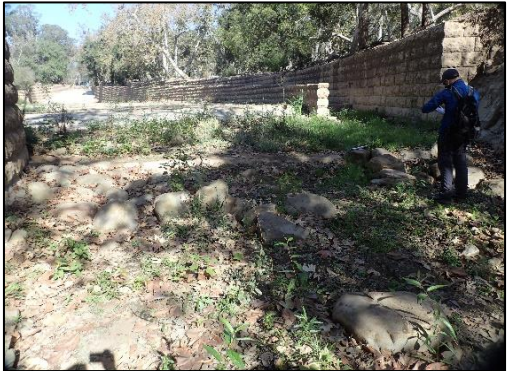
Barrier ID: MON_016_NR PAD ID: 706523	34.42691, -119.63943	Partial	Temporal & Partial	Small concrete boulder rip rap grade control at outlet of debris basin. Mean height: 1.1 ft Mean breadth: 1.2 ft Mean cascade length: 1.6 ft Remediation score: 3.4

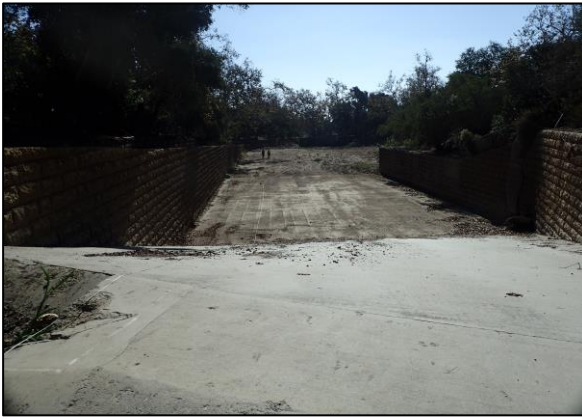
Figure 78. Upstream view of debris basin and inlet apron on Montecito Creek.

A large fully concrete lined debris basin is located 0.9 stream miles from the Pacific Ocean on Montecito Creek. The debris basin contains a wide and steep inlet apron leading into the basin. The height of this apron is 21 ft. The entire length of the structure is 512 ft. A steel slate fishway is located on the river left side of the basin. The previous assessment of the basin indicated a general lack of stream flow through the fishway. No streamflow was present at the time of assessment and the functionality of the fishway could not be determined. As a result, no definitive barrier status could be assigned to the structure. The debris basin and fishway leads directly into to an extended concrete flood control channel (MON_018_NR). The combination of passage constraints present between the debris basin, its fishway, and the upstream flood control channel likely greatly limit upstream passage of all life stages of *O. mykiss* and may present as a total barrier. Extending the fishway upstream past the inlet of the flood control channel would likely greatly improve the chances for successful *O. mykiss* passage.

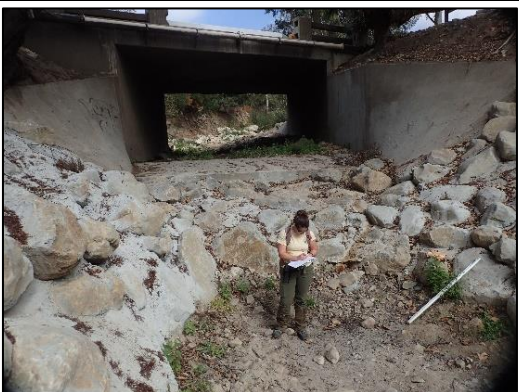
Barrier ID: HSP_011_NR PAD ID: None Assigned	34.44896, -119.64626	Unassessed	Temporal	Concrete boulder riprap grade control downstream of East Mountain Drive bridge crossing. Mean height: 5.6 ft Mean breadth: 14.7 ft Mean cascade length: 14.9 ft Remediation score: 5.4

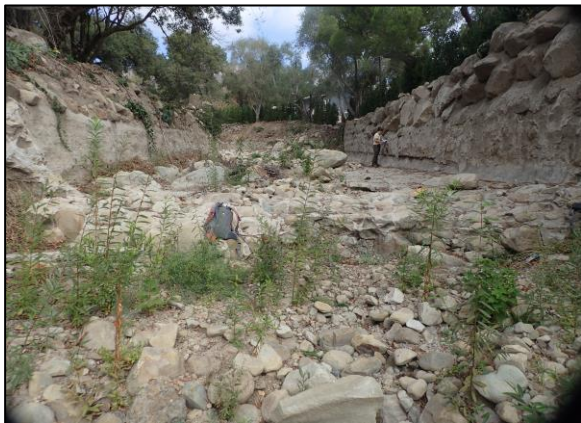
Figure 81. Downstream view of HSP_008_NR flood control channel.

Two relatively short portions of stream channel within Hot Springs Creek are fully lined with concrete boulder riprap for flood control. These flood control channels are located roughly 250 ft from each other and 0.3 stream miles from the Montecito Creek confluence. The initial of these two flood control channels (HSP_008_NR) has a length of 75 ft and a small 3.4 ft plunge point at its outlet. The other flood control channel (HSP_009_NR) has a length of 126 ft and a plunge point of 2.6 ft at its outlet. The concrete lining of the stream bed in these locations increase the difficulty of passage for all *O. mykiss* life stages as it limits stream flow dynamics and depth while also increasing streamflow velocity. It is likely these structures are only passable at higher rates of streamflow. A temporal and partial barrier status was assigned to each flood control channel.

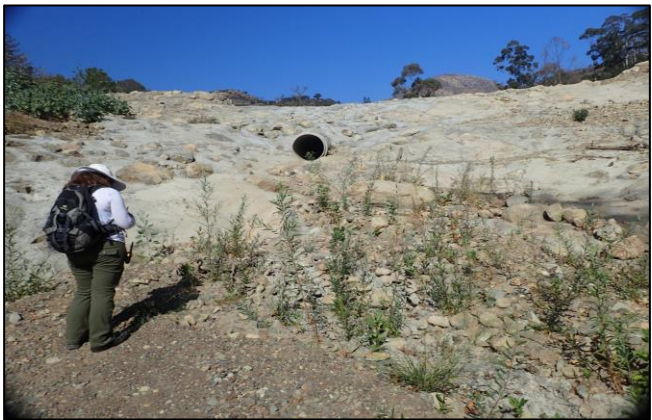
Figure 84. View of debris basin outlet on Cold Springs Creek.

The only man-made structure assessed to contain passage constraints to *O. mykiss* on Cold Springs Creek was a concrete boulder riprap lined debris basin located 0.6 stream miles from the Montecito Creek confluence. A culvert was located at the outlet of the basin, but was not passable to *O. mykiss* due to concrete apron at the outlet of the culvert with a height of 10.1 ft. The mean height of the basin structure was 27.6 ft. A total barrier status was assigned to the debris basin. It is highly unlikely any life stage of *O. mykiss* could successfully pass upstream of this debris basin.

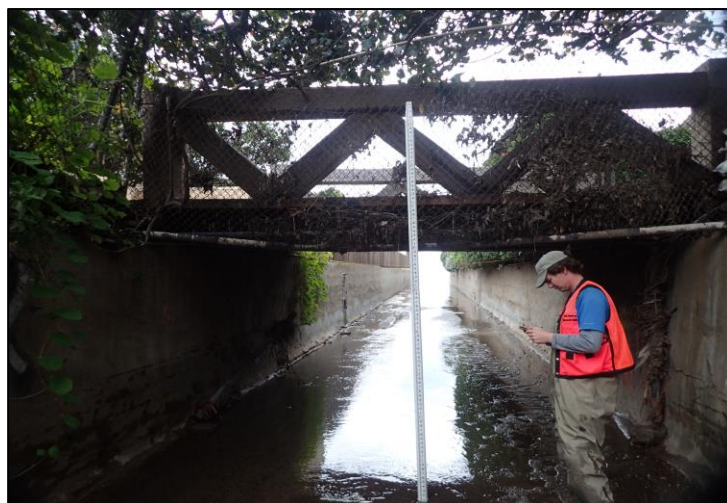
Figure 85. Downstream view of flood control channel at mouth of Oak Creek and Fernald Point Lane bridge.

The initial structure assessed to limit *O. mykiss* upstream migration on Oak Creek is a fully concrete lined flood control channel and is located at the mouth of the creek. This flood control channel was measured to have a length of 213.3 ft and a uniform width of 12.1 ft. A small concrete and boulder riprap apron was present at the outlet and the concrete lining ran under the Fernald Point Lane road crossing bridge. FishXing was used to assess the structure by modeling it as a box culvert and estimated accelerated stream flow velocities occurring during high rates of stream flow through the narrow channel would prevent all life stages of *O. mykiss* from gaining successful passage. As a result, a total barrier status was assigned to the structure.

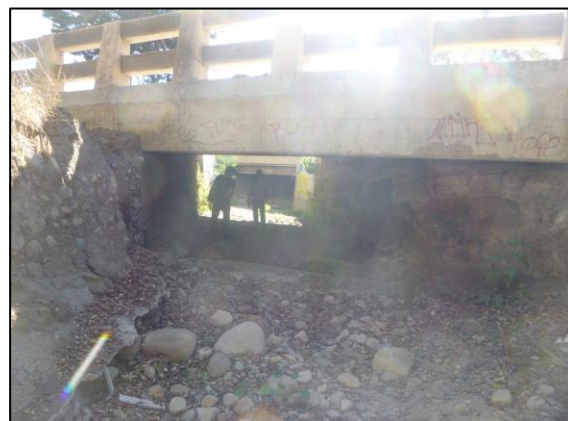
Figure 86. View of inlet of North Jameson Lane bridge.

The North Jameson Lane Road crossing is a free spanning bridge crossing over two small concrete grade control structures. Each of these structures had a mean height of 2.0 ft. This crossing is located 0.1 stream miles from the Pacific Ocean. FishXing was used to assess *O. mykiss* passage abilities and estimated steelhead are likely to gain passage at streamflow rates greater 86.1 ft³/s, but also estimated resident *O. mykiss* life stages would not be able to gain passage at any rate of streamflow. A temporal and partial barrier status was assigned to the crossing to reflect this assessment.

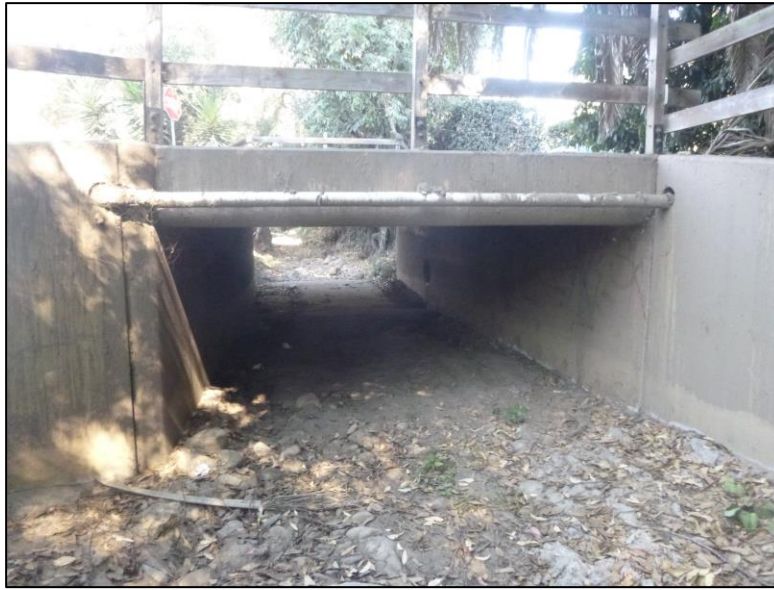
Figure 87. Downstream view of Palmer Lane road crossing culvert.

Conception Coast Watersheds – Oak Creek – Palmer Lane Crossing						
Barrier ID	PAD ID	Location	Previous Barrier Status	Current Barrier Status	Remediation Score	Figure
OAK_006_R	None Assigned	34.42259, -119.62677	Unassessed	Temporal & Partial	10

The Palmer Lane crossing is located 0.3 stream miles from the Pacific Ocean and is a bridge over a fully concrete lined box culvert with inlet and outlet aprons. The length of the culvert is 36.1 ft, with a uniform width of 10.5 ft, and mean height of 6.3 ft. FishXing analysis of this culvert estimated steelhead were likely to gain passage at streamflow rates greater than 54.2 ft³/s, but also estimated the crossing would not be passable to resident *O. mykiss* life stages. This analysis was reflected with a temporal and partial barrier status being assigned to the crossing.

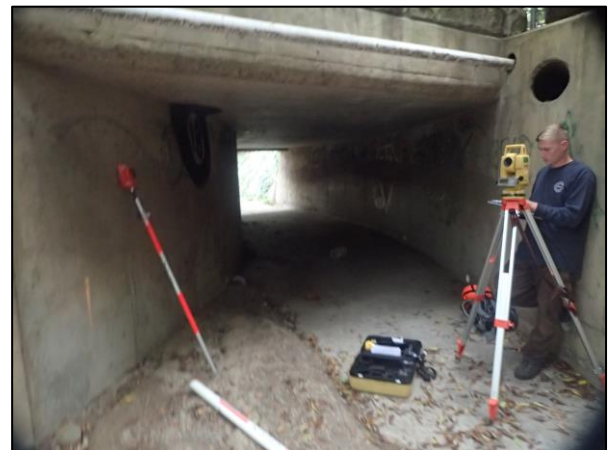
Figure 88. Hixon Road crossing concrete box culvert.

Conception Coast Watersheds – Oak Creek – Hixon Road Crossing						
Barrier ID	PAD ID	Location	Previous Barrier Status	Current Barrier Status	Remediation Score	Figure
OAK_007_R	None Assigned	34.42359, 119.62698	Unassessed	Temporal & Partial	9	88

The Hixon Road crossing is located 0.4 stream miles from the Pacific Ocean and is similar to the Palmer Lane crossing in that it is a fully lined concrete box culvert with inlet and outlet aprons. It is different from the Palmer Lane crossing in that its orientation is not consistent. The length of culvert is 42.7 ft, has a uniform width of 7.0 ft, and mean height of 10 ft. FishXing analysis of this culvert estimated steelhead were likely to gain passage at streamflow rates greater than 55.1 ft³/s, but also estimated the crossing would not be passable to resident *O. mykiss* life stages. This analysis was reflected with a temporal and partial barrier status being assigned to the crossing.

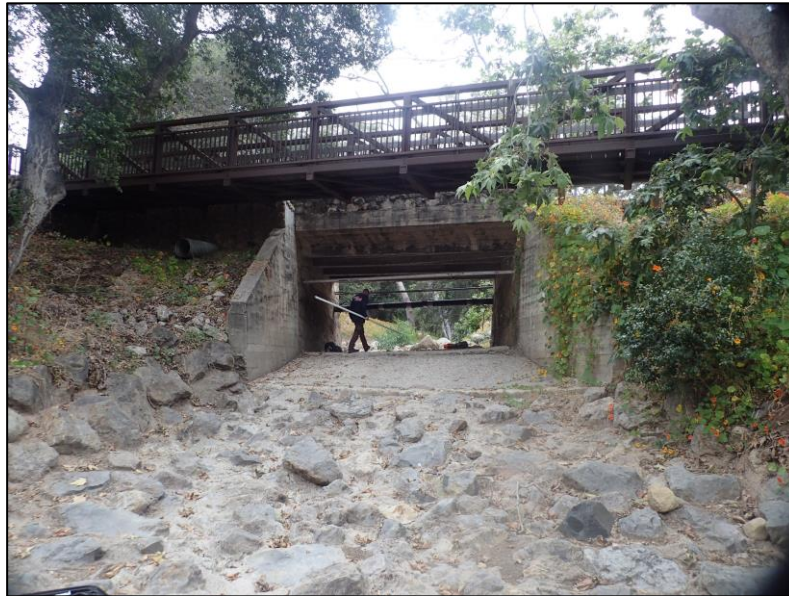
Figure 89. View of boulder and concrete outlet apron at Santa Rosa Lane crossing on Oak Creek.

Conception Coast Watersheds – Oak Creek – Santa Rosa Lane Crossing						
Barrier ID	PAD ID	Location	Previous Barrier Status	Current Barrier Status	Remediation Score	Figure
OAK_016_R	None Assigned	34.43283, -119.63151	Unassessed	Total	11	89

The Santa Rosa Lane crossing also contains a fully concrete lined box culvert with inlet and outlet aprons located between vertical concrete wingwalls. The outlet apron also contains boulder riprap and extends 47.4 ft downstream from the culvert outlet. The outlet apron has a considerable height of 7.8 ft. The culvert has a length of 23.1 ft, uniform width of 17.5 ft, and mean height of 8.7 ft. FishXing analysis estimated the height and length of the outlet apron makes the structure impassable to all life stages of *O. mykiss* at all rates of streamflow and thus is a total barrier.

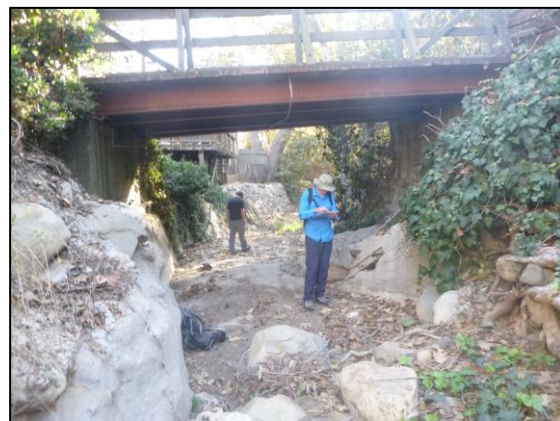
Figure 90. Private bridge crossing with concrete streambed lining on Oak Creek.

Conception Coast Watersheds – Oak Creek – Private Bridge Crossing						
Barrier ID	PAD ID	Location	Previous Barrier Status	Current Barrier Status	Remediation Score	Figure
OAK_019_R	None Assigned	34.43559, -119.63183	Unassessed	Unknown	7	90

A private bridge crossing over concrete and boulder riprap lined streambed is located 1.2 stream miles from the Pacific Ocean. The mean height of the bridge above the streambed was 10.5 ft. Unfortunately access restrictions prevented a detailed assessment from being performed and no definitive barrier status could be assigned. However, the streambed lining did not have a steep slope or any distinctive plunge points so it is unlikely this crossing structure is anything greater than a temporal barrier.

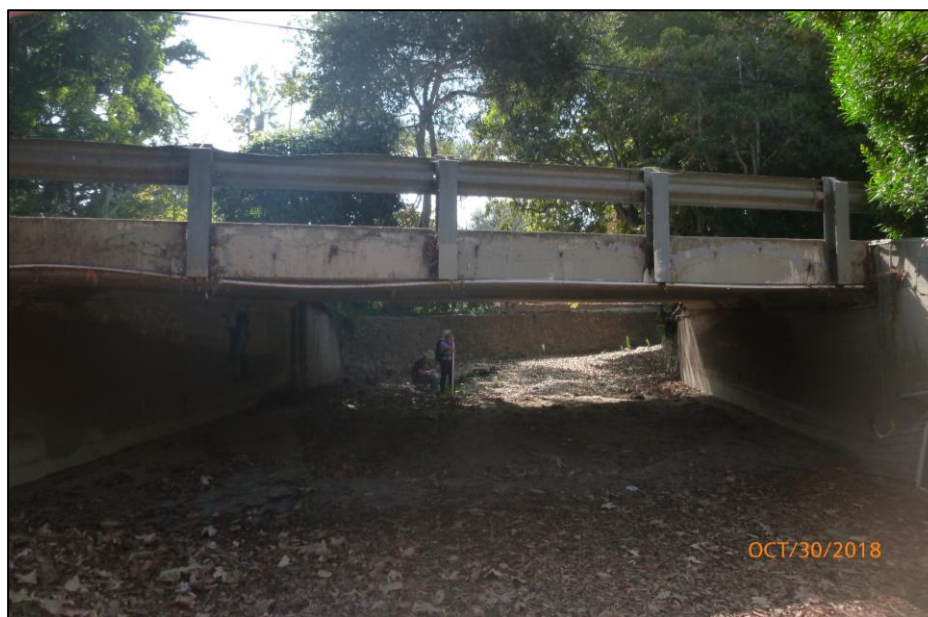
Figure 92. View of inlet at Fernald Point Lane Crossing on San Ysidro Creek.

Conception Coast Watersheds – San Ysidro Creek – Fernald Point Lane Crossing						
Barrier ID	PAD ID	Location	Previous Barrier Status	Current Barrier Status	Remediation Score	Figure
SYD_002_R	707370	34.42031, -119.62394	Partial	Temporal and Partial	18.35	92

The Fernald Point Lane crossing of San Ysidro Creek is a free spanning bridge over a fully concrete and boulder riprap lined stream channel. The bridge contains a small outlet apron constructed within the concrete channel lining with a length of 4.7 ft and a mean height of 1.0 ft. The mean height of the bridge above the streambed was 5.6 ft and its span across the stream was a uniform 23.5 ft. FishXing analysis estimated streamflow depth and velocity would be conducive to steelhead upstream passage at rates above 295.86 ft³/s. FishXing analysis estimated the crossing structure to be unpassable to resident *O. mykiss* life stages leading to a temporal and partial barriers status being assigned.

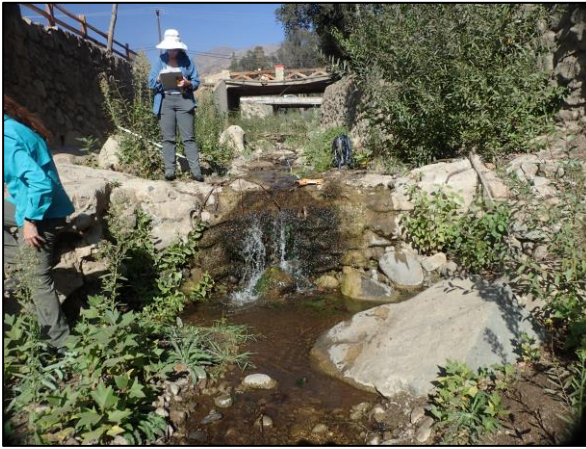
Figure 93. Plunge of SYD_002_NR grade control.

San Ysidro Creek contains two concrete boulder riprap grade control structures which were assessed to limit *O. mykiss* upstream movement. These two grade controls are located 85 ft from each other and 1.5 stream miles from the Pacific Ocean. Both grade controls span the entire width of the channel, which is lined with cement and brick walls. Both grade controls also contain vertical plunge points with a mean height of 4.5 ft at the downstream grade control (SYD_002_NR) and a mean height of 2.4 ft at the upstream grade control (SYD_003_NR). Both structures were assigned a temporal and partial barrier status.

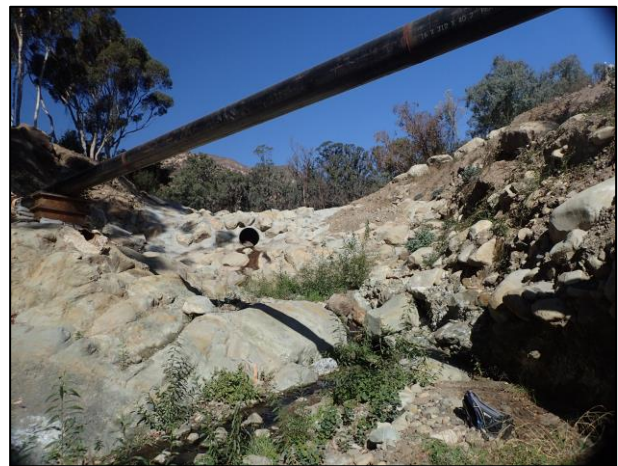
Figure 95. Debris basin outlet culvert and apron on San Ysidro Creek.

Conception Coast Watersheds – San Ysidro Creek – Debris Basin Structures						
Barrier ID	PAD ID	Location	Previous Barrier Status	Current Barrier Status	Remediation Score	Figure
SYD_007_NR	706510	34.44924, -119.62268	Total	Total	13.45	95

San Ysidro Creek contained a debris basin located 2.4 stream miles from the Pacific Ocean. A large concrete boulder riprap apron with a cylindrical culvert running through it is located at the outlet of the debris basin. The height of the apron was measured at 26.4 ft with a cascade length of 27 ft. The culvert runs through the middle portion of the apron and is assumed to be impassable to all life stages of *O. mykiss* due to excessive and turbulent water velocities that would occur through the culvert and down the face of the outlet apron during migration streamflow rates.

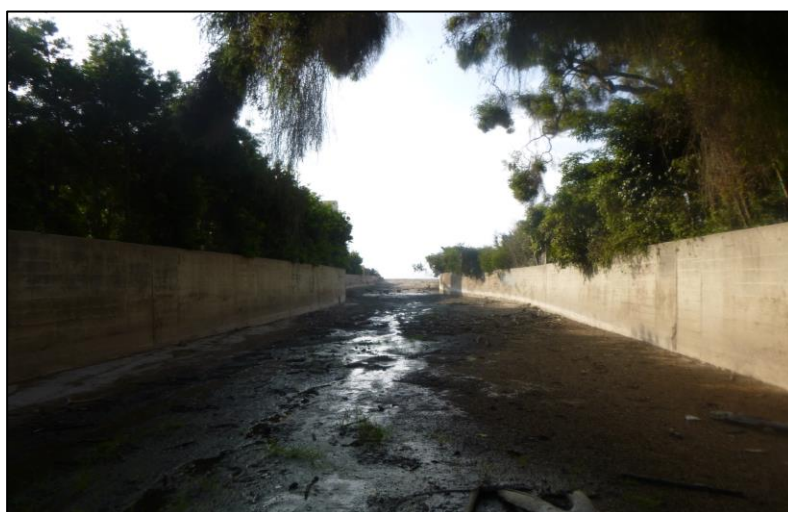
Figure 96. Flood control channel at mouth of Romero Creek.

Conception Coast Watersheds – Romero Creek – Flood Control Channel						
Barrier ID	PAD ID	Location	Previous Barrier Status	Current Barrier Status	Remediation Score	Figure
ROM_000_NR	None Assigned	34.41948, -119.62115	Unassessed	Unknown	16.05	96

The initial structure assessed to present as a barrier to *O. mykiss* attempting to move upstream was fully concrete lined flood control channel that extended approximately 900 ft from the creek mouth. The channel had a mean width of 34 ft, but did not follow a linear path. The lack of uniform orientation likely has specific effects on streamflow occurring within the flood control channel that FishXing cannot accurately model. Due to this a definitive barrier status could not be determined. Significant streamflow is likely necessary to create adequate water depth necessary for steelhead passage attempts. It is possible significant rates of streamflow could cause high water velocities which could prevent successful steelhead passage.

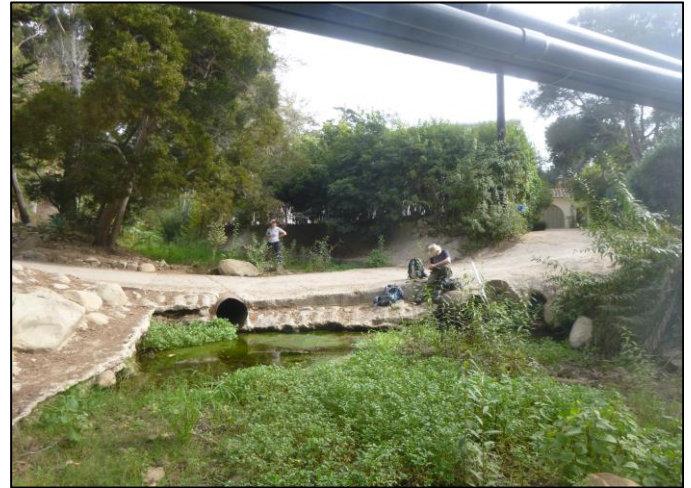
Figure 97. Loureyo Road low-water crossing on Romero Creek.

Conception Coast Watersheds – Romero Creek – Loureyo Road Low-Water Crossing						
Barrier ID	PAD ID	Location	Previous Barrier Status	Current Barrier Status	Remediation Score	Figure
ROM_005_R	None Assigned	34.42324, -119.61584	Unassessed	Temporal and Partial	11.15	97

The Loureyo Road crosses Romero Creek 0.5 stream miles from the Pacific Ocean. The crossing is a concrete low-water crossing with two small cylindrical culverts encased in the concrete. At the time of assessment (12/6/18) the inlets to both of these culverts were buried under streambed substrate. A pool unit with a mean depth of 1.5 ft was present at the outlet of the culverts despite active streamflow in the stream. FishXing analysis estimated steelhead could successfully pass the crossing at streamflow rates greater than 143.8 ft³/s, but estimated the crossing to be unpassable to resident *O. mykiss* life stages at any rate of streamflow. A temporal and partial barrier status was assigned to reflect this analysis.

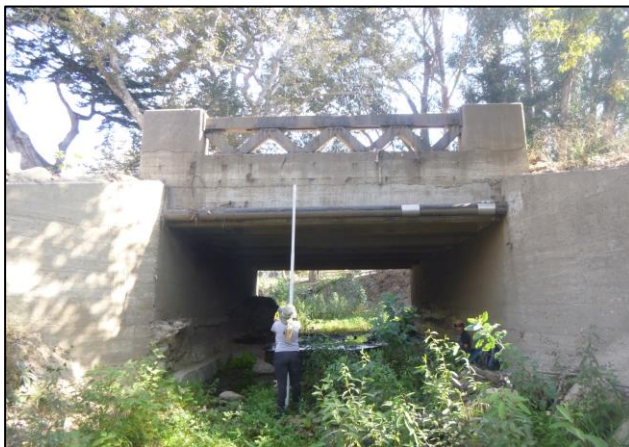
Figure 98. Outlet of Sheffield Drive bridge crossing.

Conception Coast Watersheds – Romero Creek – Sheffield Drive Crossing						
Barrier ID	PAD ID	Location	Previous Barrier Status	Current Barrier Status	Remediation Score	Figures
ROM_006_R	None Assigned	34.42319, -119.61308	Unassessed	Temporal and Partial	11.05	98 - 99

Sheffield Drive crosses Romero Creek 0.7 stream miles from the Pacific Ocean. The crossing is a bridge over a partially concrete lined box culvert. The box culvert was unique in that it contained a concrete grade control structure in the center of its base. The grade control has a plunge height of 1.9 ft, with enough scouring below it to create a small pool unit within the culvert. At the time of assessment (12/6/18) the mean water depth in this pool was 1.2 ft. The grade control structure has a concrete apron that extends to the inlet of the culvert. The culvert had a length of 35 ft, uniform width of 15.4 ft, and mean height of 9.7 ft. FishXing analysis estimated the crossing to be passable to steelhead at streamflow rates greater than 111.1 ft³/s, but estimated the crossing to be unpassable to resident *O. mykiss* life stages at any rate of streamflow. A temporal and partial barrier status was assigned to reflect this analysis.

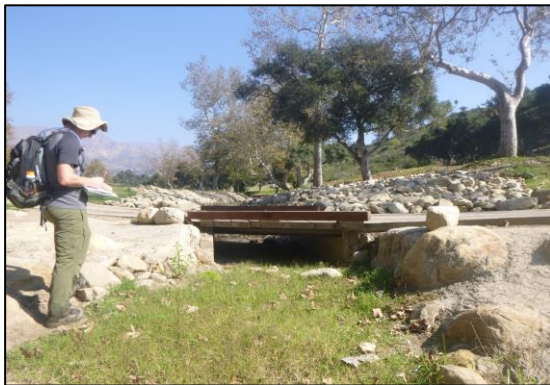
Figure. 100 Initial (ROM_008_R) Birnam Wood Golf Course crossing.

Conception Coast Watersheds – Romero Creek – Birnam Wood Golf Course Crossings						
Barrier ID	PAD ID	Location	Previous Barrier Status	Current Barrier Status	Remediation Score	Figure
ROM_008_R	None Assigned	34.43072, -119.60485	Unassessed	Unknown	8.15	100
ROM_010_R	None Assigned	34.43321, -119.59979	Unassessed	Unknown	6.95	101

Two notched low-water crossings over Romero Creek are located on the Birnam Wood Golf Course. These crossings are located 0.8 and 1.2 stream miles from the Pacific Ocean. The notch in both of these crossings has low clearance and is fully lined with concrete. The notch at the second crossing is separated by a concrete support. Permission to perform a detailed assessment on these crossings was not obtained from the golf course. As a result no definitive barrier status could be determined for these crossings although it is assumed with adequate streamflow both crossings could be passed by all life stages of *O. mykiss*.

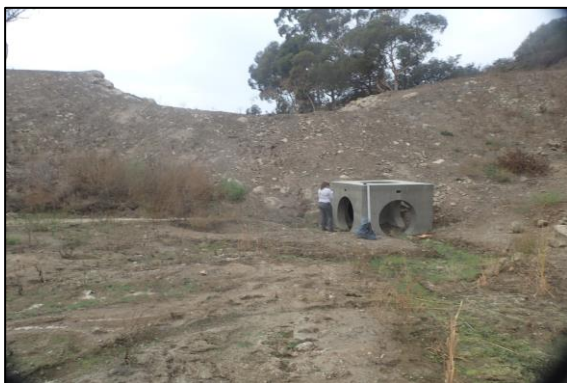
Figure 102. Drainage intake for debris basin on Romero Creek.

Conception Coast Watersheds – Romero Creek – Debris Basin						
Barrier ID	PAD ID	Location	Previous Barrier Status	Current Barrier Status	Remediation Score	Figures
ROM_023_NR	720271	34.44648, -119.59161	Total	Total	6.1	102 – 103

Romero Creek also contains a debris basin which was assessed to be total barrier to all life stages of *O. mykiss*. A large concrete boulder riprap embankment with a drainage culvert running through it formed the downstream portion of the basin. This embankment had a mean height of 14 ft and breadth of 131 ft. The cylindrical culvert had a diameter of 3 ft and a concrete debris rack cover at its intake. This debris basin was the only structure on Romero Creek which had an existing PAD listing.

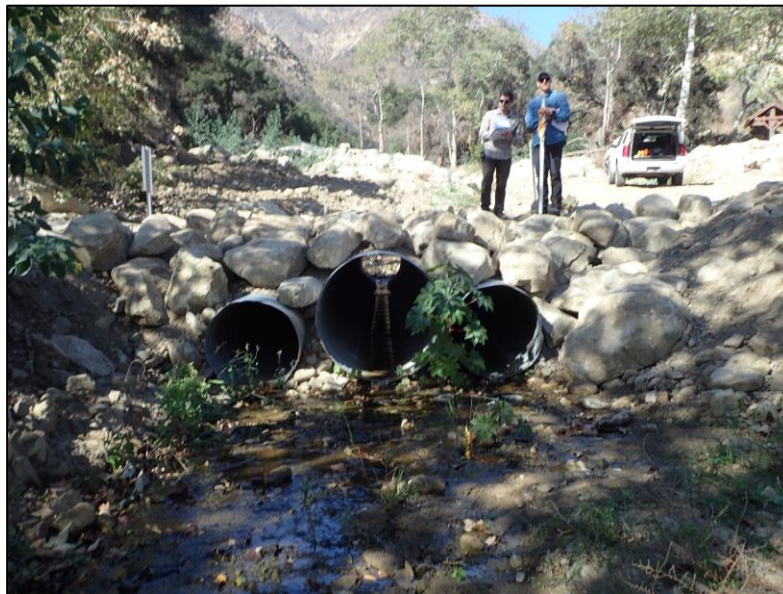
Figure 104. View of culvert outlets at Bella Vista Drive crossing.

Conception Coast Watersheds – Romero Creek – Bella Vista Drive Crossing						
Barrier ID	PAD ID	Location	Previous Barrier Status	Current Barrier Status	Remediation Score	Figure
ROM_013_R	None Assigned	34.44291, -119.59091	Unassessed	Temporal and Partial	3.3	104

Located 3.4 stream miles from the Pacific Ocean the Bella Vista Drive crossing on Romero Creek consists of boulders and gravel fill with three cylindrical culverts running through it. A concrete road surface has been laid on top of the fill. The center culvert has a diameter of 4 ft and the diameter of the two side culverts was 3 ft. All three culverts have a length of 50 ft and project from the road fill at both the inlet and outlet. At the time of assessment on 10/30/18 no plunge was present at the outlet of the culverts. This crossing structure was recently constructed as the former crossing structure was blown out during the debris flow event following the Thomas Fire. The new crossing structure is also likely susceptible to damage during high flow events due to its shallow fill. FishXing analysis estimated the culverts to be passable by steelhead at streamflow rates between 58.6 ft³/s and 255.2 ft³/s, but not passable to resident life stages of *O. mykiss* at any rate of streamflow. A temporal and partial barriers status was assigned to reflect this status.

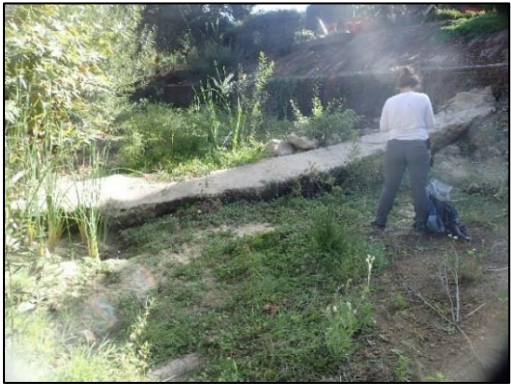
Barrier ID: ROM_004_NR PAD ID: None Assigned	34.42982, -119.60559	Unassessed	Total	Extended concrete boulder riprap apron grade control. Mean height: 9.5 ft Mean breadth: 19.5 ft Mean cascade length: 21 ft Remediation score: 12.05

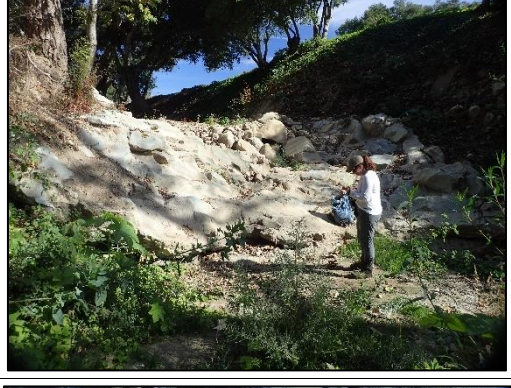
Barrier ID: ROM_005_NR PAD ID: None Assigned	34.43217, -119.60263	Unassessed	Temporal & Partial	Concrete grade control between wing walls with vertical plunge. Mean height: 2.3 ft Mean breadth: 1.0 ft Mean cascade length: 2.5 ft Remediation score: 8.25

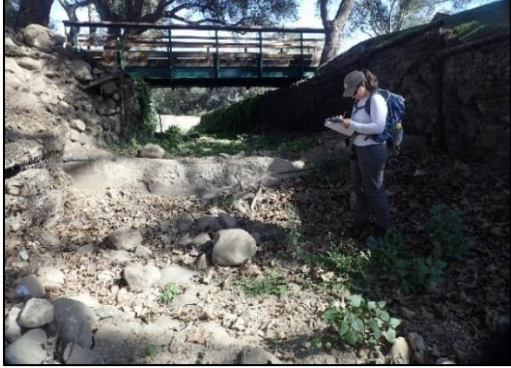
Barrier and PAD ID	Location	Previous Barrier Status	Current Barrier Status	Description, Dimensions, and Remediation Score	Picture
Barrier ID: ROM_006_NR PAD ID: None Assigned	34.43906, -119.59735	Unassessed	Temporal & Partial	Concrete apron grade control Mean height: 2.3 ft Mean breadth: 5 ft Mean cascade length: 5.6 ft Remediation score: 6.45

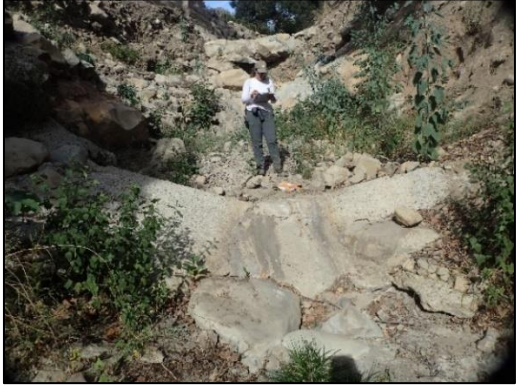
Barrier ID: ROM_007_NR PAD ID: None Assigned	34.43916, -119.5972	Unassessed	Total	Substantial concrete boulder rip rap grade control structure. Mean height: 4.8 ft Mean breadth: 6.6 ft Mean cascade length: 8.2 ft Remediation score: 6.45

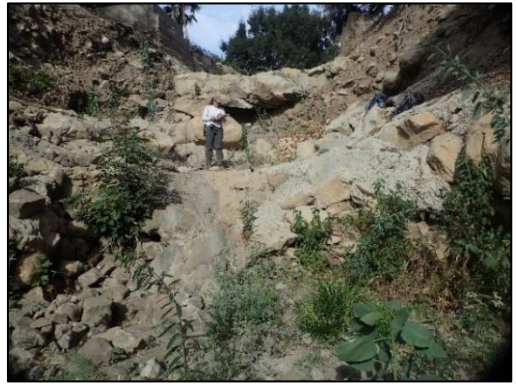
Barrier ID: ROM_008_NR PAD ID: None Assigned	34.43929, -119.59718	Unassessed	Total	Substantial concrete boulder rip rap grade control structure immediately upstream of ROM_008_NR grade control. Mean height: 13.4 ft Mean breadth: 15 ft Mean cascade length: 24 ft Remediation score: 6.45

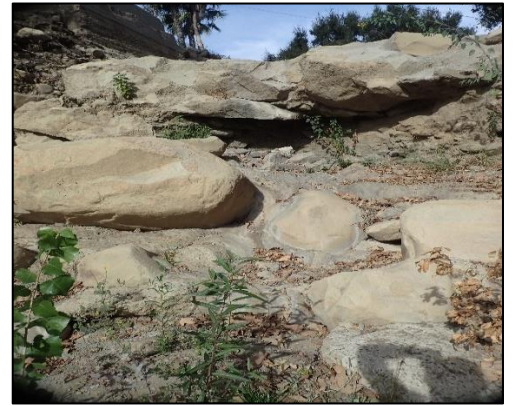
Barrier ID: ROM_009_NR PAD ID: None Assigned	34.43958, -119.59697	Unassessed	Temporal & Partial	Concrete boulder riprap grade control. Mean height: 2.4 ft Mean breadth: 1.9 ft Mean cascade length: 3.6 ft Remediation score: 4.35

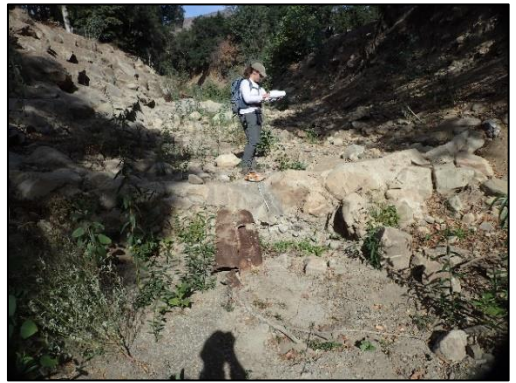
Barrier and PAD ID	Location	Previous Barrier Status	Current Barrier Status	Description, Dimensions, and Remediation Score	Picture
Barrier ID: ROM_010_NR PAD ID: None Assigned	34.43975, -119.59689	Unassessed	Temporal & Partial	Concrete apron grade control with distinct center flow point. Mean height: 3.5 ft Mean breadth: 4.5 ft Mean cascade length: 5.6 ft Remediation score: 4.35

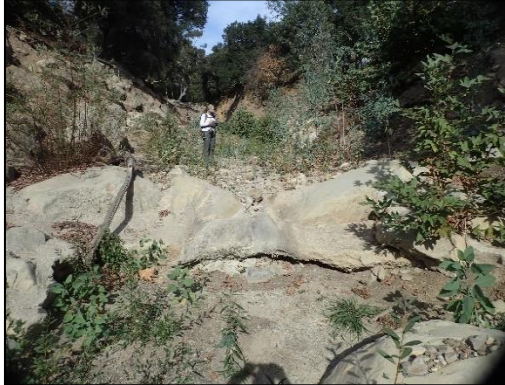
Barrier ID: ROM_011_NR PAD ID: None Assigned	34.4402, -119.59669	Unassessed	Total	Remnants of concrete boulder riprap grade control with significant scour below plunge. Mean height: 9.0 ft Mean breadth: 9.0 ft Mean cascade length: 13.6 ft Remediation score: 6.35

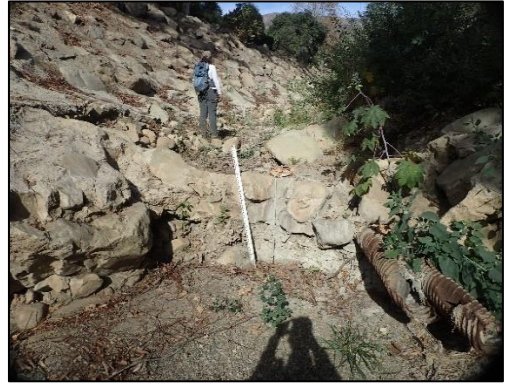
Barrier ID: ROM_012_NR PAD ID: None Assigned	34.44059, -119.59658	Unassessed	Total	Concrete boulder riprap grade control with center plunge point. Mean height: 3.0 ft Mean breadth: 1.3 ft Mean cascade length: 4.0 ft Remediation score: 6.35

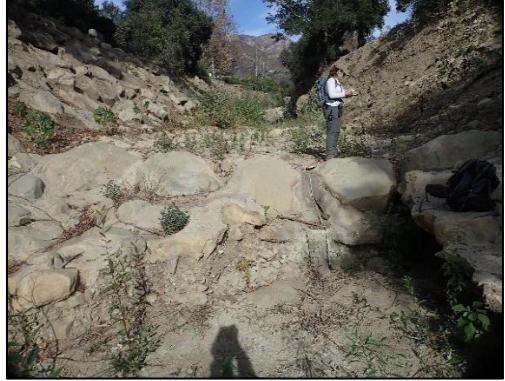
Barrier ID: ROM_013_NR PAD ID: None Assigned	34.44071, -119.59642	Unassessed	Temporal & Partial	Concrete boulder riprap grade control creating cascade. Mean height: 3.3 ft Mean breadth: 6.4 ft Mean cascade length: 8.3 ft Remediation score: 5.3

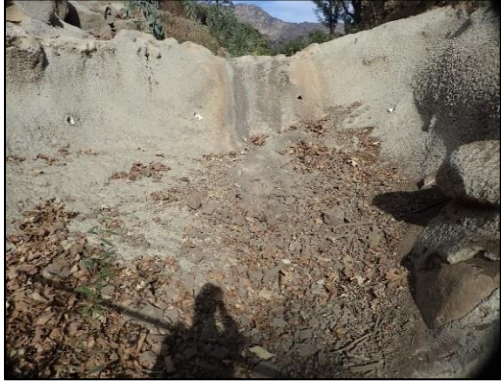
Barrier and PAD ID	Location	Previous Barrier Status	Current Barrier Status	Description, Dimensions, and Remediation Score	Picture
Barrier ID: ROM_014_NR PAD ID: None Assigned	34.44111, -119.59599	Unassessed	Total	Concrete grade control with center plunge point. Mean height: 9.5 ft Mean breadth: 26.0 ft Mean cascade length: 29 ft Remediation score: 6.4

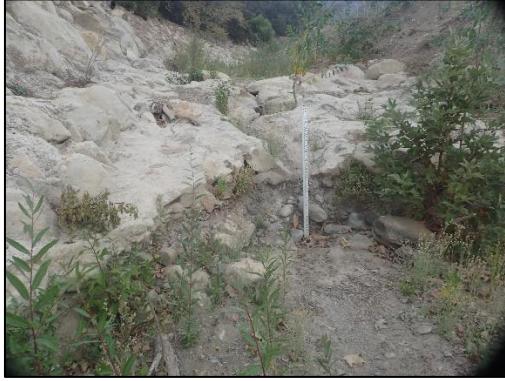
Barrier and PAD ID	Location	Previous Barrier Status	Current Barrier Status	Description, Dimensions, and Remediation Score	Picture
Barrier ID: ROM_018_NR PAD ID: None Assigned	34.44459, -119.59335	Unassessed	Temporal & Partial	Concrete boulder riprap grade control creating cascade. Mean height: 2.0 ft Mean breadth: 1.6 ft Mean cascade length: 3.1 ft Remediation score: 5

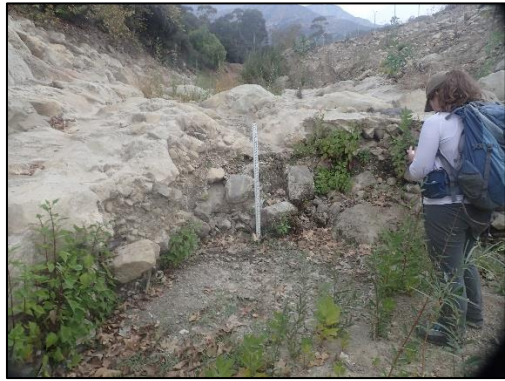
Barrier ID: ROM_019_NR PAD ID: None Assigned	34.44497, -119.59312	Unassessed	Temporal & Partial	Concrete boulder riprap grade control with cascade and plunge point. Mean height: 3.5 ft Mean breadth: 2.8 ft Mean cascade length: 5.8 ft Remediation score: 5

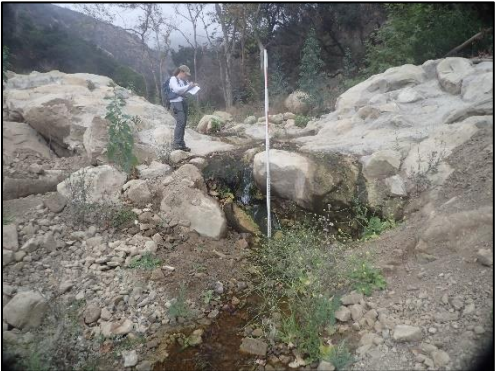
Barrier ID: ROM_028_NR PAD ID: None Assigned	34.45314, -119.59101	Unassessed	Temporal & Partial	Wide concrete boulder riprap grade control with eroded center. Mean height: 3.9 ft Mean breadth: 4.0 ft Mean cascade length: 6.0 ft Remediation score: 3.4

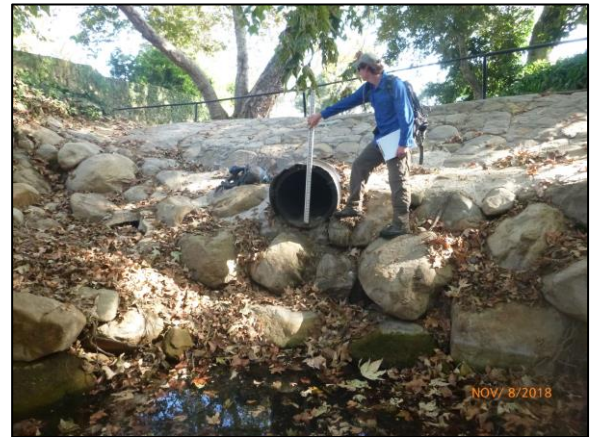
Three Buena Vista Creek road crossings within the Birnam Wood community were assessed to contain passage constraints to *O. mykiss*. Two of these crossings were on the community's golf course. The most downstream these crossings is located 0.3 stream miles from the Romero Creek confluence and is a concrete and boulder riprap low-water crossing with a small cylindrical culvert running through it (BV_004_R). The diameter of the culvert is 2 ft and its outlet is perched above the streambed with a 4.2 ft plunge. This plunge and the high turbulent streamflow velocities that occur through the culvert make this crossing structure impassable to all life stages of *O. mykiss*. The next crossing (BV_005_R) is located 0.4 stream miles from the Romero Creek confluence and is a free spanning bridge over concrete channel lining. A notched grade control structure is also included in the channel lining. The grade control notch has a uniform width of 3.2 ft. The Birnam Wood Drive crossing (BV_006_R) is the third structure within the community to contain passage constraints and is located 0.5 stream miles from the Romero Creek confluence. The crossing was a bridge over a fully concrete lined box culvert. A small grade control with a height of 1.5 ft was located within the center of the culvert. Additionally, a concrete cobble riprap apron extended upstream from the culvert inlet. Unfortunately access to conduct detailed assessments within the community was not granted and a definitive barrier status could not be assigned for the BV_005_R and BV_006_R crossings. However, it is likely steelhead can gain passage at these two crossings when streamflow rates permit adequate conditions.

Figure 105. Outlet of culvert for BV_004_R crossing.

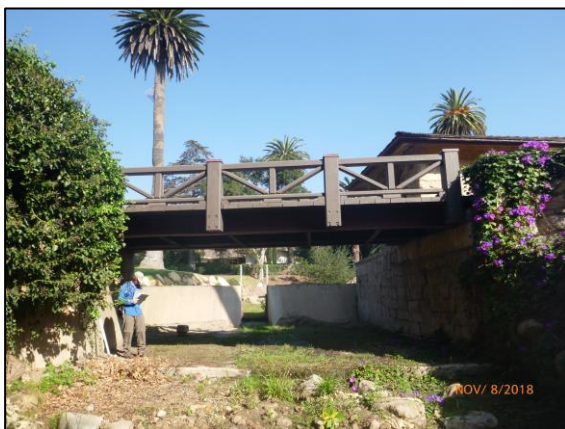
Figure 106. Downstream view of BV_005_R crossing.

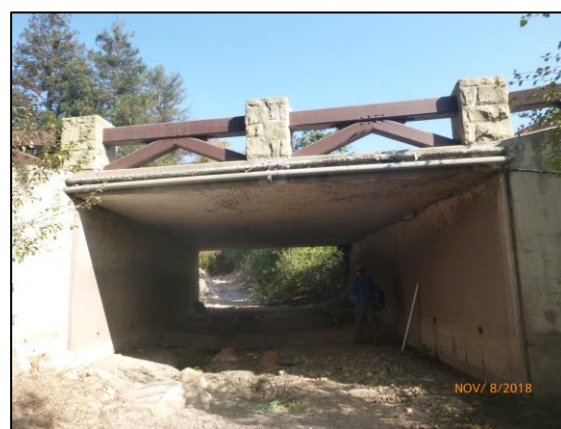
Figure 107. Downstream view of Birnam Wood Drive (BV_006_R) crossing.

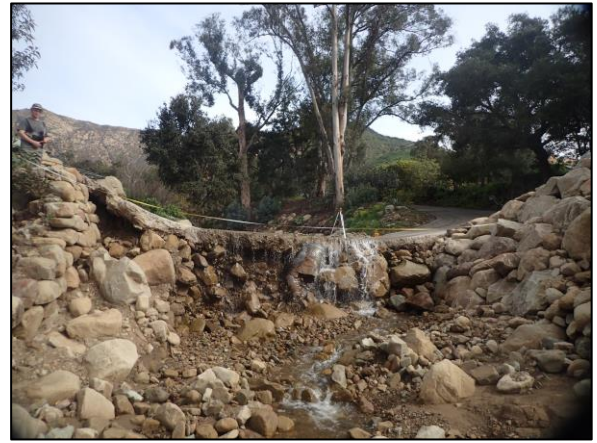
Buena Vista Drive includes a concrete low-water crossing of Buena Vista Creek 1.6 stream miles from the Romero Creek confluence. Significant scour downstream of the crossing has created a 7 ft high cascade at the outlet of the crossing. Boulders and cobble were located below this cascade creating an extended riffle unit. Due to this cascade FishXing analysis estimated this crossing to be impassable by all life stages of *O. mykiss*.

Figure 108. Downstream view of Buena Vista Drive crossing.

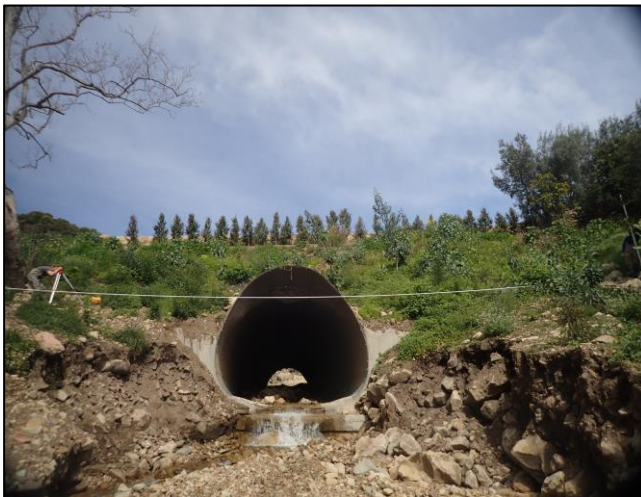
A large 14 ft high arched culvert is present at the Park Lane crossing of Buena Vista Creek. This crossing is located 1.7 stream miles from the Romero Creek confluence and marks the upstream extent of surveys conducted on Buena Vista Creek. When assessed on 3/11/19 the culvert was partially embedded with cobble, gravel, and boulders. The depth of the embedded substrate could not be determined, but appeared to be much greater at the inlet of the culvert than the outlet. A 4.6 ft long concrete apron is located at the outlet of the culvert. Scour has occurred downstream of the outlet apron creating a 3 ft plunge point. The length of the culvert is 115 ft and it runs under soil fill. FishXing analysis estimated the crossing to be impassable to all life stages of *O. mykiss*.

Figure 109. Park Lane culvert outlet.

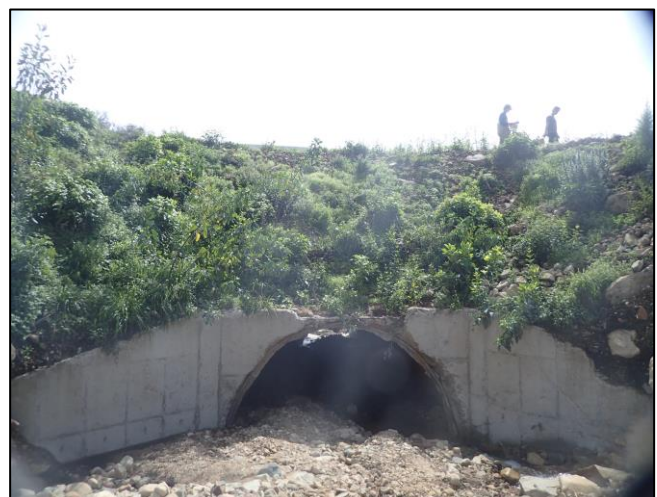
Figure 110. Embedded Park Lane culvert inlet.

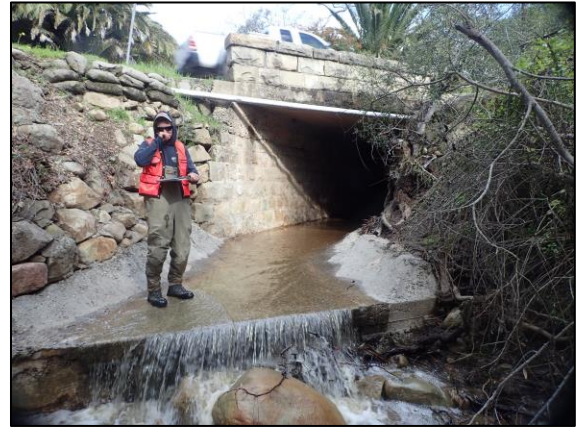
The California state highway 192 crossing was the first structure assessed to contain passage constraints on Picay Creek. This crossing is a bridge over natural substrate and is located 0.4 stream miles from the Romero Creek confluence. Vertical brick channel walls are located under the bridge. The crossing contains a 18.3 ft long concrete outlet apron with a 3 ft high plunge point to the downstream substrate. Minimal scour was present below the plunge at the time of assessment. The width of the bridge is only 8.5 ft. FishXing analysis estimated a steelhead could pass the structure at streamflow rates greater than 50 ft³/s, but would not be passable to resident life stages of *O. mykiss*. A temporal and partial barrier status was assigned to reflect this analysis.

Figure 111. Outlet apron and plunge point at Hwy 192 crossing on Romero Creek.

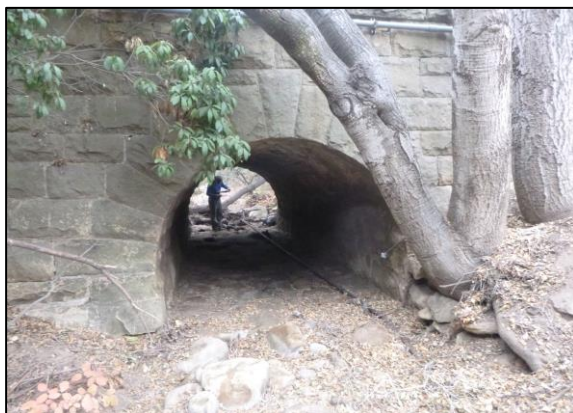
Two brick and cement lined arched culverts run under private road crossings upstream of the highway 192 crossing. Both of these crossing structures were assessed to contain passage constraints. The initial of these two crossings (PCY_003_R) is located 0.5 stream miles from the Romero Creek confluence. This crossing contains a short outlet apron with a 4 ft plunge to the downstream substrate. The culvert has a mean width 7.5 ft and a mean height of 6.2 ft. The next crossing (PCY_004_R) is located 0.6 stream miles from the Romero Creek confluence and marks the upstream extent of surveys conducted within Picay Creek. This crossing contains an inlet apron and a small 0.8 ft plunge point within the culvert. Permission to perform detailed assessments of these two crossing structures was not received from the private landowners and a definitive barrier status could not be determined. The 4 ft plunge point on the PCY_003_R crossing likely greatly limits *O. mykiss* passage.

Figure 112. Inlet of PCY 003 R private crossing culvert.

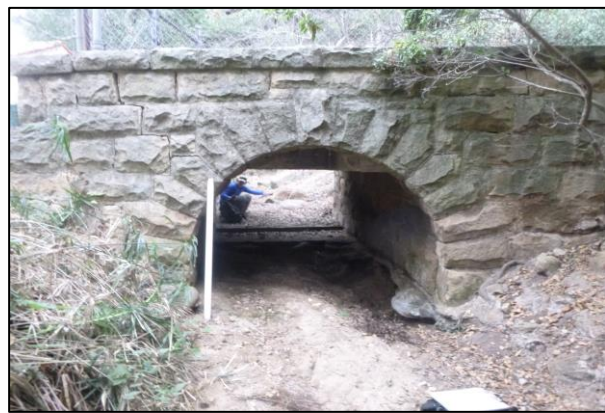
Figure 113. Outlet of PCY_004_R private crossing culvert.
