Assessment of Steelhead Habitat and Migration Barriers within Watersheds Impacted by the Thomas, Whitter, and Topanga Wildfires

Pacific States Marine Fisheries Commission

California Department of Fisheries and Wildlife

September 10, 2019

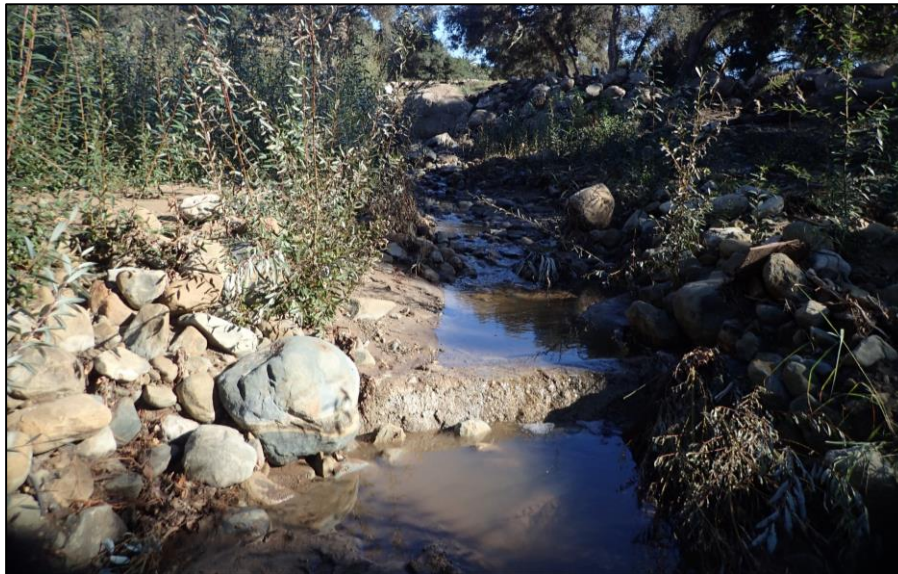
The initial structure assessed to contain *O. mykiss* passage constraints on Arroyo Paredon Creek is a small concrete grade control structure located 1.4 stream miles from the Pacific Ocean. At the time of assessment most of the structure appeared to be buried under streambed sediment. The exposed portion of the structure had a mean height of 2.2 ft, breadth of 0.7 ft, and cascade length of 2.6 ft. The small structure is likely easily passable to all life stages of *O. mykiss* under moderate and high rates of streamflow.

Figure 114. Exposed portion of concrete grade control on Arroyo Paredon Creek.

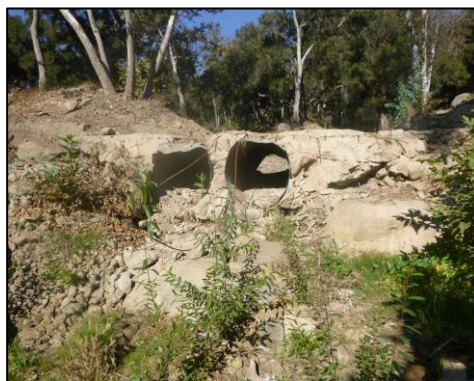
Three private road crossings with passage constraints are present within Arroyo Paredon Creek. The initial of these structures (AYP_005_R) is located 1.5 stream miles from the Pacific Ocean. This crossing contained two cylindrical culverts running through shallow gravel road fill reinforced with boulder riprap. Both culverts projected from the fill, but were at the level of streambed substrate. The diameter of both culverts is 4.8 ft. The crossing structure appeared as if it may have been reconstructed after damage from post Thomas Fire debris flows. Damage from future high stream flow events is appears to be possible due to the shallow road fill. The landowner did not respond to inquiries for permission to conduct a detailed assessment and a definitive barrier status could not be determined, however if the condition of the crossing does not change steelhead likely can successfully pass under adequate rates of streamflow. The next private road crossing (AYP_008_R) on Arroyo Paredon Creek is located 2.8 stream miles from the Pacific Ocean. This configuration of this crossing is similar to the AYP_005_R crossing as it contains two cylindrical culverts under shallow gravel road fill. This crossing however was reinforced with a concrete road surface. The culverts and road surface of this crossing were heavily damaged at the time of assessment. A gradual cascade with a height of 3.8 ft and length of 9.5 ft was present at the outlet of the culverts. FishXing analysis estimated the crossing to be impassable to all life stages of *O. mykiss*. The third private road crossing (AYP_010_R) is located 3.1 stream miles from the Pacific Ocean and is a fully concrete lined box culvert with wingwalls at the inlet and outlet. The culvert at this crossing has a steep slope, but could not be measured as the landowner asked surveyors to leave before culverts measurements could be conducted. This landowner also denied access for any further upstream surveys so this crossing marked the upstream extent of barrier and habitat assessments on Arroyo Paredon Creek. Due to the lack of data collected a definitive barrier status could not be determined for this private road crossing, however considering the steep slope of the culvert high flow velocities likely occur through the structure and prevent any life stages of *O. mykiss* from successfully gaining passage at this crossing structure.

Figure 116. Outlet of culverts at AYP_008_R private road crossing.

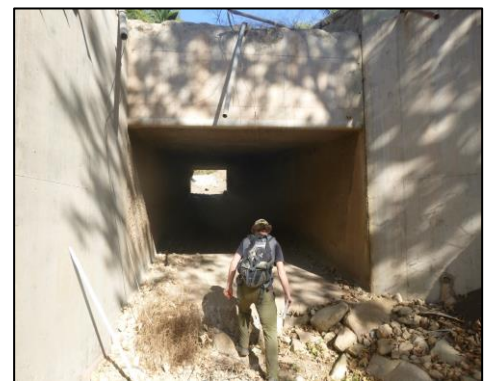
Figure 117. Outlet of box culvert at AYP_010_R private road crossing.

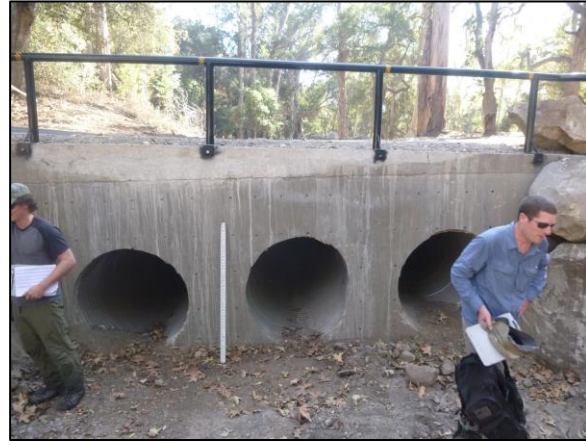
The Toro Canyon Park Road crossing is located 3.0 stream miles from the Pacific Ocean and contains three cylindrical culverts running under concrete, gravel, boulder road fill, and an asphalt road surface. The inlets of the culverts are fully encased in a concrete headwall and the outlets are under gravel and boulder fill. All three culverts have a diameter of 3.7 ft, length of 41 ft, and were level with streambed substrate at the time of assessment. This crossing structure was rebuilt due to severe damage from the debris flow event following the Thomas Fire. FishXing analysis estimated the crossing to be passable by steelhead between streamflow rates of 13 ft³/s and 255 ft³/s, but not passable to resident *O. mykiss* life stages.

Figure 119. Inlet of Toro Canyon Park Road crossing culverts Arroyo Paredon Creek.

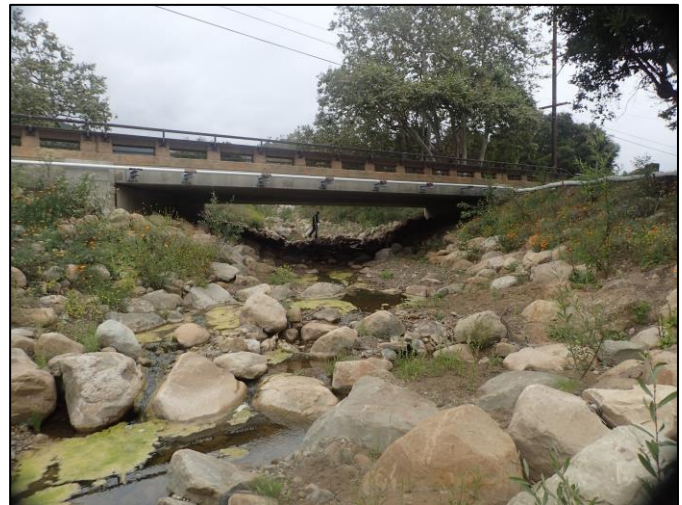
The debris flow event on Arroyo Paredon Creek following the Thomas Fire severely damaged the highway 192 crossing. A new free spanning bridge was constructed and finished in 2019. This new bridge was assessed to be free of *O. mykiss* passage constraints. The previous crossing structure had been assigned a temporal barrier status.

Figure 120. Downstream view of new Hwy 192 bridge crossing on Arroyo Paredon Creek.

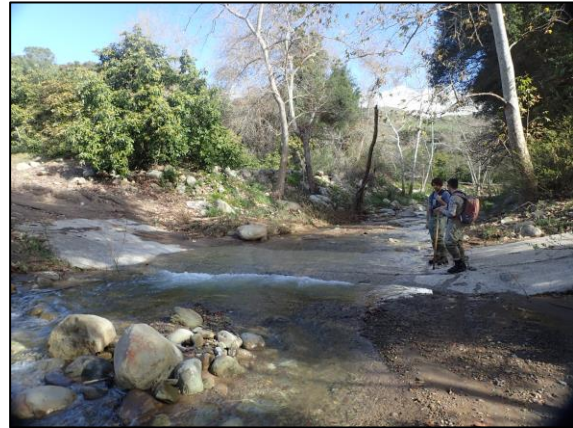
The initial of only two structures containing passage constrains within Gobernador Creek is a concrete low-water crossing located 1.1 stream miles from the Carpinteria Creek confluence. The crossing surface gradually elevated to 1.1 ft above the downstream streambed substrate at the time of assessment. FishXing analysis estimated steelhead would be able to successfully pass the crossing at streamflow rates greater than 63 ft³/s and resident *O. mykiss* at streamflow rates greater than 98 ft³/s. A temporal barrier status was assigned to reflect this analysis, which matched the previously assigned barrier status listed in PAD.

Figure 122. Private low-water crossing on Gobernador Creek.

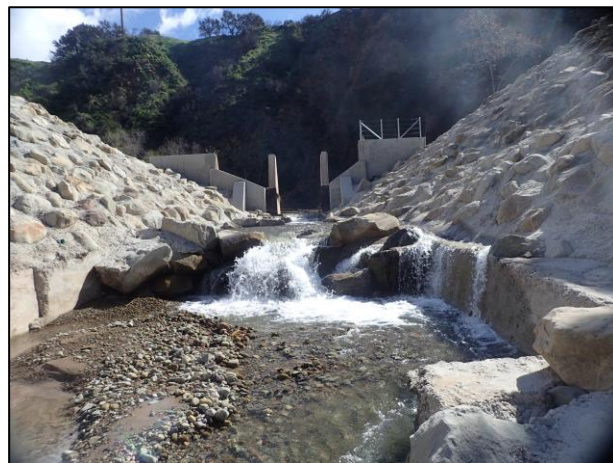
The debris basin on Gobernador Creek is located 1.6 stream miles from the Carpinteria Creek confluence. The outlet of the debris basin contains a two grade control structures between slanted concrete boulder riprap channel walls. The initial downstream grade control is an extension of the channel walls into the stream channel. This grade control has a height of 4.2 ft, breadth of 9 ft, and cascade length of 10.8 ft. A pool unit was located below this grade control with a mean water depth of 1.7 ft. At high rates of streamflow the downstream unit depth would increase and allow steelhead to make successful passage. It is however unlikely resident *O. mykiss* can successfully pass this concrete and riprap grade control structure. The next grade control structure consists of a series of concrete trash rack walls with perpendicular and parallel orientations in relation to the stream channel. A notch with a mean width of 6.8 ft is present at the center of these concrete walls. A small cascade caused by scattered boulders was present at the time of assessment just downstream of this notch. Under assessed conditions this cascade and the concrete boulders walls are likely easily passed by steelhead under adequate rates of streamflow.

Figure 123. Outlet and grade control of debris basin on Gobernador Creek.

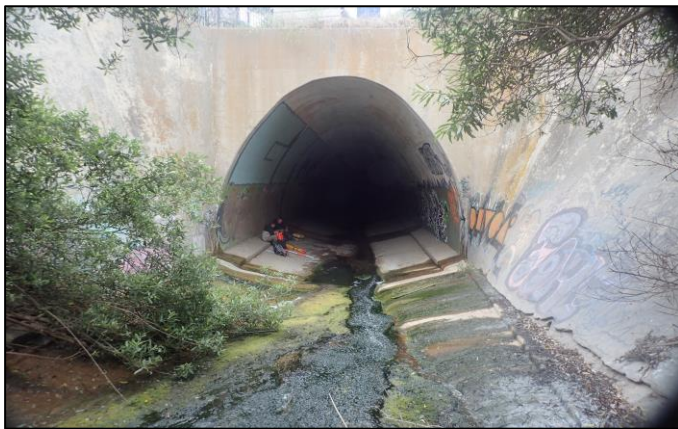
The highway 101 crossing is the initial structure limiting *O. mykiss* upstream movement on Rincon Creek and is located at the upstream extent of the estuary. A large arched culvert fully encased in concrete passes 880 ft under the road surface and railroad tracks. The culvert is fully lined with concrete and its base is tapered inward slightly so streamflow is channeled to the center of the culvert. The culvert maintains a uniform height of 16.7 ft and width of 20 ft. The structure contains a 39 ft long concrete inlet apron centered between concrete wingwalls. The apron descends 6.2 ft from its upstream extent to the inlet of the culvert. This apron creates high streamflow velocities and was estimated to be the main factor preventing passage to all life stages of *O. mykiss* at this crossing structure from FishXing analysis. This structure prevents steelhead from accessing the entire Rincon Creek watershed.

Figure 124. Inlet of Hwy 101 culvert on Rincon Creek.

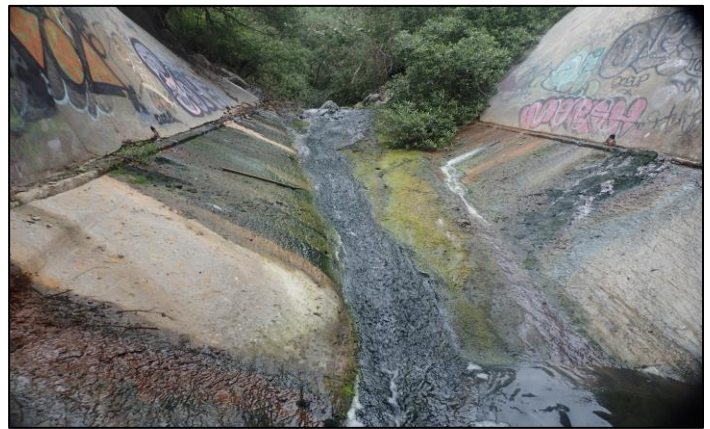
Figure 125. Inlet apron at Hwy 101 crossing structure on Rincon Creek.

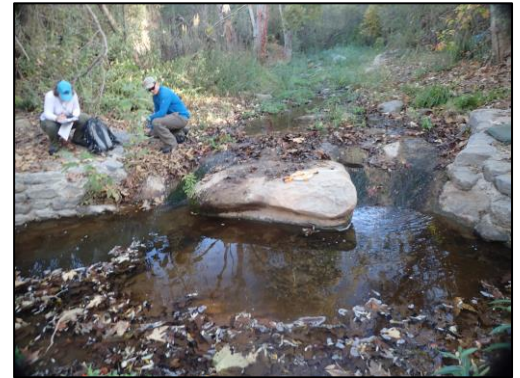
A small concrete and cobble riprap grade control structure is located adjacent to a private residence 2.8 stream miles from the Pacific Ocean. The structure contains two distinct cascade points over concrete. The mean height of the structure is 2.4 ft, with a mean breadth of 4.9 ft, and mean cascade length of 3 ft. A pool unit is located downstream of the structure with a mean water depth of 1.7 ft at the time of assessment on 11/28/18. The downstream pool unit and the minimal height of the structure likely allow for successful passage of all *O. mykiss* life stages at higher rates of streamflow.

Figure 126. Downstream view of grade control structure on Rincon Creek.

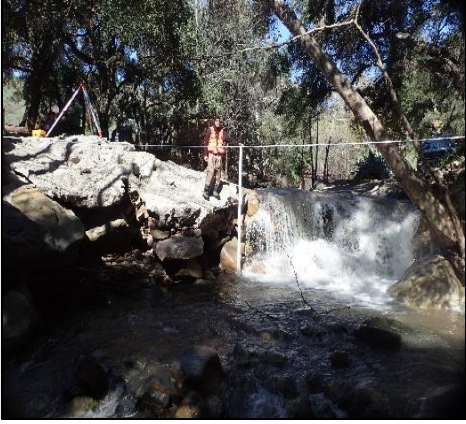
Barrier and PAD ID	Location	Previous Barrier Status	Current Barrier Status	Description, Dimensions, and Remediation Score	Picture
Barrier ID: RNC_010_R PAD ID: 706217	34.40206, -119.44678	Temporal	Total	Concrete low-water crossing with short outlet apron and downstream scour creating significant plunge from outlet apron onto boulders. Outlet apron length: 17.7 ft Outlet apron height: 4 ft Outlet plunge height: 4.5 ft Water depth below plunge: 2.4 ft Road surface width: 16.3 ft Remediation score: 12.15

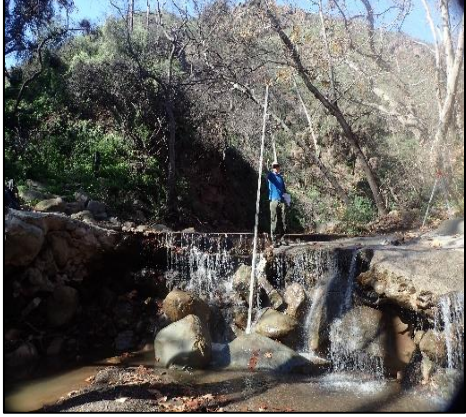
Barrier ID: RNC_013_R PAD ID: 706220	34.40673, -119.44547	Temporal	Total	Concrete low-water crossing with downstream scour and damage creating significant cascade over boulder and concrete from outlet. Outlet cascade height: 8 ft Outlet cascade length: 8.4 ft Water depth below cascade: 0.8 ft Road surface width: 12.9 ft Remediation score: 9.95

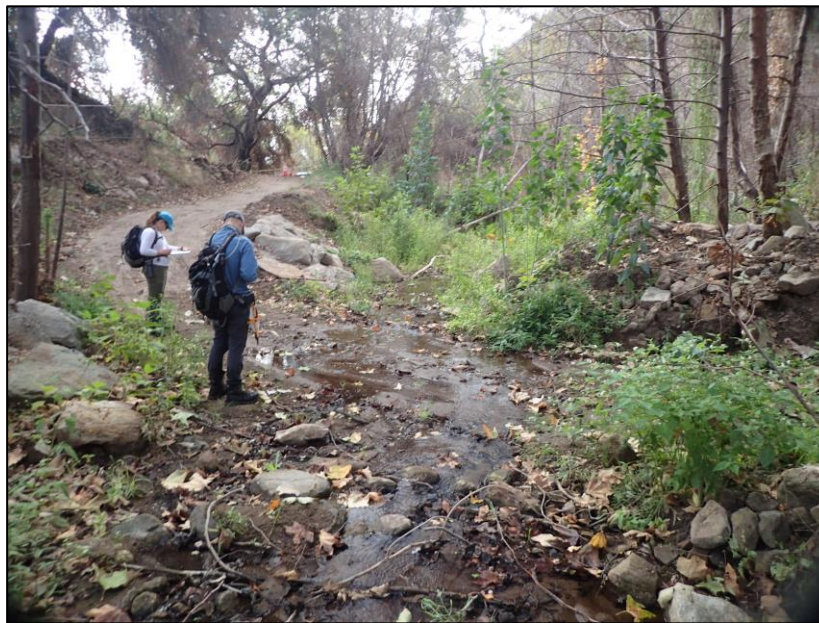
Two listings within PAD for low-water crossings on Rincon Creek with temporal barrier statuses were assessed to no longer constrict upstream *O. mykiss* movement. The low-water crossing for one of these listings (RNC_012_R) is no longer present within the stream channel and is assumed to have been eroded away. The other low-water crossing (RNC_014_R) is still present, but the gravel roadway appeared to be seldomly used and the low-water crossing portion of the roadway was buried under sediment. If this roadway is utilized for vehicle crossings again in the future any efforts to reestablish the low-water crossing could potentially lead to conditions which limits upstream migrating *O. mykiss*.

Figure 127. Upstream view of sediment buried RNC_014_R gravel low-water crossing.

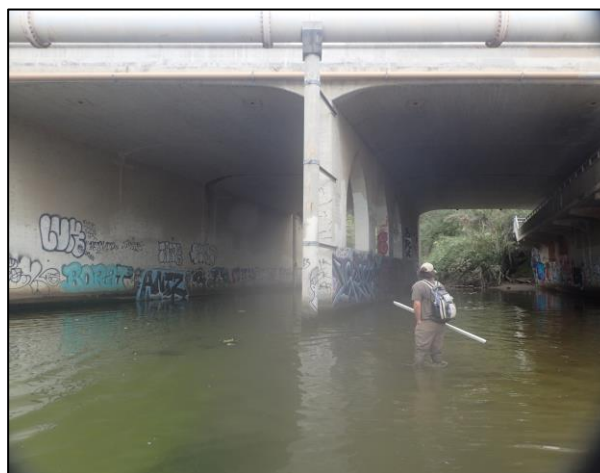
The only man-made structure on Topanga Creek assessed to no longer constrict *O. mykiss* movement is the highway 101 bridge crossing. The bridge passes over standing estuary water and thus all life stages of *O. mykiss* can easily swim under the bridge. All other PAD listings assessed to no longer constrict *O. mykiss* upstream movement were for natural features and in all cases no evidence of the listed natural feature was present within the stream channel.

Figure 128. Standing estuary water under Hwy 1 bridge on Topanga Creek.

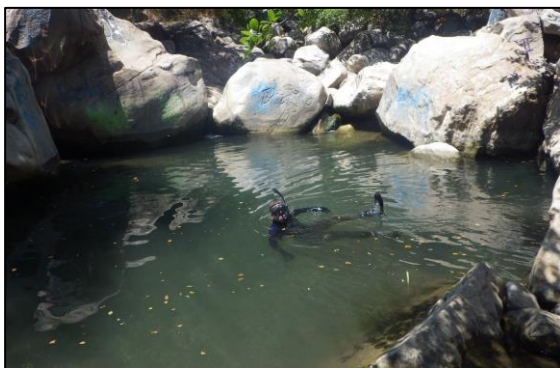
Figure 129. North Fork Matilija Creek Aug 2016 (CDFW Unpublished Data)

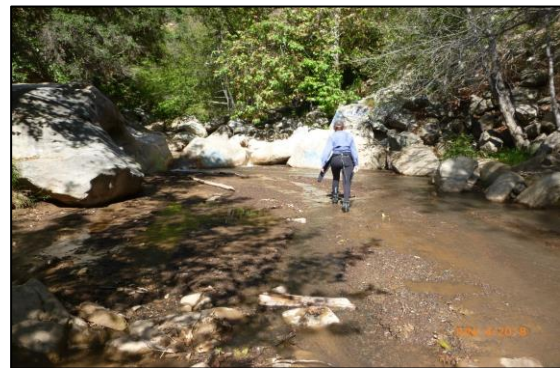
Most impacted by post fire rain events were streams within the Thomas Fire burn scar. Rain events not only occurred directly following the fire, but also delivered intense rates of rainfall of up to 0.60 inches in just a five-minute period (National Weather Service 2019). This produced destructive debris flows which caused rapid and significant alterations to the stream channel, riparian zone vegetation, and destroyed multiple man-made structures within the floodplain. This extreme sedimentation was visually evident during habitat assessments. An example of this sedimentation is shown in figures 129 & 130. When comparing our unit dimension results to those documented prior to the Thomas, Whittier, Rye, and Topanga wildfires, there is an evident decrease in unit depths and widths as well as an increase in mean unit lengths (Table 27). Unfortunately, these past snorkel reports did not include documentation of unit types so a comparison of pool, flatwater, and riffle abundances within these streams prior to and post fire and debris flows is not possible. Despite this, the comparison of unit dimensions reflects the general shift observed in stream habitat from diverse habitat structure to one dominated by long shallow low gradient riffles. While shallow riffles are suitable habitat for *O. mykiss* fry and small juveniles due to the protection they provide from predation and competition, larger adults require pool habitat units in order to thrive (Raleigh et al. 1984; Rosenfeld and Boss 2001). The reduction in overall stream depth limits the available habitat for adults to access in future spawning seasons.

Figure 130. Same location of North Fork Matilija June 2018 (Horgan et al. 2018)

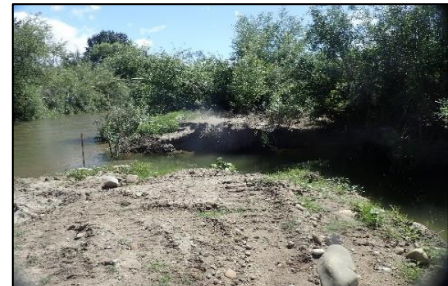
Barrier ID: SCL_007_NR PAD ID: 758971	34.35159, -119.04469	Unassessed	Not a Barrier	Large, earthen diversion dam. Land is cut out for water for agriculture. Used to have screen but is now blasted out.

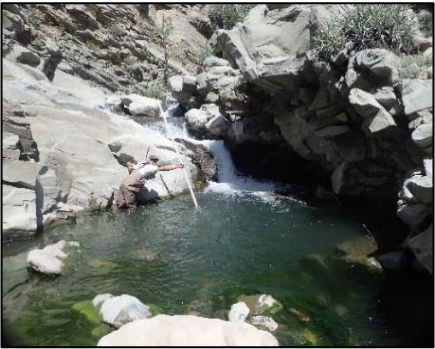
Barrier & PAD ID	Location	Previous Barrier Status	Current Barrier Status	Description and Dimensions	Picture
Barrier ID: SPL_011_NR PAD ID: 723745	34.4496, -119.05848	Total	Temporal & Partial	Bedrock step pools with plunge and cascade. Total height of barrier: 6 ft Water depth below plunge: 2.4 ft Water depth below cascade: 1.6 ft

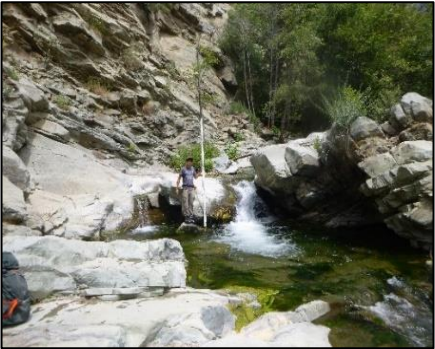
Barrier ID: SPL_012_NR PAD ID: None Assigned	34.44952, -119.05846	Unassessed	Temporal	Cascade at bedrock chute. Barrier height: 4.4 ft Water depth below cascade: 3.8 ft

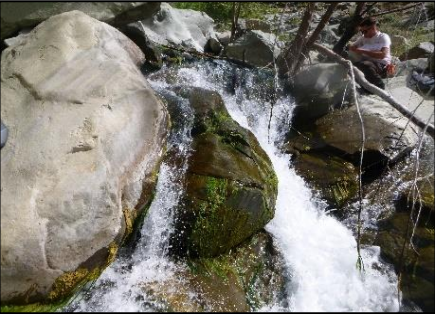
Barrier ID: SPL_013_NR PAD ID: None Assigned	34.44918, -119.05804	Unassessed	Temporal	Cascade over boulders. Barrier height: 5.6 ft Water depth below cascade: 2.1 ft

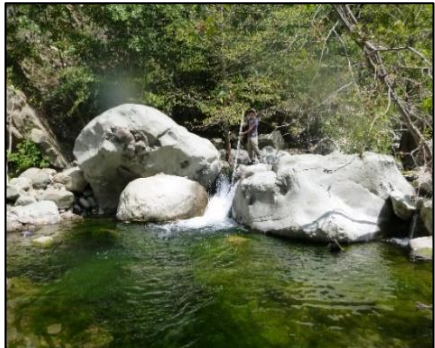
Barrier ID: SPL_014_NR PAD ID: None Assigned	34.44914, -119.05797	Unassessed	Temporal	Plunge over bedrock. Barrier height: 3.4 ft Water depth below plunge: 4 ft

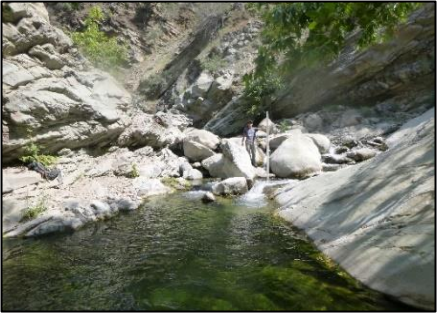
Barrier & PAD ID	Location	Previous Barrier Status	Current Barrier Status	Description and Dimensions	Picture
Barrier ID: SPL_015_NR PAD ID: None Assigned	34.44876, -119.05786	Unassessed	Temporal & Partial	Cascade over boulders and bedrock. Barrier height: 5.7 ft Water depth below plunge: 2.1 ft

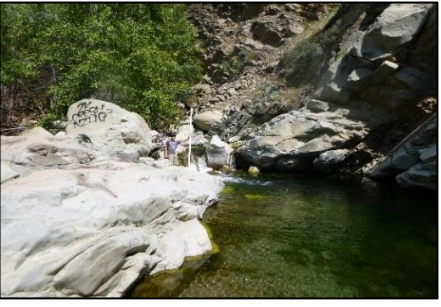
Barrier ID: SPL_016_NR PAD ID: None Assigned	34.44865, -119.05769	Unassessed	Temporal	Cascade over boulders and on to bedrock sheet. Barrier height: 4.2 ft Water depth below cascade: 1.1 ft

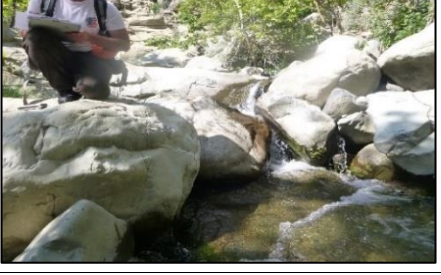
Barrier ID: SPL_017_NR PAD ID: None Assigned	34.44870, -119.05666	Unassessed	Temporal	Cascade over boulders and onto bedrock. Barrier height: 5.5 ft Water depth below cascade: 0.3 ft

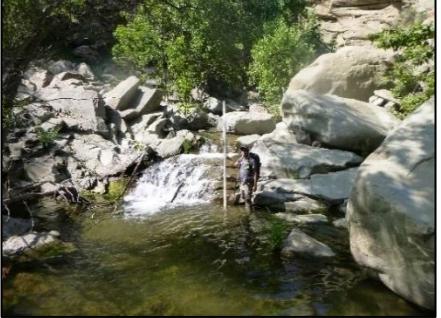
Barrier ID: SPL_018_NR PAD ID: None Assigned	34.44897, -119.05633	Unassessed	Temporal & Partial	Cascade over bedrock. Barrier height: 4.2 ft Water depth below cascade: 1.7 ft

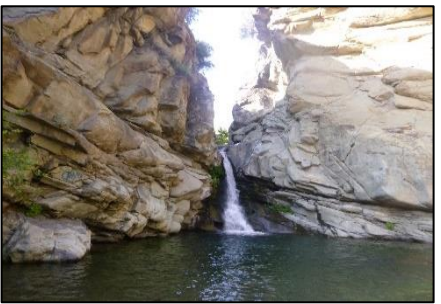
Barrier ID: SPL_019_NR PAD ID: 705163	34.44908, -119.05673	Total	Total	Waterfall over bedrock. Barrier height: >17 ft Water depth below cascade: 8.3 ft

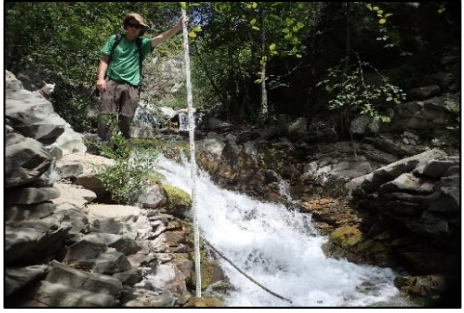
Barrier ID: EFSP_002_NR PAD ID: None Assigned	34.44866, -119.05621	Unassessed	Temporal & Partial	Cascade over bedrock. Cascade height: 6.8 ft Water depth below cascade 1.7 ft

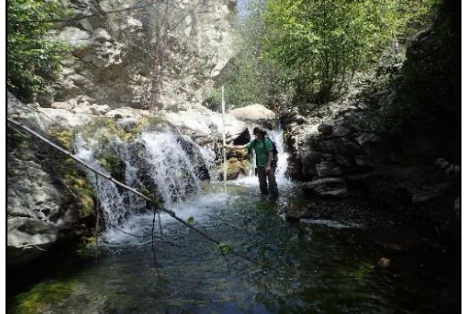
Barrier ID: EFSP_003_NR PAD ID: None Assigned	34.44863, -119.05607	Unassessed	Temporal & Partial	Plunge over bedrock. Plunge height: 6.7 ft Water depth below plunge: 1 ft

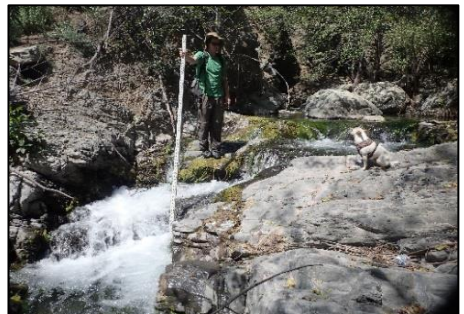
Barrier ID: EFSP_004_NR PAD ID: None Assigned	34.44831, -119.05486	Unassessed	Temporal & Partial	Cascade over bedrock. Cascade height: 5.1 ft Water depth below plunge: 2 ft

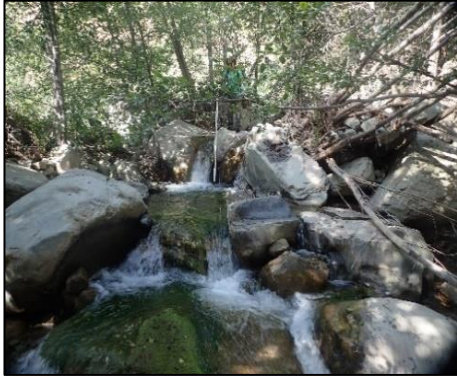
Barrier & PAD ID	Location	Previous Barrier Status	Current Barrier Status	Description	Picture
Barrier ID: EFSP_005_NR PAD ID: None Assigned	34.44796, -119.05205	Unassessed	Partial	Cascade step pools over bedrock. Height of 1 st cascade: 3.9 ft Height of 2 nd cascade: 3.6 ft Water depth below 1 st cascade 1.6 ft Water depth below 2 nd cascade 1.6 ft

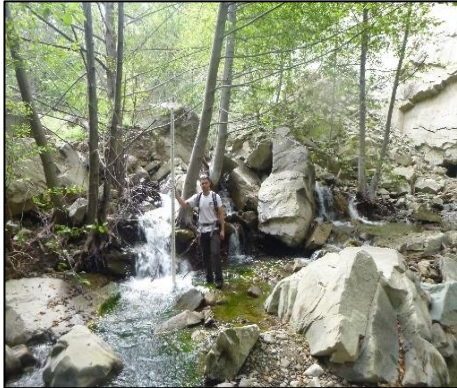
Barrier ID: EFSP_006_NR PAD ID: None Assigned	34.44714, -119.05130	Unassessed	Temporal & Partial	Cascade over landslide rock rubble. Cascade height: 6.2 ft Water depth below cascade: 0.8 ft

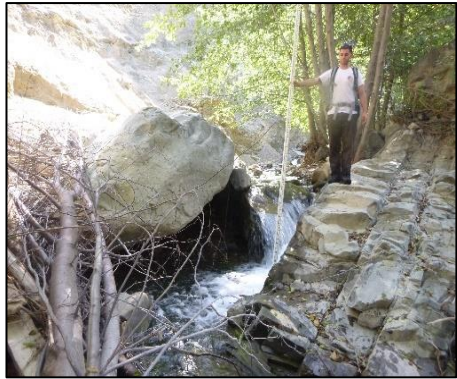
Barrier ID: EFSP_007_NR PAD ID: None Assigned	34.44728, -119.05008	Unassessed	Temporal & Partial	Plunge point over and between bedrock. Plunge height: 3.6 ft Water depth below plunge: 1.5 ft

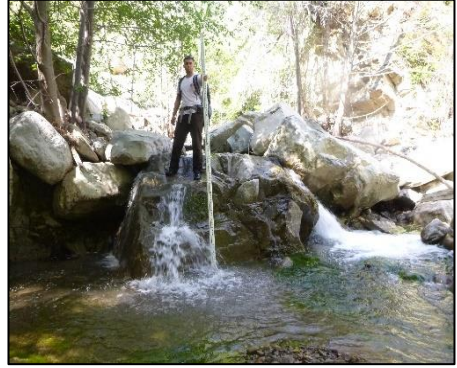
Barrier ID: EFSP_008_NR PAD ID: None Assigned	34.44683, -119.04963	Unassessed	Temporal & Partial	Plunge over large boulders. Plunge height: 4.7 ft Water depth below plunge: 2.0 ft

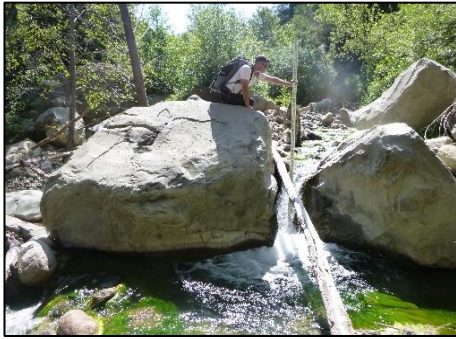
Barrier & PAD ID	Location	Previous Barrier Status	Current Barrier Status	Description	Picture
Barrier ID: EFSP_009_NR PAD ID: None Assigned	34.44676, -119.04964	Unassessed	Temporal & Partial	Narrow plunge point between bedrock and boulders. Plunge height: 3.2 ft Water depth below plunge: 2.5 ft

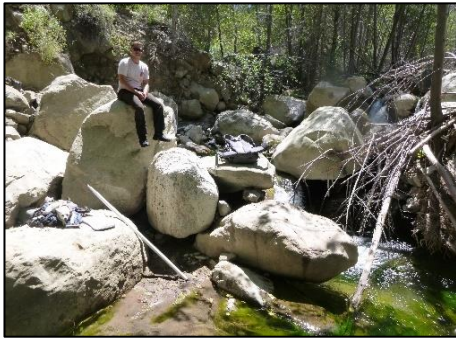
Barrier ID: EFSP_010_NR PAD ID: None Assigned	34.44703, -119.04784	Unassessed	Temporal & Partial	Three plunge points and step pools over large boulders. Total height of barrier: 10.1 ft Depth below 1st plunge: 1.8 ft Depth below 2 nd plunge: 1.4 ft Depth below 3 rd plunge: 1.1 ft

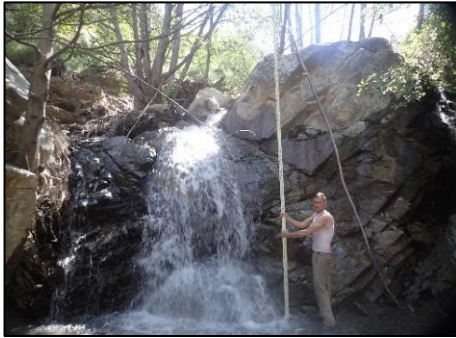
Barrier ID: EFSP_011_NR PAD ID: None Assigned	34.44727, -119.03366	Unassessed	Total	Waterfall over bedrock. Waterfall height: 16.5 ft Depth below plunge: 0.6 ft

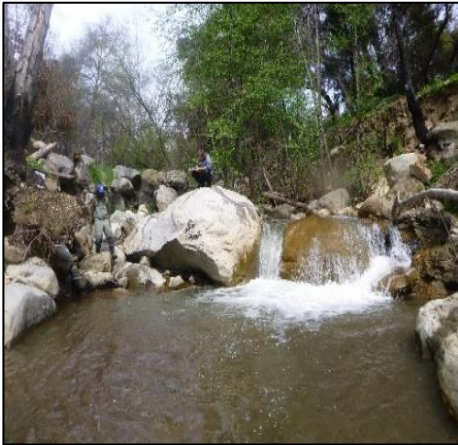
Barrier & PAD ID	Location	Previous Barrier Status	Current Barrier Status	Description and Dimensions	Picture
Barrier ID: SIS_007_NR PAD ID: None Assigned	34.43186, -119.12341	Unassessed	Temporal & Partial	Plunge over boulders and bedrock. Height of barrier: 7.2 ft Water depth below plunge: 3 ft

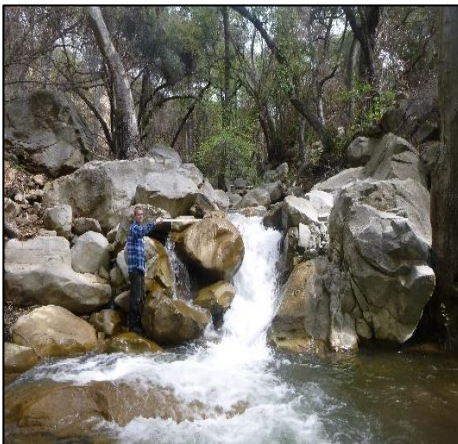
Barrier ID: SIS_013_NR PAD ID: None Assigned	34.46513, -119.12646	Unassessed	Temporal & Partial	Cascade over boulders. Height of barrier: 8.5 ft Water depth below cascade: 0.5 ft

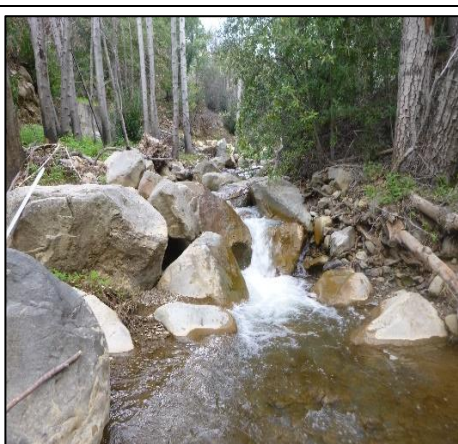
Barrier & PAD ID	Location	Previous Barrier Status	Current Barrier Status	Description and Dimensions	Picture
Barrier ID: SIS_015_NR PAD ID: None Assigned	34.46812, -119.12519	Unassessed	Temporal & Partial	Plunge over large boulders. Height of barrier: 6.1 ft Water depth below plunge: 1.3 ft

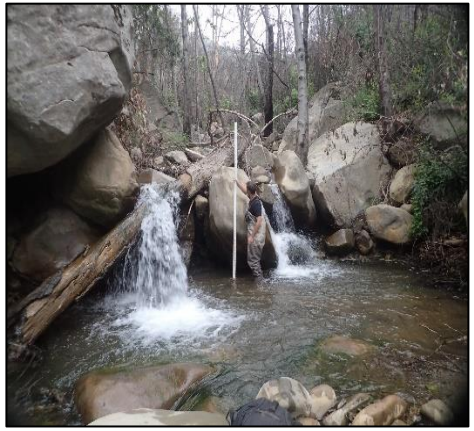
Barrier ID: SIS_016_NR PAD ID: None Assigned	34.46829, -119.12498	Unassessed	Temporal & Partial	Cascade over large boulders. Height of barrier: 6.0 ft Water depth below cascade: 3.3 ft

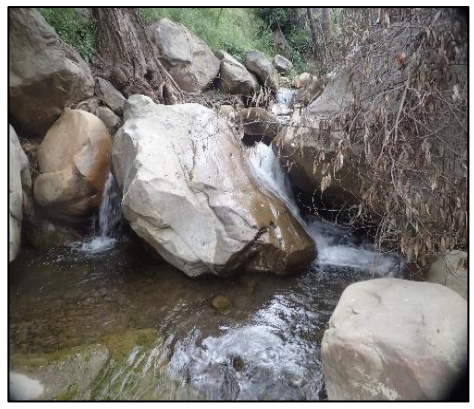
Barrier ID: SIS_017_NR PAD ID: 723747	34.46997, -119.12427	Total	Total	Plunge off of overhanging bedrock and large boulder. Height of barrier: 9.4 ft Water depth below plunge: 1.5 ft

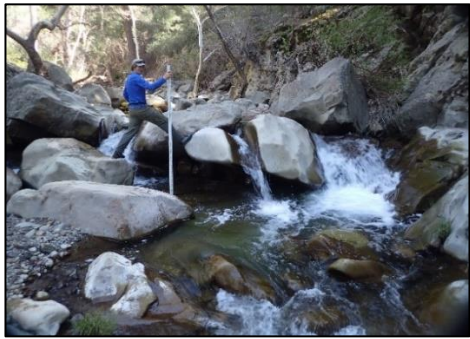
Barrier & PAD ID	Location	Previous Barrier Status	Current Barrier Status	Description	Picture
Barrier ID: LYN_001_NR PAD ID: None Assigned	34.55537, -119.16569	Unassessed	Temporal & Partial	Plunge over bedrock and boulders. Height of barrier: 5.0 ft Water depth below plunge: 2.0 ft

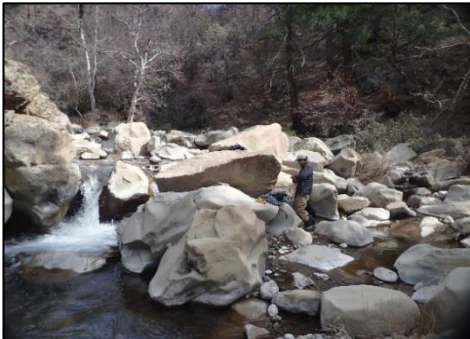
Barrier ID: LYN_006_NR PAD ID: None Assigned	34.53871, -119.16095	Unassessed	Temporal & Partial	Cascade over boulders. Height of barrier: 3.7 ft Water depth below cascade: 2.6 ft

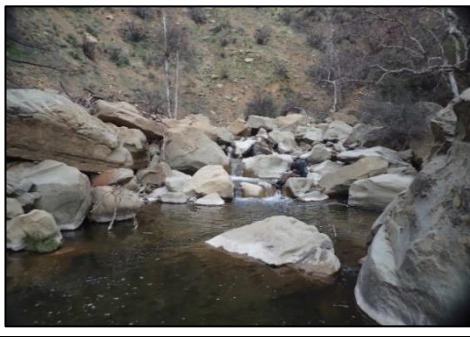
Barrier ID: LYN_007_NR PAD ID: None Assigned	34.53886, -119.16003	Unassessed	Temporal & Partial	Cascade over bedrock and boulders. Height of barrier: 12 ft Water depth below cascade: 2.8 ft

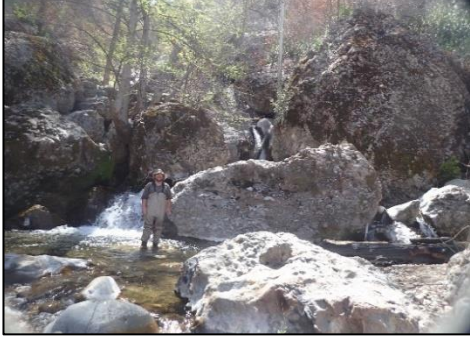
Barrier ID: ELYN_001_NR PAD ID: 723785	34.52751, -119.14328	Total	Total	Waterfall and cascade over bedrock. Height of barrier: > 25 ft Water depth below plunge: > 10 ft

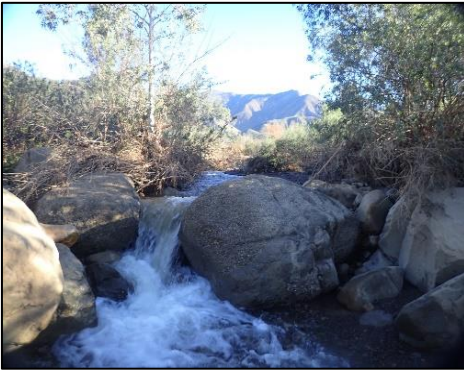
Barrier & PAD ID	Location	Previous Barrier Status	Current Barrier Status	Description and Dimensions	Picture
Barrier ID: SNT_023_NR PAD ID: None Assigned	34.46452, -119.2077	Unassessed	Temporal and Partial	Centralized plunge point over large boulders Height of the plunge: 3.8 ft Water depth below plunge: 1.2 ft

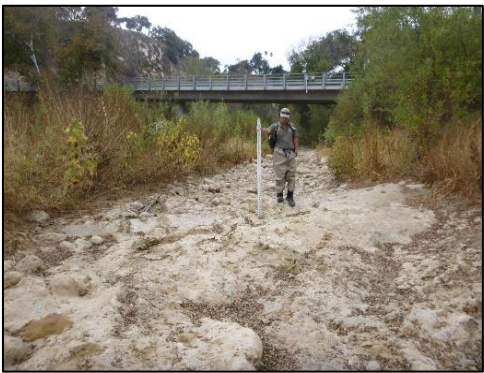
Barrier ID: SNT_004_NR PAD ID: None Assigned	34.38218, -119.30258	N/A	Not a Barrier	Embedded utility pipe with damaged concrete encasing.

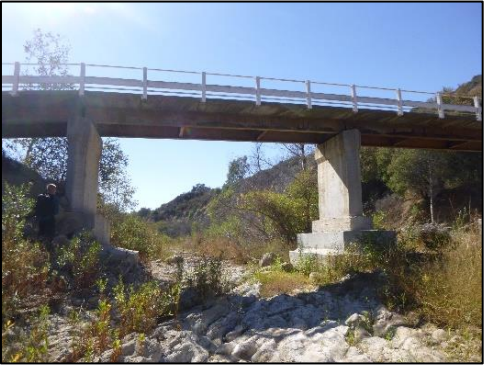
Barrier & PAD ID	Location	Previous Barrier Status	Current Barrier Status	Description	Picture
Barrier ID: SNT_011_R PAD ID: None Assigned	34.42075, -119.26686	N/A	Not a Barrier	Bridge with two supports in channel over natural streambed substrate.

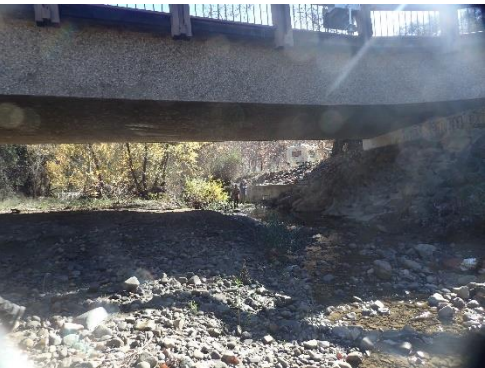
Barrier ID: SNT_013_R PAD ID: 705658	34.42695, -119.25841	Temporal	Not a Barrier	Free spanning concrete bridge with rip rap on both banks. Over natural streambed substrate. Concrete channel wall downstream on river right.

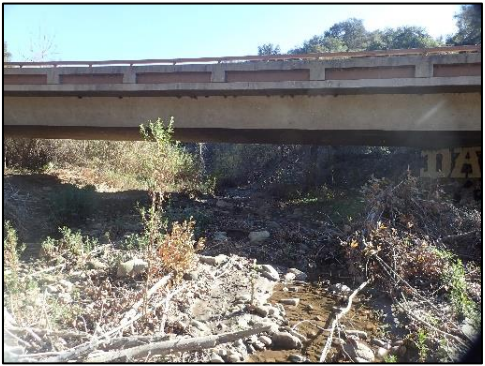
Barrier ID: SNT_014_R PAD ID: 705659	34.43151, -119.25352	Not a Barrier	Not a Barrier	Free spanning concrete bridge over natural streambed.

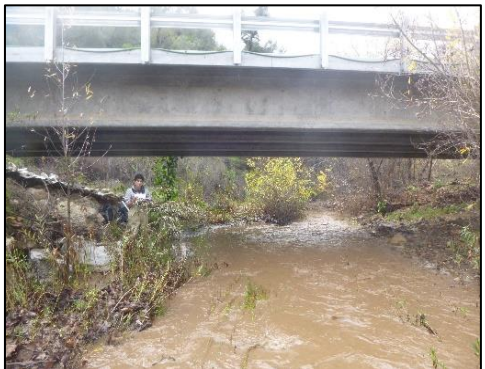
Barrier ID: SNT_015_R PAD ID: 705660	34.43481, -119.24658	N/A	Not a Barrier	Free spanning bridge over natural substrate. Boulder rip rap channel walls under bridge.

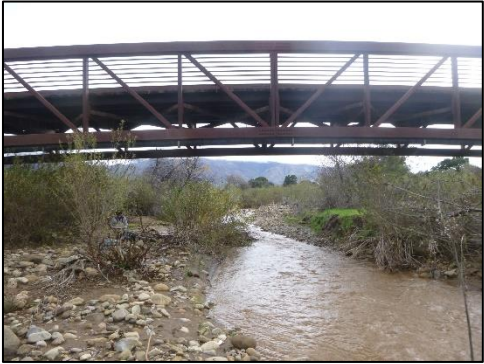
Barrier & PAD ID	Location	Previous Barrier Status	Current Barrier Status	Description	Picture
Barrier ID: SNT_016_R PAD ID: 713871	34.44198, -119.23275	Partial	Not a Barrier	Free spanning golf course bridge over natural streambed substrate.

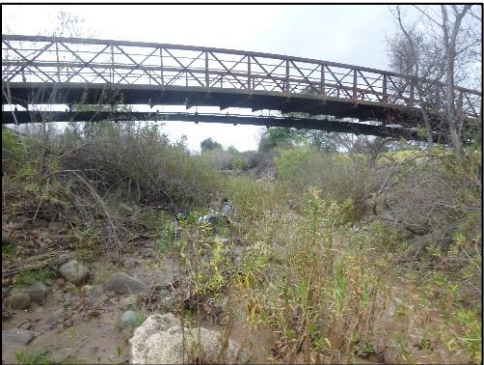
Barrier ID: SNT_017_R PAD ID: 713872	34.44445, -119.23015	Remediated, fish response unconfirmed	Not a Barrier	Free spanning golf course bridge over natural streambed substrate.

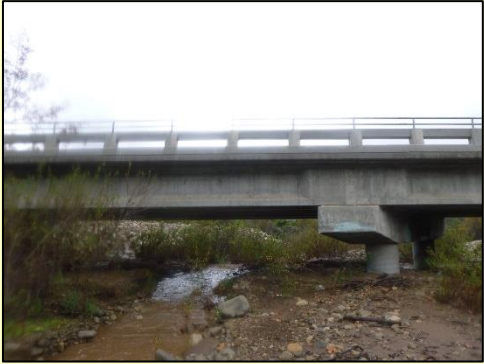
Barrier ID: SNT_018_R PAD ID: 713873	34.44914, -119.22465	Partial	Not a Barrier	Hwy 150 bridge over natural streambed substrate with instream concrete supports. Post Mile: 18.76

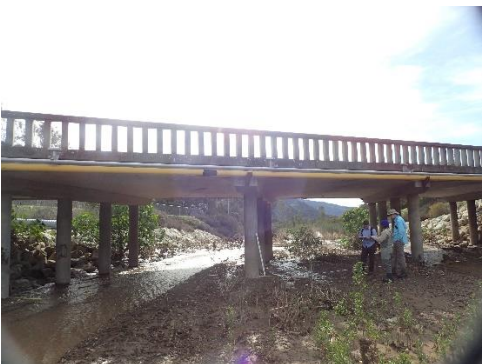
Barrier ID: SNT_021_R PAD ID: 705661	34.45435, -119.22173	Temporal & Partial	Not a Barrier	Bridge with six sets of support pillars over natural substrate; four of which are in the stream bed. Boulder rip rap on channel banks.

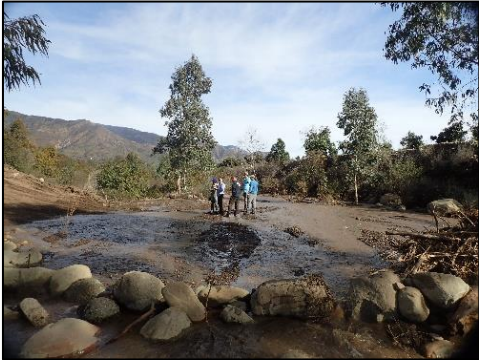
Barrier & PAD ID	Location	Previous Barrier Status	Current Barrier Status	Description	Picture
Barrier ID: SNT_022_R PAD ID: 713876	34.46131, -119.21491	N/A	Not a barrier	Low water crossing through natural streambed substrate. Dirt road.

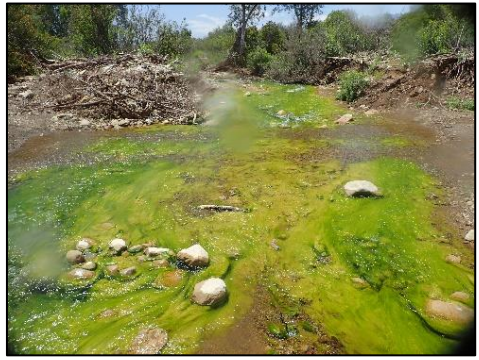
Barrier ID: SNT_024_R PAD ID: None Assigned	34.46497, -119.20721	N/A	Not a Barrier	Low water crossing through natural streambed substrate. Dirt road.

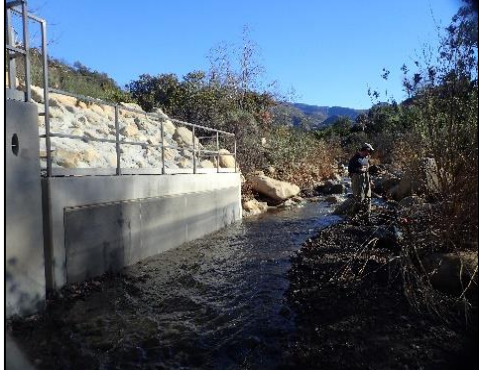
Barrier ID: SNT_025_NR PAD ID: None Assigned	34.46634, -119.20532	N/A	Not a Barrier	Water diversion structure with intake on river right bank.

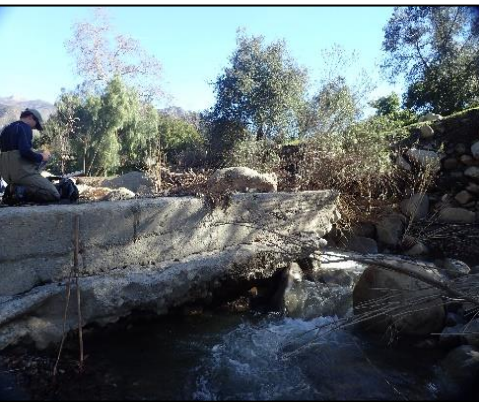
Barrier ID: SNT_026_NR PAD ID: None Assigned	34.46703, -119.20389	N/A	Not a Barrier	Grade control extending 80% across channel. River left is open for fish passage.

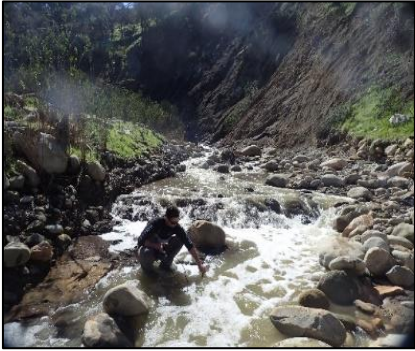
Barrier & PAD ID	Location	Previous Barrier Status	Assessed Barrier Status	Description and Dimensions	Picture
Barrier ID: LNC_002_NR PAD ID: None Assigned	34.42084, -119.26294	N/A	Temporal	Cascade over a bedrock outcropping. Height of cascade: 1.2 ft Water depth below cascade: 0.6 ft

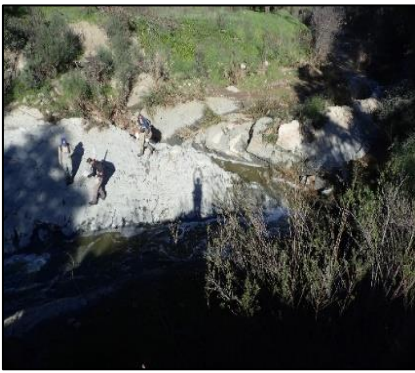
Barrier ID: LNC_004_NR PAD ID: 713891	34.41879, -119.24934	Temporal	Temporal & Partial	Bedrock outcropping with plunge point and cascade. Height of plunge point: 3.1 ft Water depth below plunge: 1.3 ft Height of cascade: 3.3 ft Length of cascade: 15.2 ft

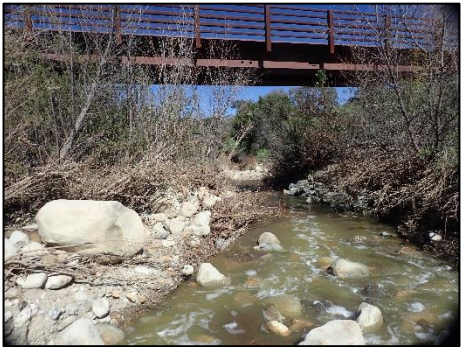
Barrier & PAD ID	Location	Previous Barrier Status	Assessed Barrier Status	Description	Picture
Barrier ID: LNC_001_R PAD ID: 713879	34.421, -119.26288	Remediated, Fish response Unconfirmed	Not a Barrier	Free spanning bridge over boulder rip rap in natural streambed substrate.

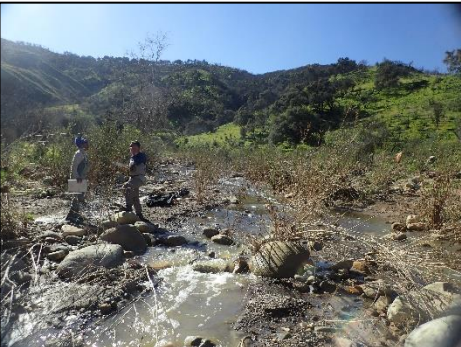
Barrier ID: LNC_003_R PAD ID: None Assigned	34.41917, -119.25957	N/A	Not a Barrier	Low water crossing through natural streambed substrate.

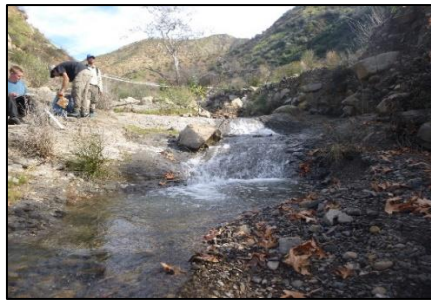
Only one naturally occurring stream feature on Thacher Creek was assessed to limit *O. mykiss* upstream movement. This feature is the total natural barrier and limit to anadromy on Thacher Creek.

Barrier & PAD ID	Location	Previous Barrier Status	Assessed Barrier Status	Description and Dimensions	Picture
Barrier ID: THC_017_NR PAD ID: None Assigned	34.46666, -119.17474	N/A	Total	Series of cascades over sheer bedrock outcropping. Measurements only taken for most downstream cascade. Cascade height: 6.4 ft Cascade length: 32.5 ft Water depth below cascade: 1.0 ft

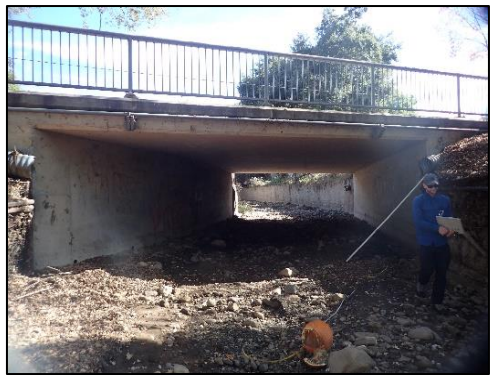
Barrier & PAD ID	Location	Previous Barrier Status	Assessed Barrier Status	Description	Picture
Barrier ID: THC_005_R PAD ID: 705663	34.44512, -119.21983	N/A	Not a Barrier	Free spanning bridge over concrete channel walls and natural substrate.

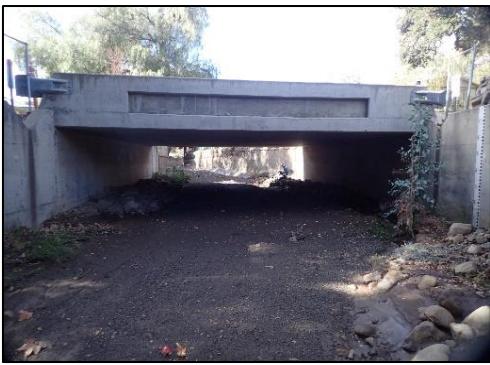
Barrier ID: THC_007_R PAD ID: 705664	34.44513, -119.2187	N/A	Not a Barrier	Free spanning bridge over concrete channel walls and natural streambed substrate.

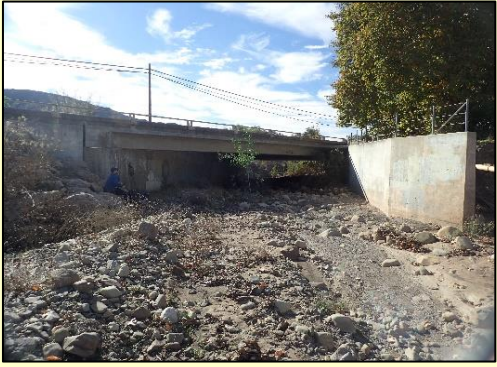
Barrier & PAD ID	Location	Previous Barrier Status	Assessed Barrier Status	Description	Picture
Barrier ID: THC_008_R PAD ID: 731449	34.44666, -119.21101	N/A	Not a Barrier	Free spanning Hwy 150 bridge over concrete channel walls and natural streambed substrate. Post Mile: 19.57

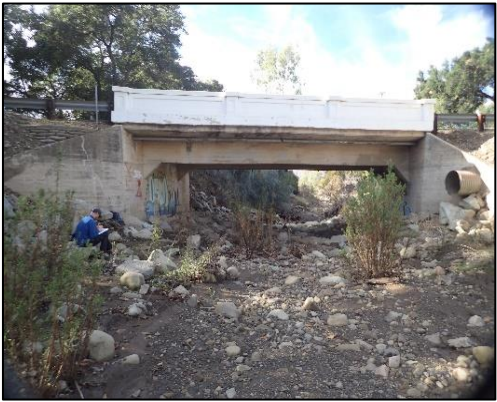
Barrier ID: THC_009_R PAD ID: 705665	34.44687, -119.2063	N/A	Not a Barrier	Free spanning bridge over concrete channel walls and natural streambed substrate.

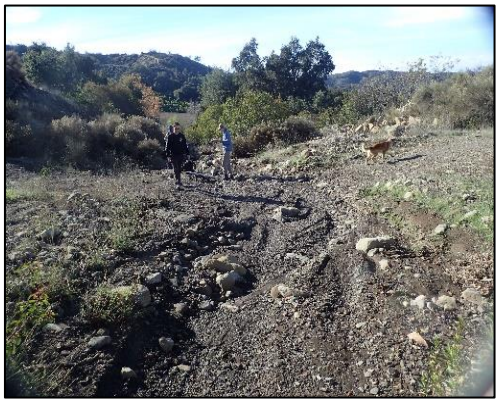
Barrier ID: THC_012_R PAD ID: None Assigned	34.44948, -119.19453	N/A	Not a Barrier	Low water crossing with natural streambed. Textile channel lining on river left.

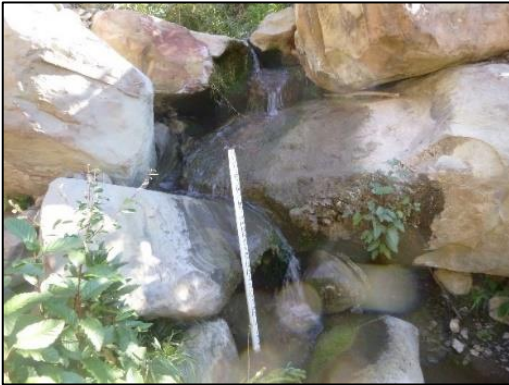
Barrier & PAD ID	Location	Previous Barrier Status	Assessed Barrier Status	Description	Picture
Barrier ID: NFM_002_NR PAD ID: 713765	34.52739, -119.26364	Partial	Temporal & Partial	Large boulder pile cascade lacking any steps. Height of barrier: 6.6 ft.

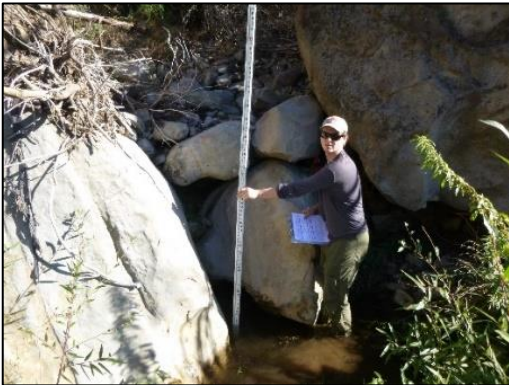
Barrier ID: NFM_003_NR PAD ID: None Assigned	34.53307, -119.25797	Unassessed	Temporal & Partial	Large boulder pile in narrow channel with plunge into shallow pool. Height of plunge: 5.7 ft

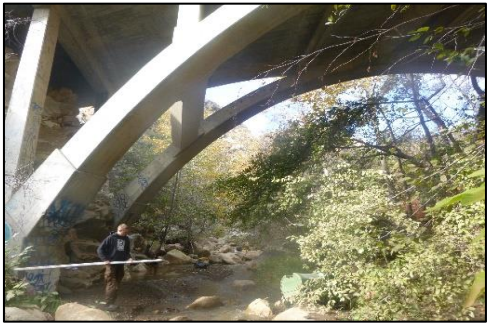
Barrier & PAD ID	Location	Previous Barrier Status	Assessed Barrier Status	Description	Picture
Barrier ID: NFM_001_R PAD ID: 705672	34.48534, -119.30068	N/A	Not a Barrier	Free spanning bridge over natural channel.

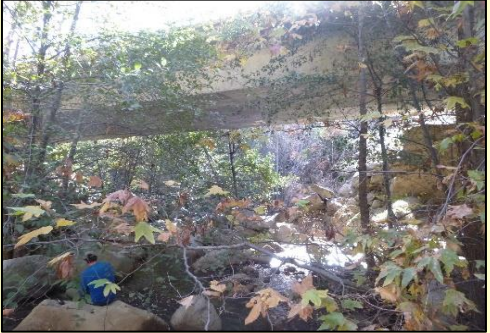
Barrier ID: NFM_002_R PAD ID: 731844	34.48558, -119.30224	N/A	Not a Barrier	Hwy 33 free spanning bridge over natural channel. Post Mile: 15.54

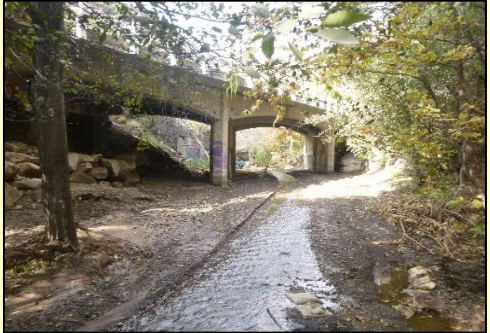
Barrier ID: NFM_003_R PAD ID: 731927	34.48875, -119.30486	N/A	Not a Barrier	Hwy 33 bridge with two concrete supports in stream bed. Post Mile: 15.85

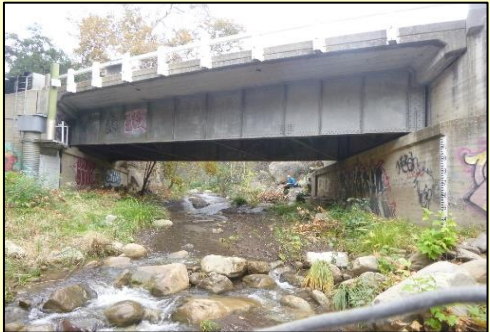
Barrier ID: NFM_004_R PAD ID: 732341	34.49274, -119.30668	N/A	Not a Barrier	Hwy 33 free spanning bridge with concrete channel walls. Post Mile: 16.13

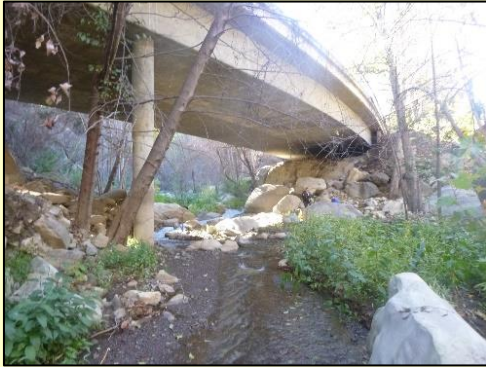
Barrier & PAD ID	Location	Previous Barrier Status	Current Barrier Status	Description	Picture
Barrier ID: NFM_005_R PAD ID: 731769	34.50702, -119.29569	Not a Barrier	Not a Barrier	Hwy 33 bridge with concrete support in river left channel. Over natural substrate. Post Mile: 17.42

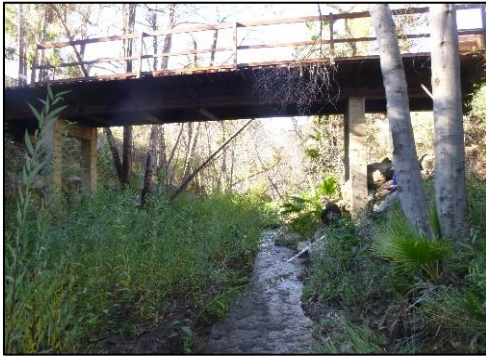
Barrier ID: NFM_006_R PAD ID: None Assigned	34.50801, -119.29569	N/A	Not a Barrier	Private bridge with two supports over natural substrate and concrete boulder rip rap walls.

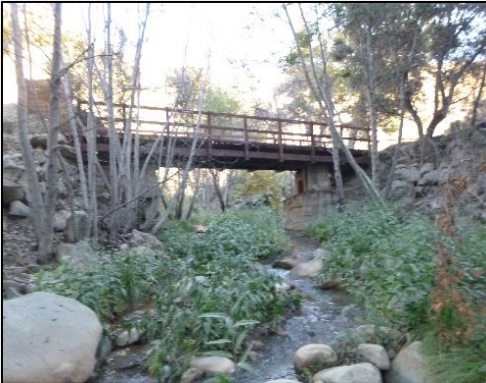
Barrier ID: NFM_007_R PAD ID: None Assigned	34.5083, -119.2895	N/A	Not a Barrier	Private bridge with concrete supports on both channel banks. Over natural substrate and boulder rip rap channel walls.

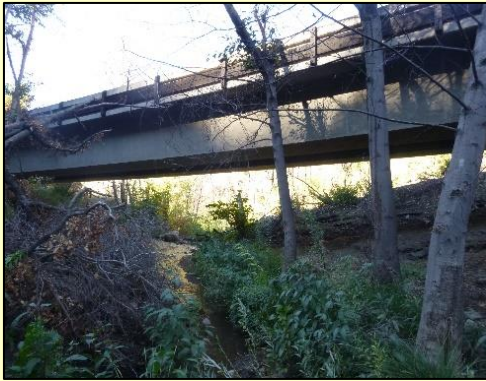
Barrier ID: NFM_008_R PAD ID: 731490	34.50855, -119.28833	Not a Barrier	Not a Barrier	Hwy 33 free spanning bridge over natural substrate. Post Mile: 17.85

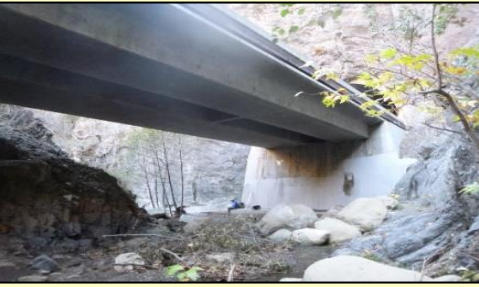
Barrier & PAD ID	Location	Previous Barrier Status	Current Barrier Status	Description	Picture
Barrier ID: NFM_009_R PAD ID: 731490	34.50572, -119.27782	Not a Barrier	Not a Barrier	Free spanning bridge over natural substrate with concrete channel walls. Post Mile: 18.7	 
Barrier ID: NFM_010_R PAD ID: 731723	34.50751, -119.27574	Not a Barrier	Not a Barrier	Free spanning bridge over natural streambed substrate. Post Mile: 18.9	 
Barrier ID: NFM_011_R PAD ID: 731804	34.50804, -119.27522	Not a Barrier	Not a Barrier	Free spanning bridge over natural streambed and concrete channel walls. Post Mile: 18.93
