Assessment of Steelhead Habitat and Migration Barriers within Watersheds Impacted by the Thomas, Whitter, and Topanga Wildfires

Pacific States Marine Fisheries Commission

California Department of Fisheries and Wildlife

September 10, 2019

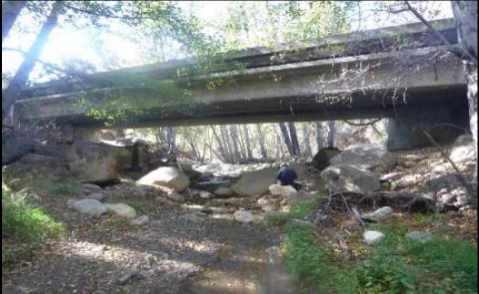
Barrier ID: NFM_012_R PAD ID: 707669	34.51068, -119.27515	Not a Barrier	Not a Barrier	Free spanning bridge over natural substrate. Concrete channel walls and wing walls at inlet and outlet.	 
Barrier ID: NFM_015_R PAD ID: 731366	34.51861, -119.27081	Not a Barrier	Not a Barrier	Free spanning bridge over natural substrate with old concrete support structure remnants under bridge on both channel banks. Post Mile: 19.73

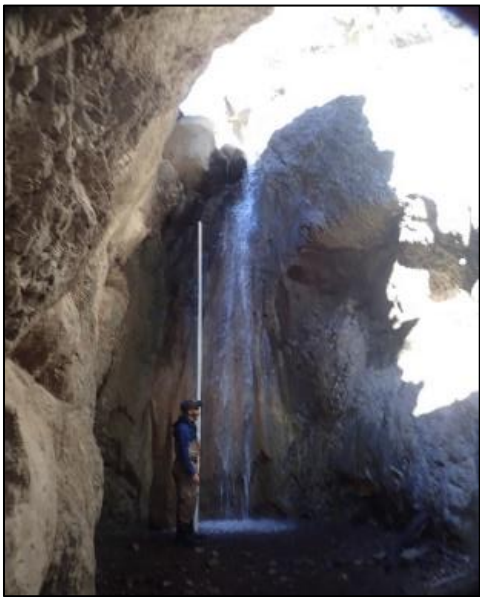
The only natural feature constraining *O. mykiss* upstream movement on Bear Creek is a waterfall located 1.7 stream miles from the North Fork Matilija Creek confluence.

Barrier & PAD ID	Location	Previous Barrier Status	Assessed Barrier Status	Description and Dimensions	Picture
PAD ID: None Assigned Barrier ID: BER_004_NR	34.51004, -119.24998	Unassessed	Total	Waterfall with plunge greater than 25 ft.

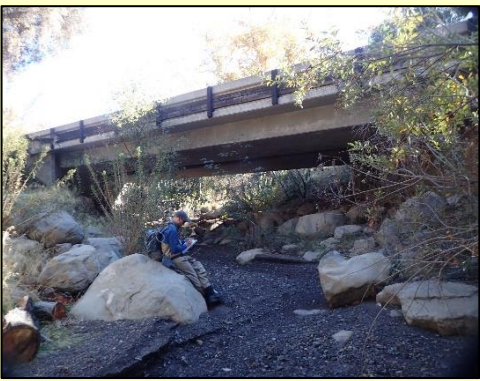
Barrier & PAD ID	Location	Previous Barrier Status	Assessed Barrier Status	Description	Picture
Barrier ID: BER_003_R PAD ID: 731352	34.51378, -119.27207	Not a Barrier	Not a Barrier	Hwy 33 free spanning concrete bridge over natural substrate. Post Mile: 19.37

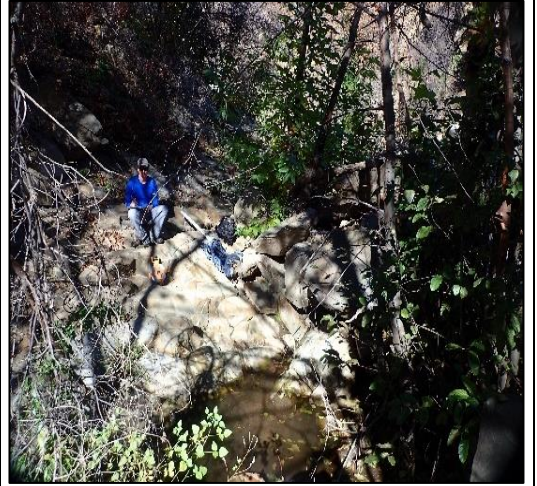
Barrier & PAD ID	Location	Previous Barrier Status	Assessed Barrier Status	Description	Picture
Barrier ID: CAN_004_NR PAD ID: None Assigned	34.51713, -119.28642	Unassessed	Temporal & Partial	Bedrock and boulder cascade with cascade length of 10.5 ft and height of 5.2 ft.

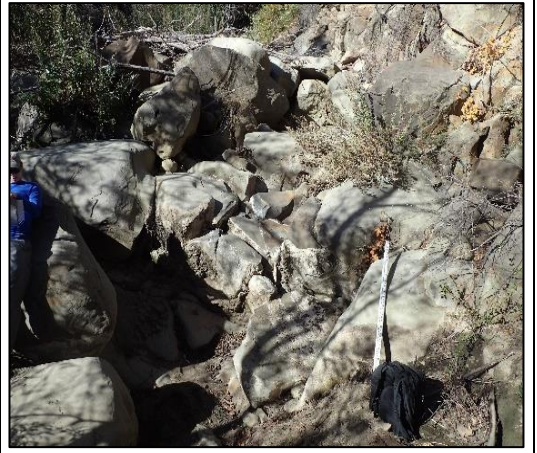
Barrier ID: CAN_005_NR PAD ID: None Assigned	34.51737, -119.28649	Unassessed	Total	Bedrock and boulder cascade in narrower bedrock lined canyon with cascade length of 24 ft and height of 9.7 ft.

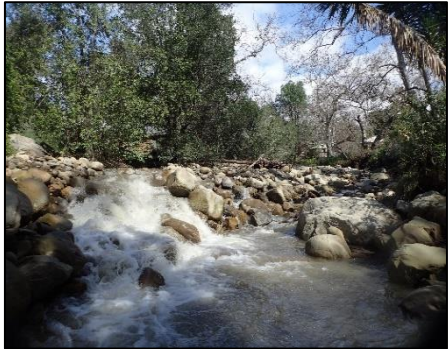
Barrier & PAD ID	Location	Previous Barrier Status	Current Barrier Status	Description and Dimensions	Picture
Barrier ID: ELC_006_NR PAD ID: None Assigned	34.47044, -120.02164	N/A	Temporal	Large boulder field causing high gradient cascade with minimal rest pools. River left channel barrier height: 8.2 ft River right channel barrier height: 4.8 ft Water depth below cascades: 1.1 ft

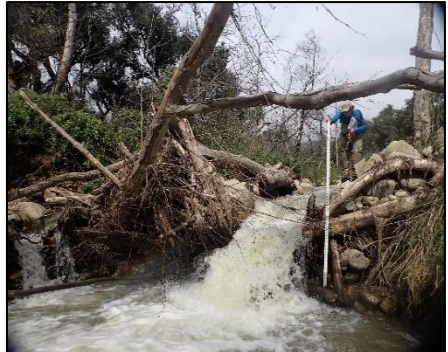
Barrier ID: ELC_009_NR PAD ID: None Assigned	34.47044, -120.01876	N/A	Temporal & Partial	Boulder and woody debris causing pile/log jam. Total height of barrier: 5.2 ft Water depth below plunge: 3 ft

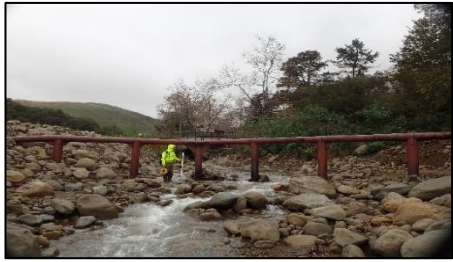
Barrier & PAD ID	Location	Previous Barrier Status	Current Barrier Status	Description	Picture
Barrier ID: ELC_003_NR PAD ID: 706641	34.46444, -120.02264	Remediated, fish response unconfirmed	Not a Barrier	Metal pipe above channel with many instream supports. Anchored by concrete grade control.

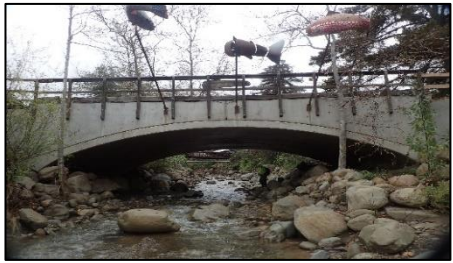
Barrier ID: ELC_004_R PAD ID: 706642	34.46498, -120.02263	Remediated, fish response unconfirmed	Not a Barrier	Free spanning bridge over natural substrate.

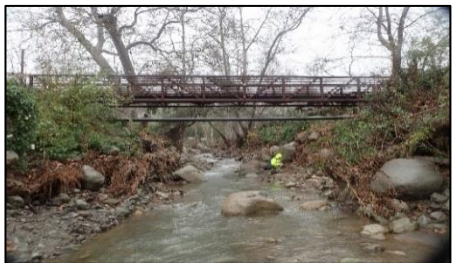
Barrier ID: ELC_005_R PAD ID: None Assigned	34.46516, -120.02261	N/A	Not a Barrier	Free spanning pedestrian bridge over natural substrate.

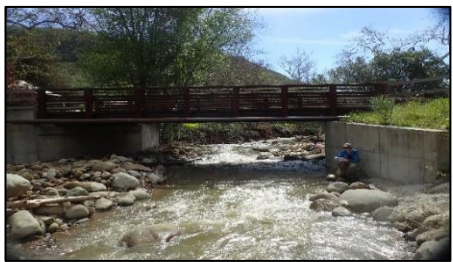
Barrier ID: ELC_007_R PAD ID: None Assigned	34.47121, -120.02151	N/A	Not a Barrier	Free spanning bridge over natural substrate with concrete wingwalls at inlet and outlet.

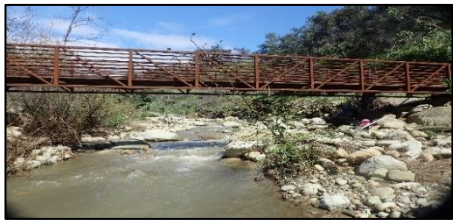
Barrier ID: ELC_008_R PAD ID: None Assigned	34.47811, -120.01981	N/A	Not a Barrier	Free spanning pedestrian bridge over natural substrate.

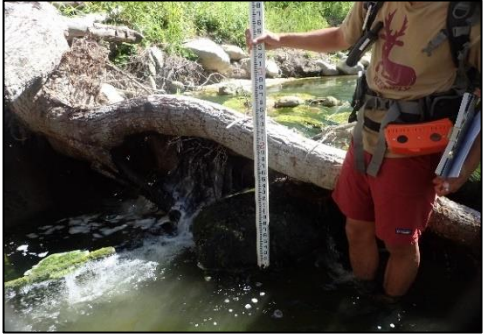
Barrier & PAD ID	Location	Previous Barrier Status	Current Barrier Status	Description and Dimensions	Picture
Barrier ID: EELC_001_NR PAD ID: None Assigned	34.48839, -120.0103	N/A	Temporal & Partial	Fallen tree with plunges on both sides of channel. Total height of barrier: 2.5 ft Water depth below plunge: 1.1 ft

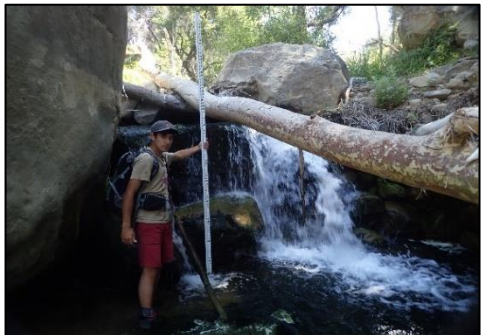
Barrier ID: EELC_002_NR PAD ID: None Assigned	34.49016, -120.00835	N/A	Temporal & Partial	Boulder cascade with fallen tree. Total height of barrier: 7.3 ft Water depth below plunge: 1.4 ft

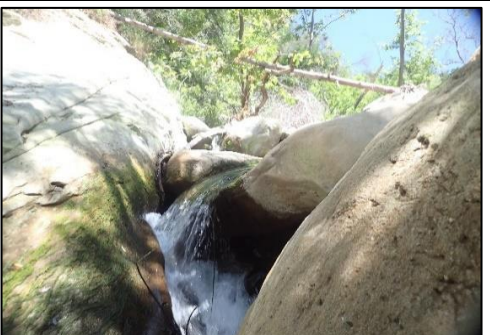
Barrier ID: EELC_003_NR PAD ID: None Assigned	34.49187, -120.00703	N/A	Temporal & Partial	Bedrock/boulder cascade. Total height of barrier: 6.3 ft Water depth below plunge: 1.6 ft

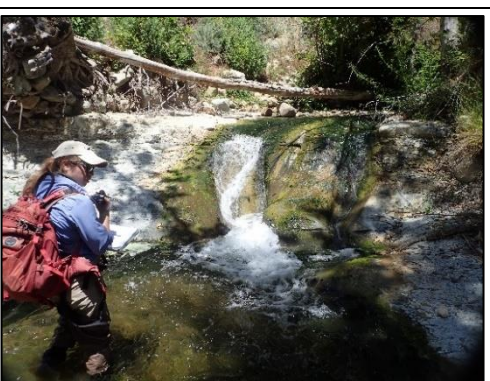
Barrier ID: EELC_004_NR PAD ID: None Assigned	34.49373, -120.0066	N/A	Temporal & Partial	Bedrock slide. Total height of barrier: 4.4 ft Water depth below plunge: 1.8 ft

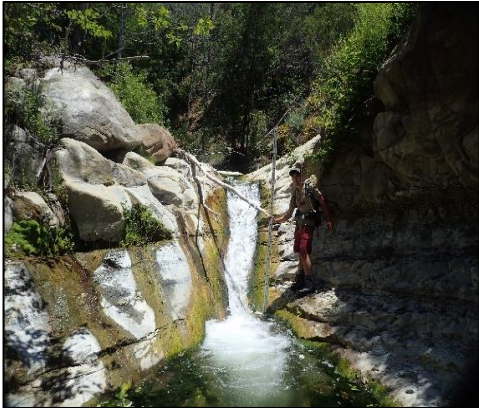
Barrier & PAD ID	Location	Previous Barrier Status	Current Barrier Status	Description and Dimensions	Picture
Barrier ID: EELC_005_NR PAD ID: None Assigned	34.4941, -120.0058	N/A	Total	Steep bedrock slide. Total height of barrier: 8.8 ft Water depth below plunge: 2 ft

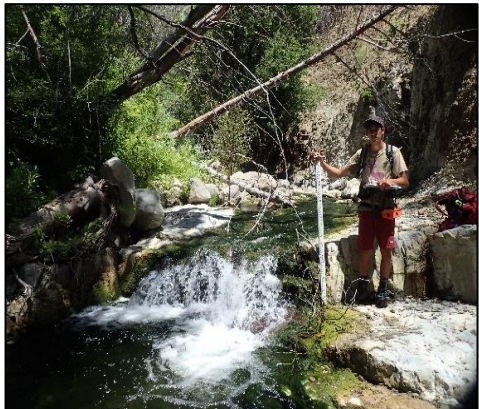
Barrier ID: EELC_006_NR PAD ID: None Assigned	34.49495, -120.00492	N/A	Temporal & Partial	Bedrock step into pool. Shallow at inlet. Total height of barrier: 3 ft Water depth below plunge: 0.7 ft

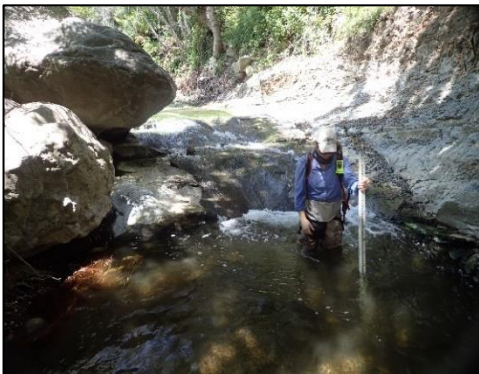
Barrier ID: EELC_007_NR PAD ID: None Assigned	34.49504, -120.00471	N/A	Temporal & Partial	Long, shallow bedrock slide. Total height of barrier: 3.1 ft Water depth below plunge: 1.5 ft

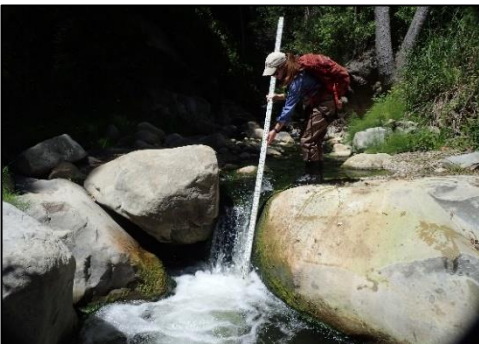
Barrier ID: EELC_008_NR PAD ID: None Assigned	34.49552, -120.00475	N/A	Temporal & Partial	Bedrock/boulder plunge. Total height of barrier: 2.5 ft Water depth below plunge: 2.9 ft

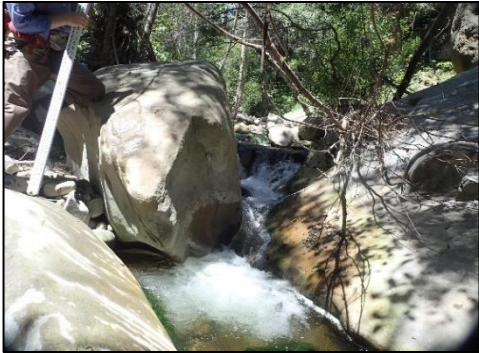
Barrier & PAD ID	Location	Previous Barrier Status	Current Barrier Status	Description and Dimensions	Picture
Barrier ID: EELC_009_NR PAD ID: None Assigned	34.49574, -120.00448	N/A	Temporal & Partial	Long bedrock chute over shallow substrate. Total height of barrier: 4.3 ft Water depth below plunge: 1.9 ft

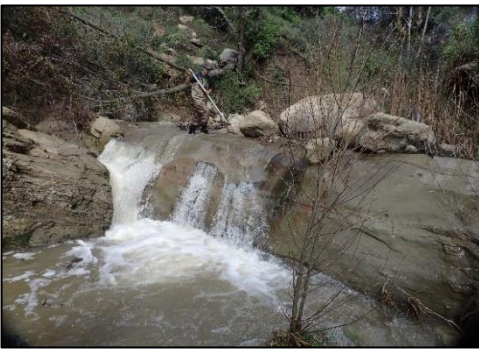
Barrier & PAD ID	Location	Previous Barrier Status	Current Barrier Status	Description and Dimensions	Picture
Barrier ID: WELC_001_NR PAD ID: None Assigned	34.4958, -120.01323	N/A	Temporal & Partial	Shallow sheet cascade over bedrock to plunge. Total height of barrier: 4.9 ft Water depth below plunge: 1.9 ft

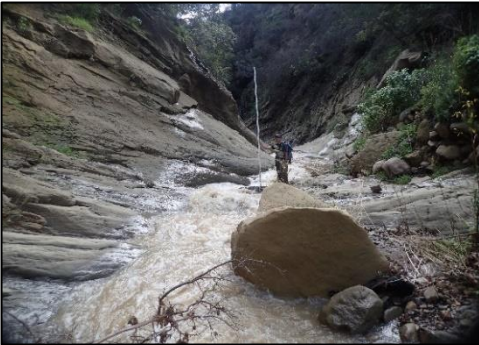
Barrier ID: WELC_002_NR PAD ID: None Assigned	34.49179, -120.01165	N/A	Temporal & Partial	Long section of bedrock. Narrow chutes with resting areas. 4 steps. Total height of barrier: 8.6 ft Water depth below plunge: 1.8 ft

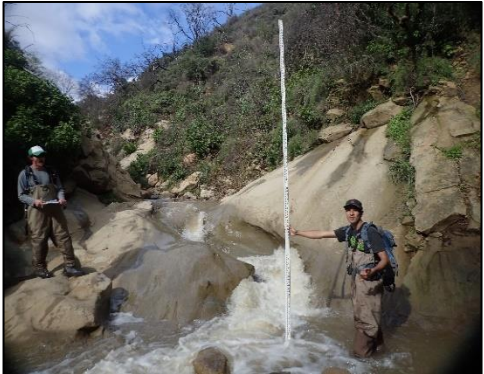
Barrier & PAD ID	Location	Previous Barrier Status	Current Barrier Status	Description and Dimensions	Picture
Barrier ID: WELC_003_NR PAD ID: None Assigned	34.49242, -120.01151	N/A	Temporal & Partial	Narrow bedrock chute/cascade. Total height of barrier: 4.7 ft Water depth below plunge: 1.6 ft

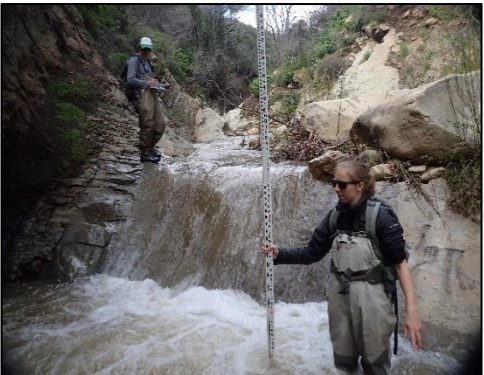
Barrier ID: WELC_004_NR PAD ID: None Assigned	34.49256, -120.01157	N/A	Temporal & Partial	Sheet cascade over bedrock. Total height of barrier: 4.3 ft Water depth below plunge: 2.3 ft

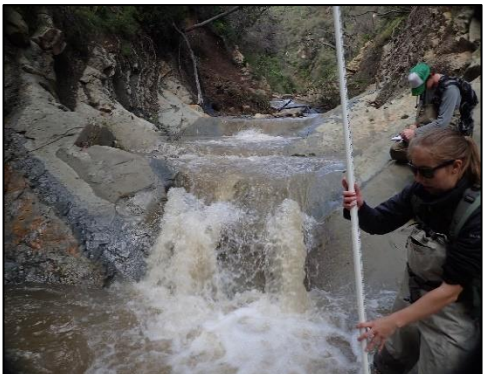
Barrier ID: WELC_005_NR PAD ID: None Assigned	34.49278, -120.01171	N/A	Temporal & Partial	Sheet cascade over bedrock. 3 steps. Total height of barrier: 6.7 ft Water depth below plunge: 2.6 ft

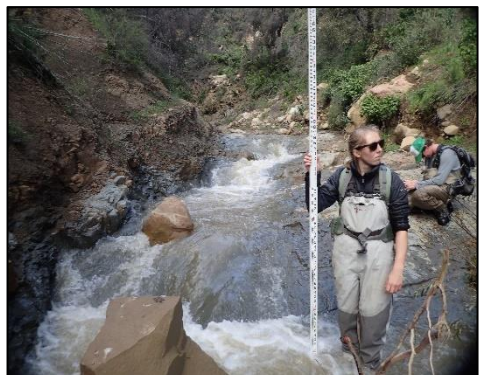
Barrier ID: WELC_006_NR PAD ID: None Assigned	34.49326, -120.0116	N/A	Temporal & Partial	Chute cascade over slick bedrock. Total height of barrier: 5 ft Water depth below plunge: 1.4 ft

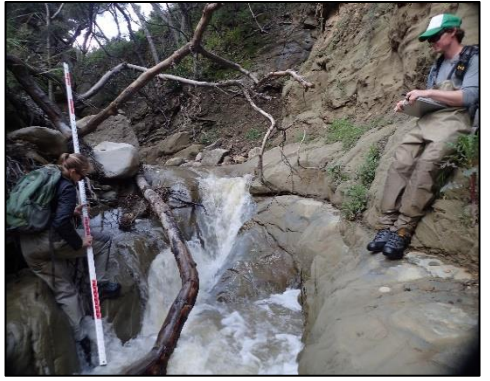
Barrier & PAD ID	Location	Previous Barrier Status	Current Barrier Status	Description and Dimensions	Picture
Barrier ID: WELC_007_NR PAD ID: None Assigned	34.49371, -120.01167	N/A	Temporal & Partial	Narrow chute cascade over slick bedrock. Total height of barrier: 5.2 ft

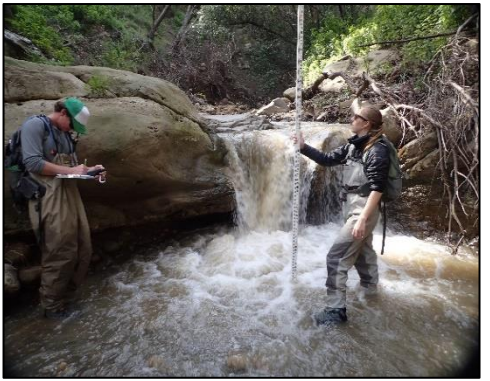
Barrier ID: WELC_008_NR PAD ID: None Assigned	34.49387, -120.01173	N/A	Temporal & Partial	Bedrock plunge into shallow pool. Total height of barrier: 3.2 ft Water depth below plunge: 1.2 ft

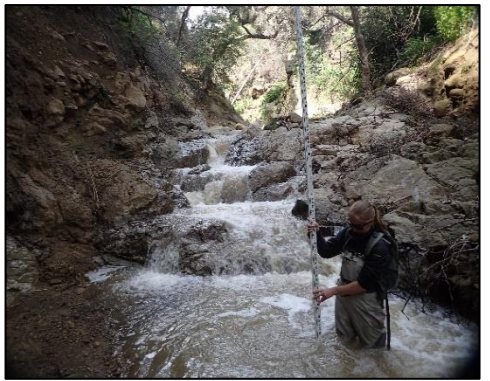
Barrier ID: WELC_009_NR PAD ID: None Assigned	34.49405, -120.0121	N/A	Temporal & Partial	Cascade over bedrock. 3 steps. Total height of barrier: 6 ft Water depth below plunge: 2.3 ft

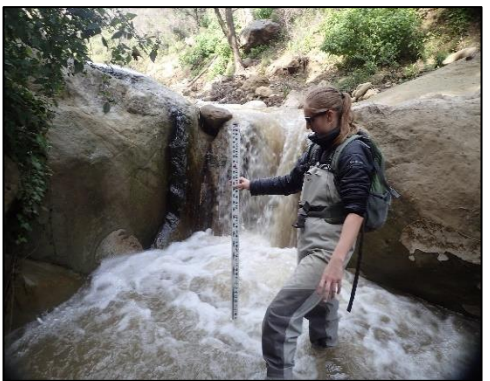
Barrier ID: WELC_010_NR PAD ID: None Assigned	34.49489, -120.01258	N/A	Temporal & Partial	Plunge over bedrock. Total height of barrier: 4.5 ft

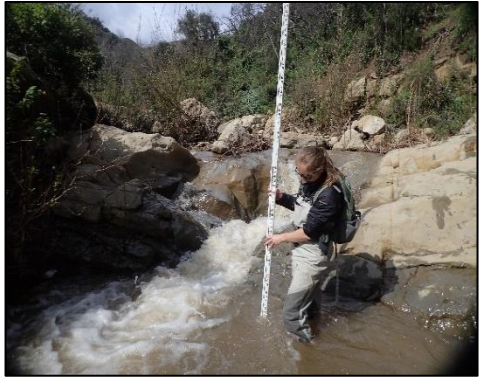
Barrier & PAD ID	Location	Previous Barrier Status	Current Barrier Status	Description and Dimensions	Picture
Barrier ID: WELC_011_NR PAD ID: None Assigned	34.49513, -120.01273	N/A	Temporal & Partial	Cascade over bedrock. Total height of barrier: 4.2 ft

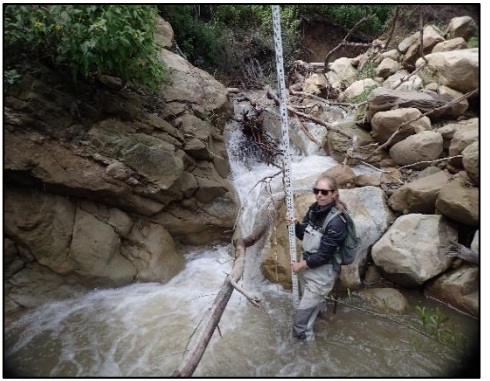
Barrier ID: WELC_013_NR PAD ID: None Assigned	34.49791, -120.01365	N/A	Temporal & Partial	Bedrock/boulder cascade. Total height of barrier: 4.9 ft Water depth below plunge: 1.9 ft

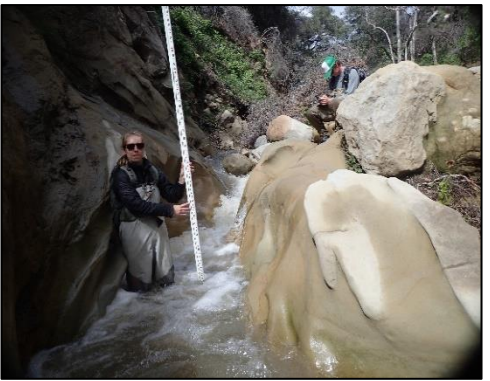
Barrier ID: WELC_014_NR PAD ID: None Assigned	34.49963, -120.01455	N/A	Temporal & Partial	Narrow, turbulent cascade/bedrock chute. Total height of barrier: 3.5 ft Water depth below plunge: 1.8 ft

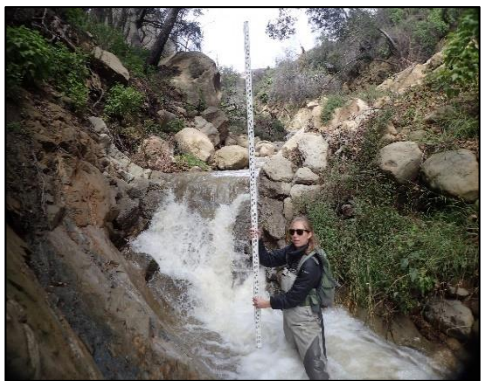
Barrier ID: WELC_015_NR PAD ID: None Assigned	34.49998, - 120.01443	N/A	Temporal & Partial	Bedrock chute. Total height of barrier: 4.8 ft Water depth below plunge: 2 ft

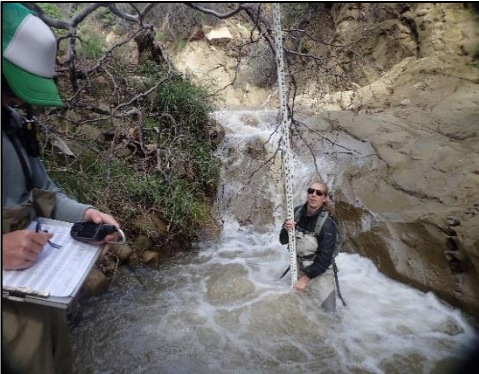
Barrier & PAD ID	Location	Previous Barrier Status	Current Barrier Status	Description and Dimensions	Picture
Barrier ID: WELC_016_NR PAD ID: None Assigned	34.50014, -120.01431	N/A	Temporal & Partial	Bedrock chute/cascade. Total height of barrier: 4.5 ft Water depth below plunge: 2.4 ft

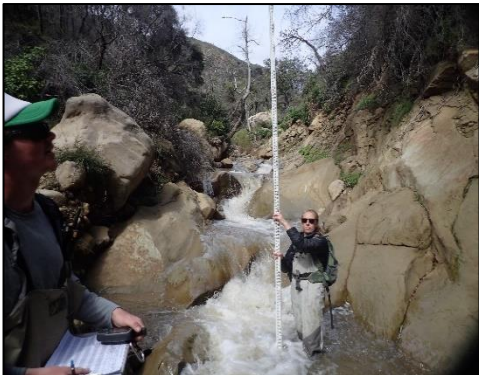
Barrier ID: WELC_017_NR PAD ID: None Assigned	34.50026, -120.01428	N/A	Temporal & Partial	Narrow bedrock chute with 3 steps. Total height of barrier: 9.2 ft Water depth below plunge: 1.2 ft

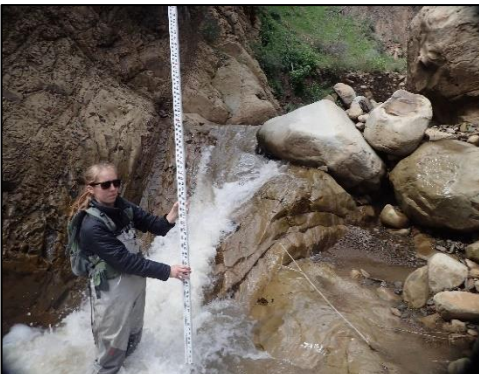
Barrier ID: WELC_018_NR PAD ID: None Assigned	34.50141, -120.01444	N/A	Temporal & Partial	Narrow and turbulent bedrock chute. Total height of barrier: 5.7 ft Water depth below plunge: 2.6 ft

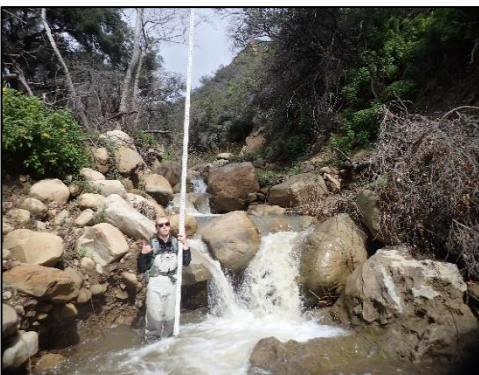
Barrier ID: WELC_019_NR PAD ID: None Assigned	34.50194, -120.01411	N/A	Temporal & Partial	Bedrock/boulder cascade. 3 steps. Total height of barrier: 9.2 ft Water depth below plunge: 1.8 ft

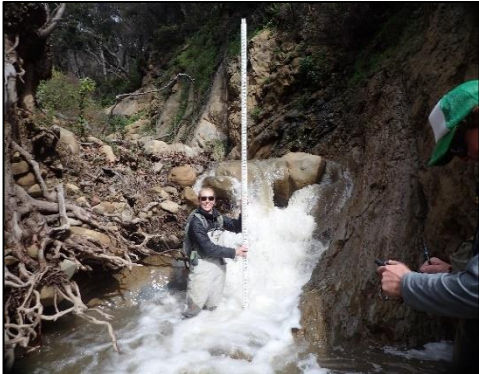
Barrier & PAD ID	Location	Previous Barrier Status	Current Barrier Status	Description and Dimensions	Picture
Barrier ID: WELC_020_NR PAD ID: None Assigned	34.50237, -120.01371	N/A	Temporal & Partial	Narrow and turbulent bedrock/boulder cascade. Total height of barrier: 4.7 ft Water depth below plunge: 1.6 ft

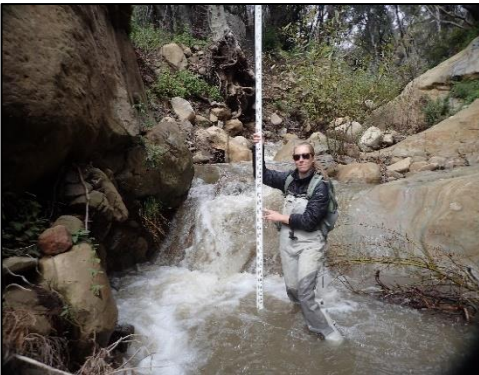
Barrier ID: WELC_021_NR PAD ID: None Assigned	34.50252, -120.01372	N/A	Temporal & Partial	Bedrock chute. Total height of barrier: 3.8 ft Water depth below plunge: 1.3 ft

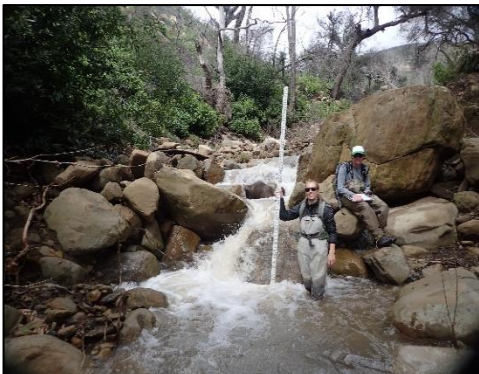
Barrier ID: WELC_022_NR PAD ID: None Assigned	34.50307, -120.01354	N/A	Temporal & Partial	Bedrock/boulder cascade. Total height of barrier: 8.5 ft Water depth below plunge: 1.4 ft

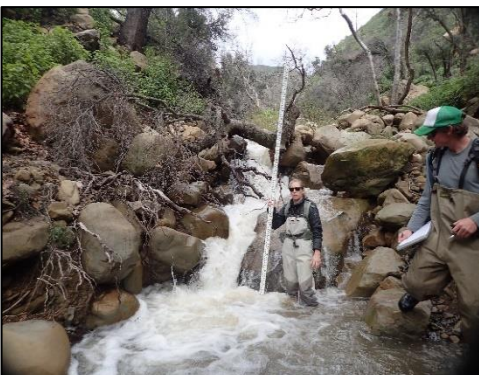
Barrier ID: WELC_023_NR PAD ID: None Assigned	34.50325, -120.01344	N/A	Temporal & Partial	Bedrock/boulder cascade with woody debris. Total height of barrier: 7.5 ft Water depth below plunge: 1.3 ft

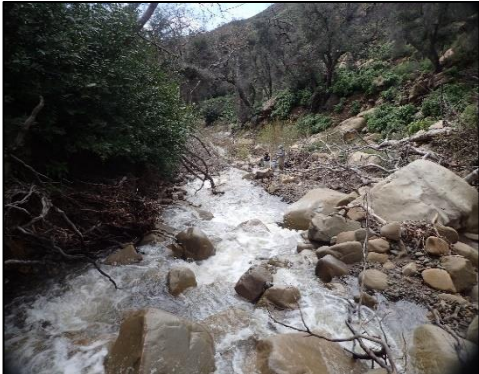
Barrier & PAD ID	Location	Previous Barrier Status	Current Barrier Status	Description and Dimensions	Picture
Barrier ID: WELC_024_NR PAD ID: None Assigned	34.50357, -120.01317	N/A	Total	Steep and lengthy boulder cascade with little rest areas. Total height of barrier: 15 ft Water depth below plunge: 1.4 ft

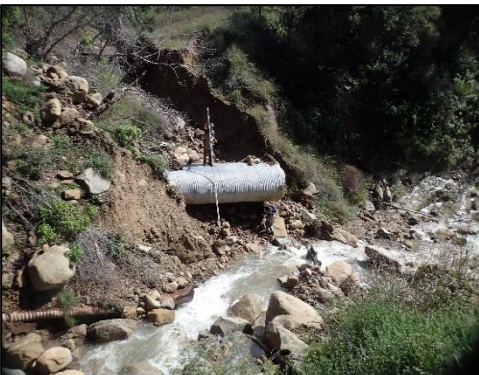
Barrier & PAD ID	Location	Previous Barrier Status	Current Barrier Status	Description and Dimensions	Picture
Barrier ID: WELC_012_NR PAD ID: 706332	34.49762, -120.01365	Total	Not a Barrier	Culvert and road fill have been blasted out. Previous road is no longer present. Steep gradient cutting through the area. Total height of barrier: 25.2 ft

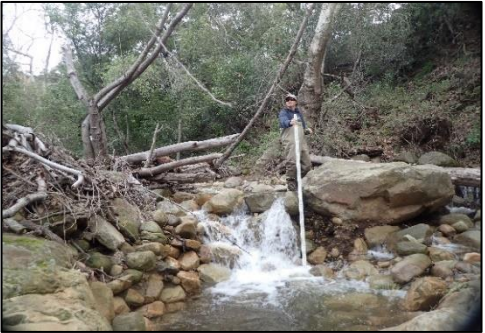
Barrier & PAD ID	Location	Previous Barrier Status	Current Barrier Status	Description and Dimensions	Picture
Barrier ID: RAT_011_NR PAD ID: None Assigned	34.45712, -119.69317	N/A	Temporal & Partial	Significant natural barrier/steep grade made of bedrock, large boulders, woody debris, and sediment. Total height of barrier: 17.1 ft Water depth below cascade: 1.3 ft

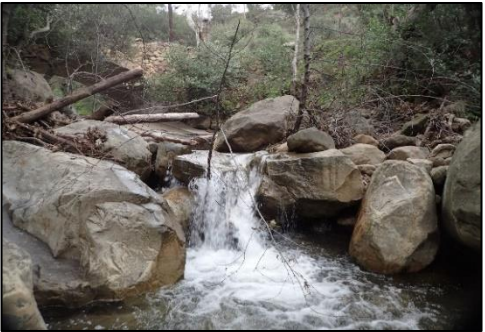
Barrier ID: RAT_012_NR PAD ID: None Assigned	34.45751, -119.69242	N/A	Temporal & Partial	Large collection of boulders with a vertical plunge into downstream pool. Total height of barrier: 4.3 ft Water depth below plunge: 2 ft

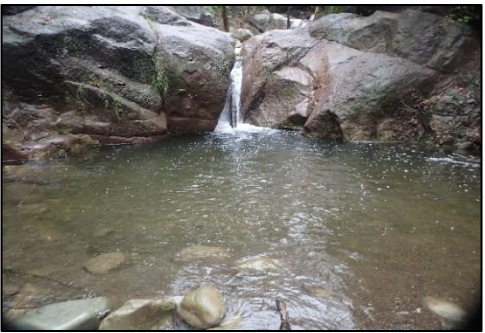
Barrier ID: RAT_015_NR PAD ID: 706557	34.4614, -119.69152	Partial	Temporal & Total	Significant bedrock waterfall through narrow channel. Potential total barrier due to large woody debris in chute. Total height of barrier: 12.5 ft Water depth below plunge: 4 ft

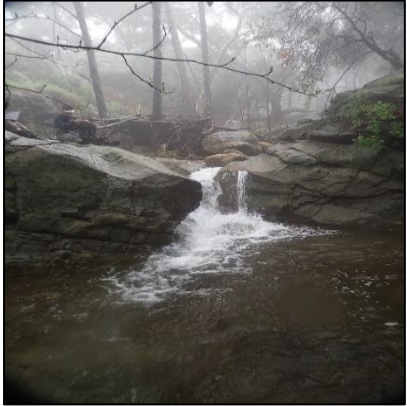
Barrier ID: RAT_017_NR PAD ID: None Assigned	34.46328, -119.69055	N/A	Temporal & Partial	Small bedrock chute with shallow plunge pool. Total height of barrier: 5 ft Water depth below plunge: 0.2 ft

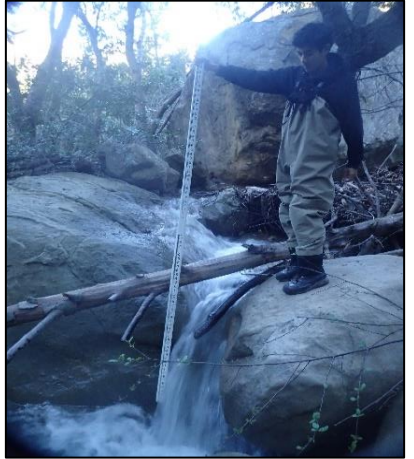
Barrier & PAD ID	Location	Previous Barrier Status	Current Barrier Status	Description and Dimensions	Picture
Barrier ID: RAT_018_NR PAD ID: None Assigned	34.46377, -119.68975	N/A	Temporal & Partial	Natural boulder/bedrock plunge with log jam at inlet. Total height of barrier: 4.8 ft Water depth below plunge: 4.6 ft

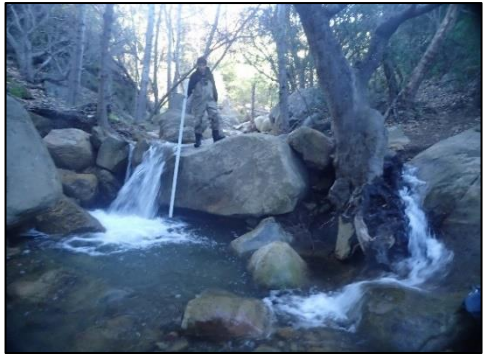
Barrier ID: RAT_019_NR PAD ID: None Assigned	34.46389, -119.68961	N/A	Temporal & Partial	Natural boulder plunge. Total height of barrier: 4.7 ft Water depth below plunge: 2.2 ft

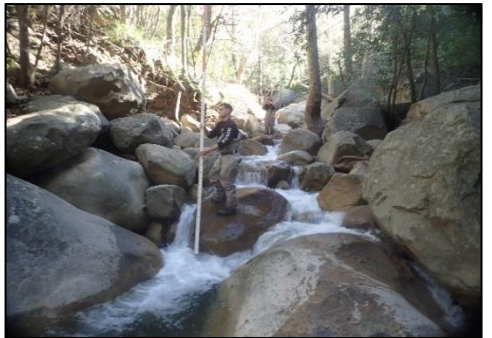
Barrier ID: RAT_020_NR PAD ID: None Assigned	34.46406, -119.68842	N/A	Temporal & Partial	Boulder cascade with two steps. Total height of barrier: 5.5 ft Water depth below plunge: 3 ft

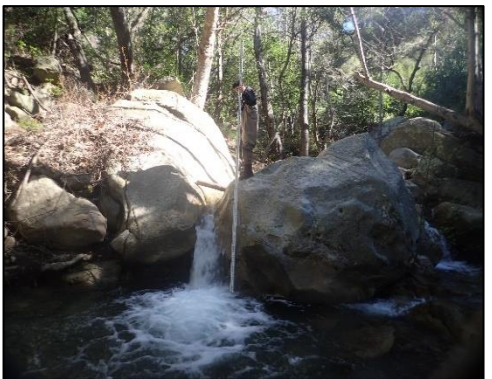
Barrier ID: RAT_021_NR PAD ID: None Assigned	34.46405, -119.68813	N/A	Temporal & Partial	Vertical bedrock plunge. Total height of barrier: 4.8 ft Water depth below plunge: 3.7 ft

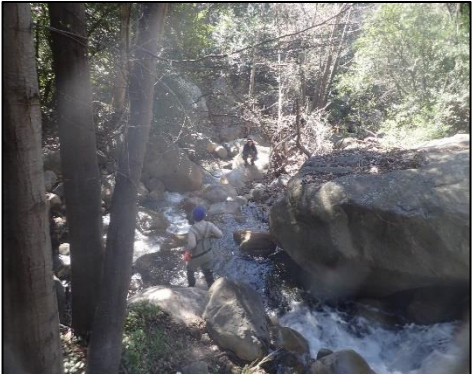
Barrier & PAD ID	Location	Previous Barrier Status	Current Barrier Status	Description and Dimensions	Picture
Barrier ID: RAT_022_NR PAD ID: None Assigned	34.46422, -119.68796	N/A	Total	Significant cascade over boulders and bedrock. Two resting pools within cascade. Total height of barrier: 20.5 ft Water depth below cascade: 1.2 ft

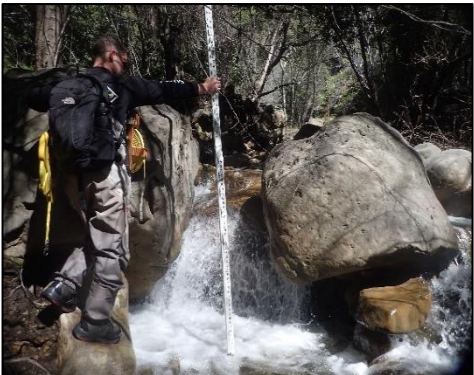
Barrier ID: RAT_023_NR PAD ID: None Assigned	34.46532, -119.68726	N/A	Temporal & Partial	Vertical boulder plunge. Total height of barrier: 4.5 ft Water depth below plunge: 1.4 ft

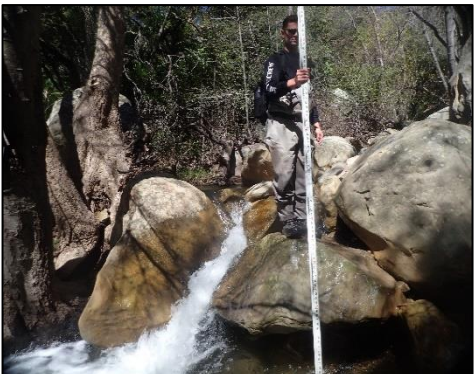
Barrier ID: RAT_024_NR PAD ID: None Assigned	34.46558, -119.68702	N/A	Temporal & Partial	Vertical boulder plunge. Total height of barrier: 4.8 ft Water depth below plunge: 2.5 ft

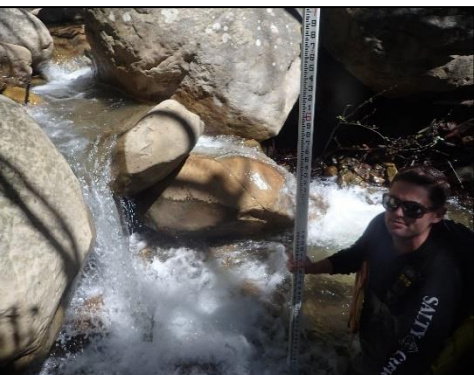
Barrier ID: RAT_025_NR PAD ID: None Assigned	34.46571, -119.6869	N/A	Temporal & Partial	Vertical boulder plunge to shallow pool. Total height of barrier: 4.9 ft Water depth below plunge: 1.6 ft

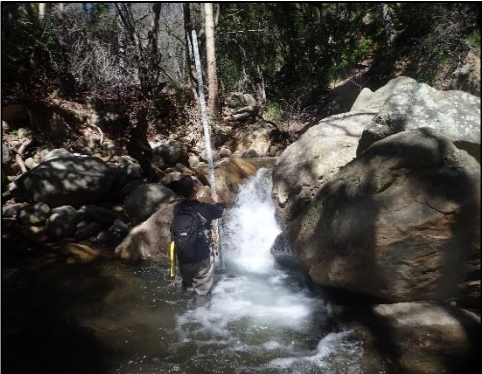
Barrier & PAD ID	Location	Previous Barrier Status	Current Barrier Status	Description and Dimensions	Picture
Barrier ID: RAT_026_NR PAD ID: None Assigned	34.46598, -119.68681	N/A	Temporal & Partial	Vertical boulder plunge to large, wide pool. Total height of barrier: 4 ft Water depth below plunge: 2.4 ft

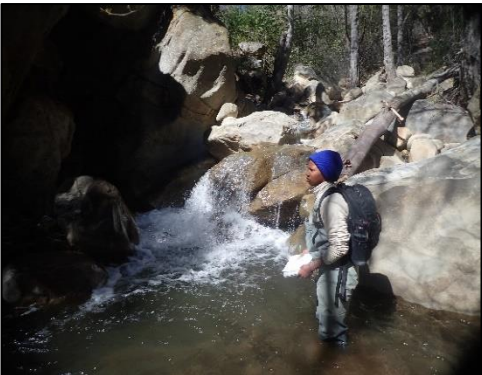
Barrier ID: RAT_027_NR PAD ID: None Assigned	34.46612, -119.68694	N/A	Temporal & Partial	Long, extended boulder cascade with few rest pools. Total height of barrier: 21.9 ft Water depth below cascade: 0.8 ft Total cascade length: 95 ft

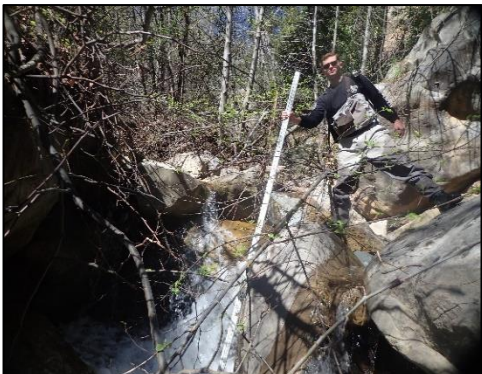
Barrier ID: RAT_028_NR PAD ID: None Assigned	34.46671, -119.68701	N/A	Temporal & Partial	Vertical boulder plunge with multiple cascades into pool. Total height of barrier: 5.8 ft Water depth below plunge: 2.3 ft

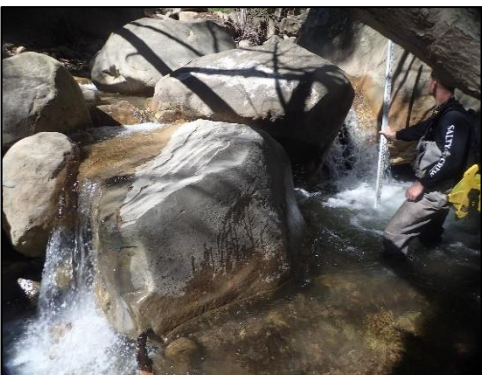
Barrier ID: RAT_029_NR PAD ID: None Assigned	34.46711, -119.68723	N/A	Temporal & Partial	Vertical boulder plunge with multiple cascades. Protected pool under bedrock. Total height of barrier: 3.8 ft Water depth below plunge: 1.2 ft

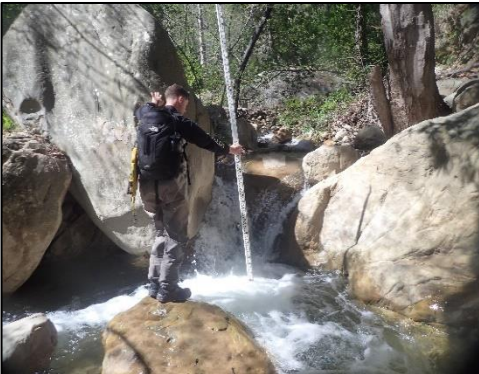
Barrier & PAD ID	Location	Previous Barrier Status	Current Barrier Status	Description and Dimensions	Picture
Barrier ID: RAT_030_NR PAD ID: None Assigned	34.46737, -119.68739	N/A	Temporal & Partial	Boulder plunge with bedrock wingwalls. Total height of barrier: 3.8 ft Water depth below plunge: 1.2 ft

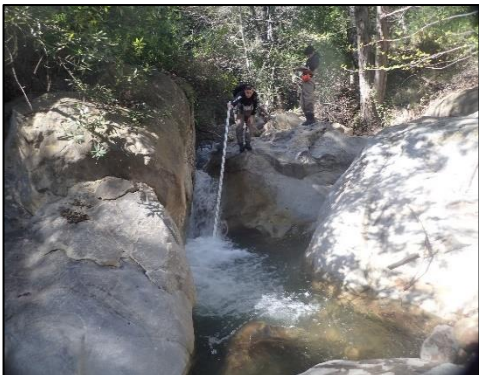
Barrier ID: RAT_031_NR PAD ID: None Assigned	34.46749, -119.68758	N/A	Total	Long bedrock chute with narrow/shallow cascade and high velocity water flow. Total height of barrier: 4.8 ft Water depth below plunge: 5.2 ft

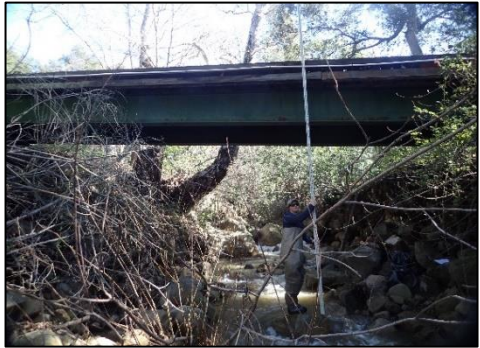
Barrier & PAD ID	Location	Previous Barrier Status	Current Barrier Status	Description and Dimensions	Picture
Barrier ID: RAT_002_R PAD ID: None Assigned	34.4521, -119.70696	N/A	Not a Barrier	Small, private, free spanning bridge over natural substrate.

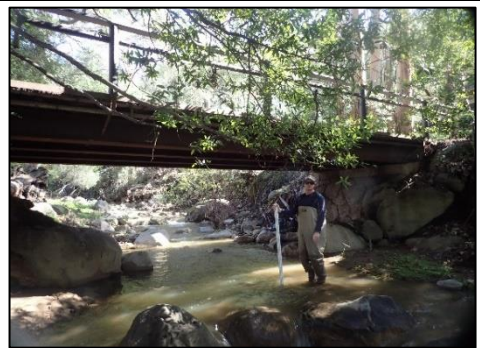
Barrier ID: RAT_003_R PAD ID: None Assigned	34.45241, -119.70428	N/A	Not a Barrier	Small, free spanning bridge over natural substrate. Concrete channel walls under bridge.

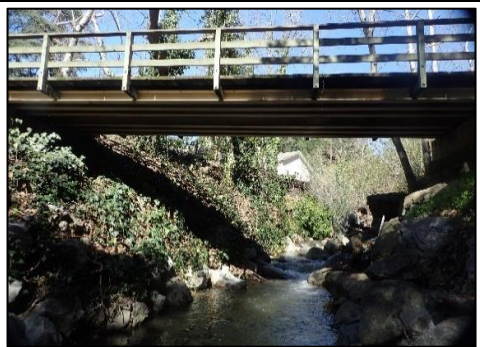
Barrier ID: RAT_004_R PAD ID: None Assigned	34.45277, -119.70338	N/A	Not a Barrier	Free spanning, private bridge over boulder rip rap channel walls.

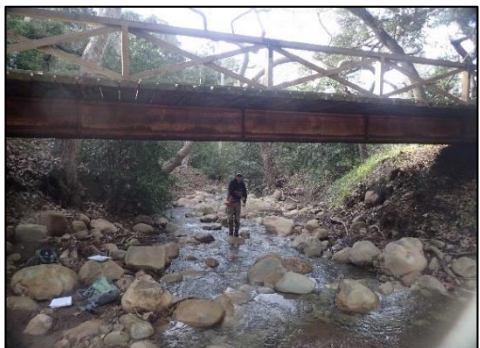
Barrier ID: RAT_007_R PAD ID: None Assigned	34.45397, -119.70159	N/A	Not a Barrier	Free spanning private bridge over natural streambed substrate.

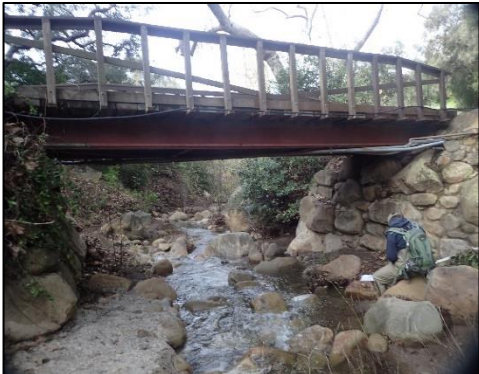
Barrier & PAD ID	Location	Previous Barrier Status	Current Barrier Status	Description and Dimensions	Picture
Barrier ID: RAT_008_R PAD ID: None Assigned	34.45475 -119.70089	N/A	Not a Barrier	Free spanning private bridge over natural streambed substrate and boulder/cement rip rap channel walls.

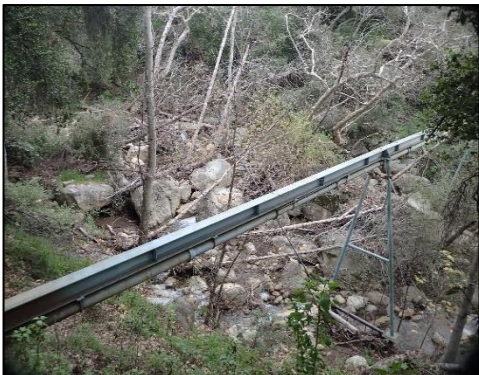
Barrier ID: RAT_010_NR PAD ID: 706554	34.45705, -119.69345	Total	Not a Barrier	Utility pipe over channel with two instream supports.

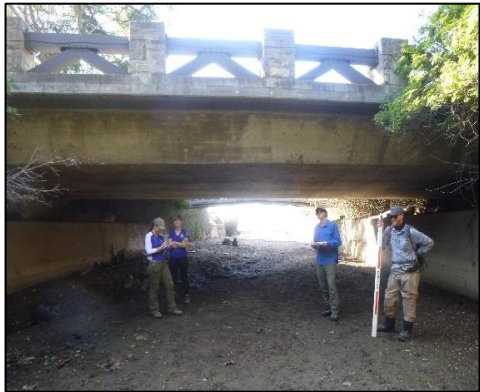
Barrier & PAD ID	Location	Previous Barrier Status	Current Barrier Status	Description and Dimensions	Picture
Barrier ID: MON_001_R PAD ID: None Assigned	34.41798, -119.63397	N/A	Not a Barrier	Free spanning bridge over concrete lined flood control channel.

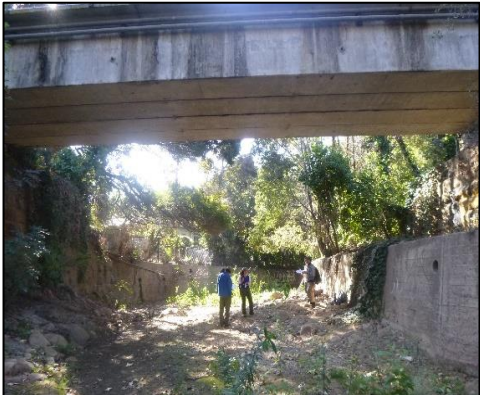
Barrier ID: MON_002_R PAD ID: None Assigned	34.41933, -119.63363	N/A	Not a Barrier	Free spanning concrete bridge.

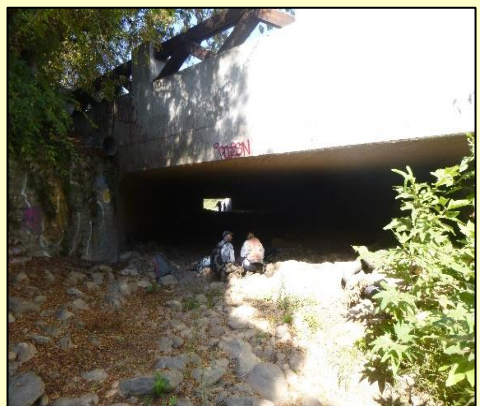
Barrier ID: MON_003_R PAD ID: None Assigned	34.42301, -119.63479	N/A	Not a Barrier	Hwy 101 free spanning concrete bridge with low clearance over natural streambed substrate. Post Mile 10.2

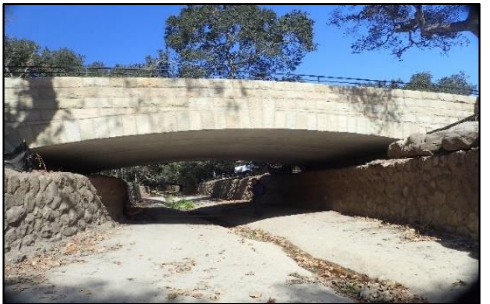
Barrier & PAD ID	Location	Previous Barrier Status	Current Barrier Status	Description and Dimensions	Picture
Barrier ID: MON_006_R PAD ID: None Assigned	34.42316, -119.63537	N/A	Not a Barrier	Free spanning concrete bridge over cement boulder rip rap channel walls. Grade control structure near outlet.	 
Barrier ID: MON_018_R PAD ID: None Assigned	34.42899, -119.6404	N/A	Not a Barrier	Free spanning bridge over concrete lined channel.

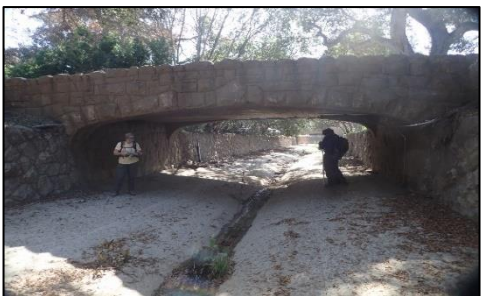
Barrier ID: MON_019_R PAD ID: None Assigned	34.42964, -119.6405	N/A	Not a Barrier	Free spanning bridge over concrete lined channel.

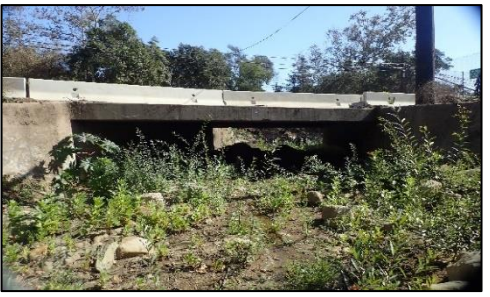
Barrier ID: MON_020_R PAD ID: None Assigned	34.43063, -119.64143	N/A	Not a Barrier	Short, free spanning bridge over natural streambed substrate.

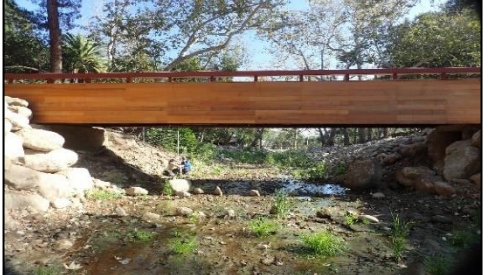
Barrier ID: MON_024_R PAD ID: None Assigned	34.43996, -119.64812	N/A	Not a Barrier	Free spanning bridge over natural substrate. Boulder rip rap on channel walls.

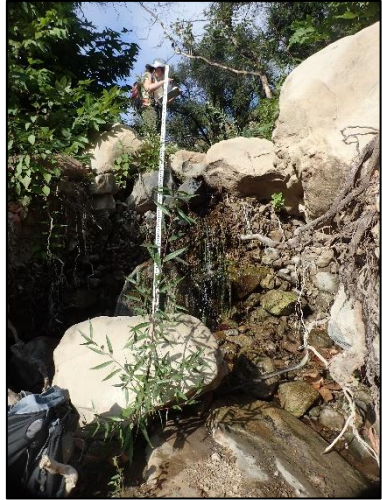
Barrier & PAD ID	Location	Previous Barrier Status	Current Barrier Status	Description and Dimensions	Picture
Barrier ID: HSP_014_NR PAD ID: None Assigned	34.45571, -119.63861	N/A	Temporal & Partial	Scoured out boulders, roots, and earth with significant drop. Total height of barrier: 7 ft

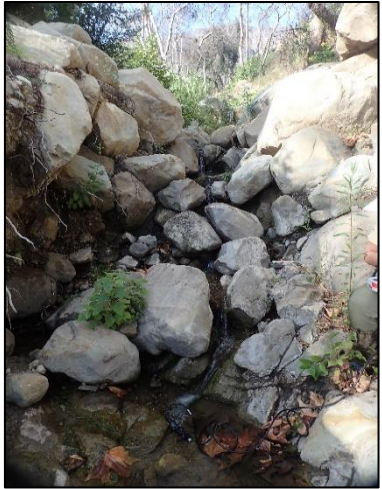
Barrier ID: HSP_015_NR PAD ID: None Assigned	34.45643, -119.63869	N/A	Total	Boulder cascade with steep gradient. Total height of barrier: 21 ft Water depth below plunges: 0.22 ft Total cascade length: 48 ft

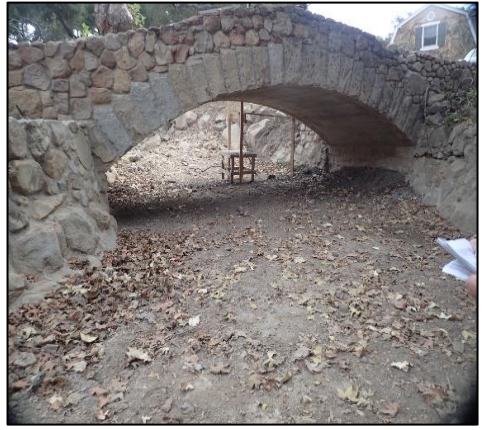
Barrier & PAD ID	Location	Previous Barrier Status	Current Barrier Status	Description and Dimensions	Picture
Barrier ID: HSP_001_R PAD ID: None Assigned	34.44335, -119.65005	N/A	Not a Barrier	Private, free spanning stone bridge over natural substrate.

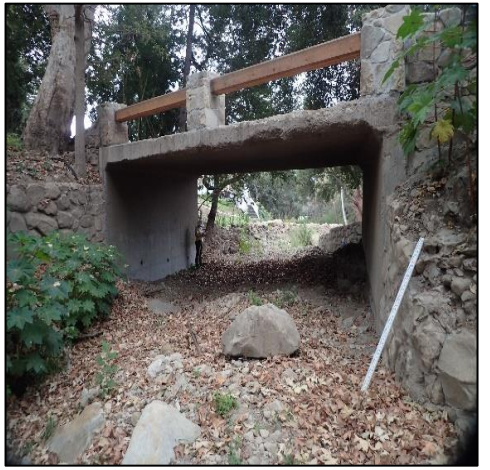
Barrier ID: HSP_005_R	34.44542, -119.64856	N/A	Not a Barrier	Free spanning concrete bridge over natural substrate.

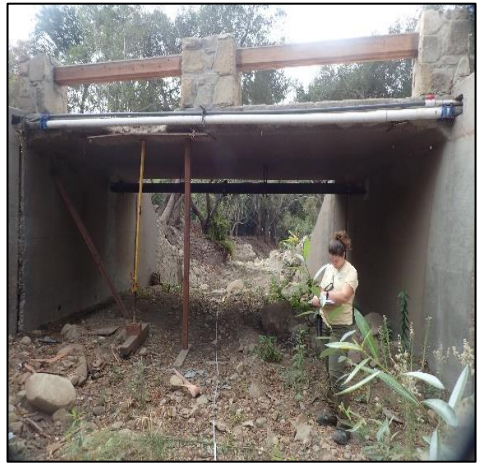
Barrier ID: HSP_007_R PAD ID: None Assigned	34.44611, -119.64746	N/A	Not a Barrier	Free spanning concrete bridge over natural substrate.

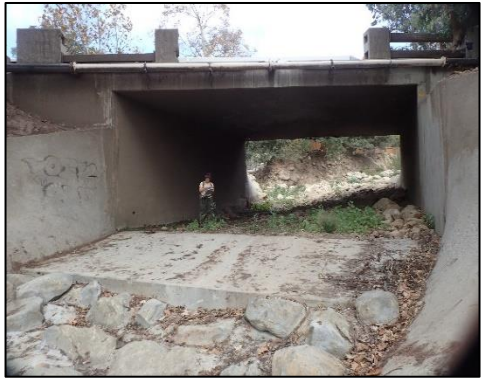
Barrier & PAD ID	Location	Previous Barrier Status	Current Barrier Status	Description and Dimensions	Picture
Barrier ID: HSP_012_R PAD ID: None Assigned	34.44918, -119.64617	N/A	Not a Barrier	Free spanning concrete bridge with concrete apron at outlet.

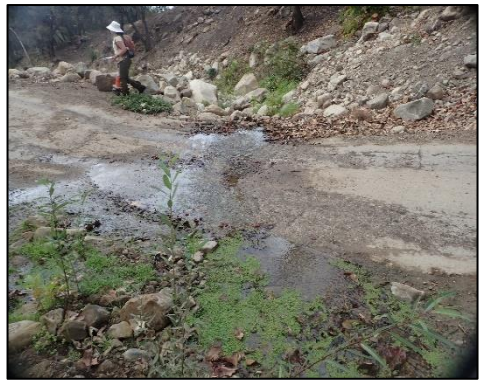
Barrier ID: HSP_013_R PAD ID: None Assigned	34.45186, -119.64324	N/A	Not a Barrier	Low-water crossing.

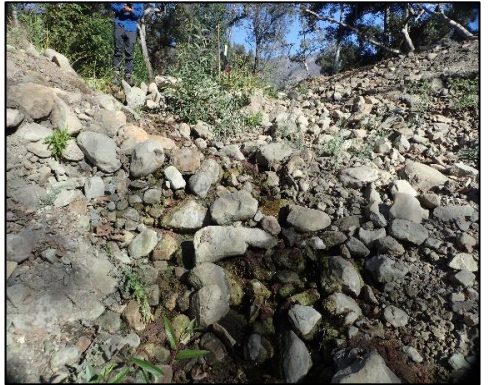
Barrier & PAD ID	Location	Previous Barrier Status	Current Barrier Status	Description and Dimensions	Picture
Barrier ID: CSP_001_NR PAD ID: None Assigned	34.44333, -119.65059	N/A	Not a Barrier	High gradient cascade of boulder and cobble. Total height of barrier: 7.1 ft Water depth below plunge: 0.2 ft Total cascade length: 20.8 ft

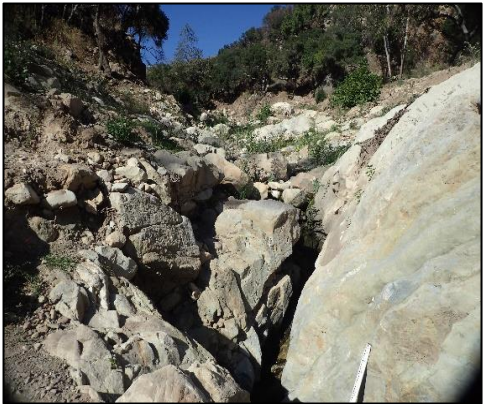
Barrier ID: CSP_005_NR PAD ID: None Assigned	34.45635, -119.65327	N/A	Total	Double waterfall. Boulder/bedrock chute. Total height of barrier: 8 ft Water depth below plunge: 0.6 ft

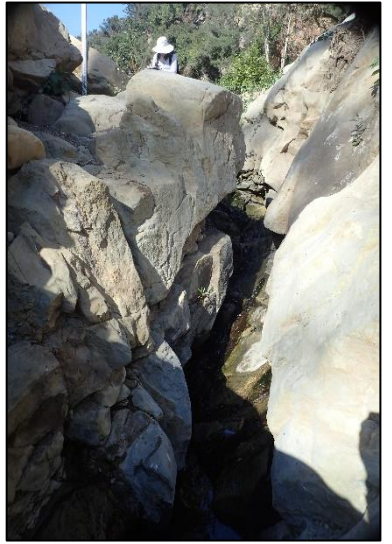
Barrier & PAD ID	Location	Previous Barrier Status	Current Barrier Status	Description and Dimensions	Picture
Barrier ID: CSP_006_NR PAD ID: None Assigned	34.45876, -119.65437	N/A	Temporal & Partial	Natural boulder cascade. Total height of barrier: 7 ft Water depth below plunge: 0.3 ft

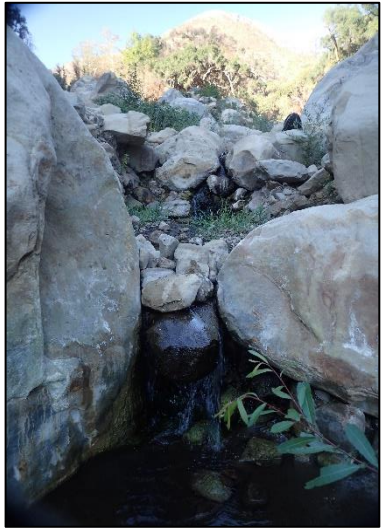
Barrier ID: CSP_007_NR PAD ID: 706254	34.45904, -119.6544	Total	Temporal & Partial	Boulder cascade. Total height of barrier: 7.7 ft Total cascade length: 17 ft

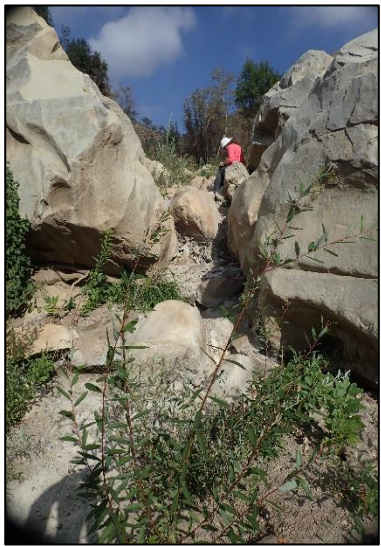
Barrier ID: CSP_008_NR PAD ID: None Assigned	34.45953, -119.6546	N/A	Temporal	Plunge over boulders. Total height of barrier: 8.6 ft Total cascade length: 13.5 ft

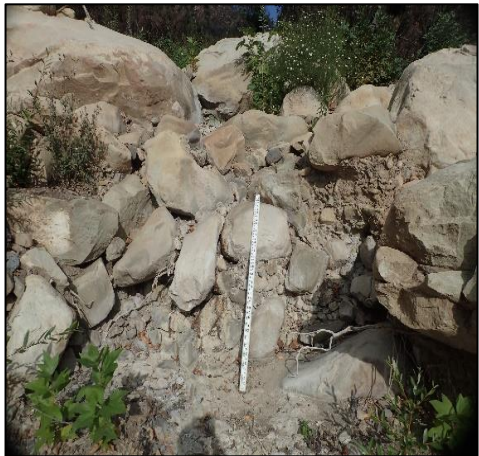
Barrier & PAD ID	Location	Previous Barrier Status	Current Barrier Status	Description and Dimensions	Picture
Barrier ID: CSP_009_NR PAD ID: None Assigned	34.46162, -119.65508	N/A	Temporal & Partial	Plunge over boulders. Total height of barrier: 8.1 ft

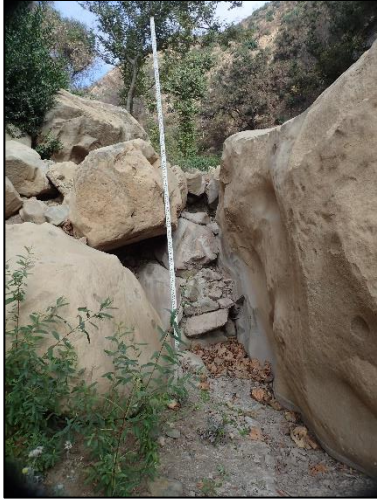
Barrier ID: CSP_010_NR PAD ID: 706531	34.4663, -119.65853	Total	Total	Bedrock cascade. Total height of barrier: 16.8 ft Water depth below plunge: 0.2 ft Total cascade length: 33 ft

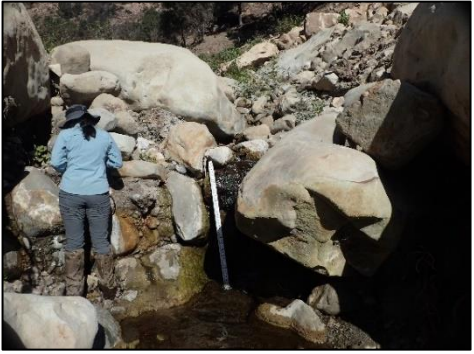
Barrier & PAD ID	Location	Previous Barrier Status	Current Barrier Status	Description and Dimensions	Picture
Barrier ID: SYD_008_NR PAD ID: None Assigned	34.45253, -119.62183	N/A	Temporal & Partial	Boulder cascade/waterfall. Total height of barrier: 10.1 ft Water depth below plunge: 0.4 ft

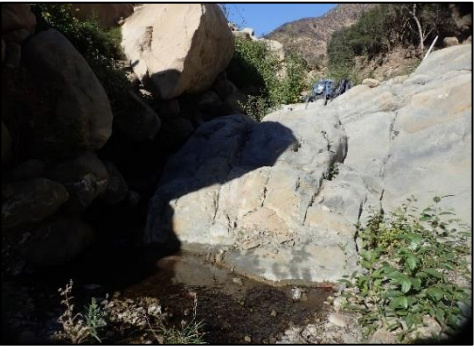
Barrier ID: SYD_009_NR PAD ID: 706511	34.45533, -119.62348	Partial	Temporal & Partial	Boulder/bedrock chute. Total height of barrier: 6.5 ft Water depth below plunge: 0.8 ft Total cascade length: 20 ft

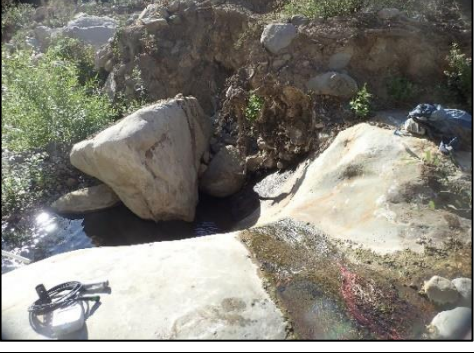
Barrier ID: SYD_010_NR PAD ID: None Assigned	34.5551, -119.6234	N/A	Temporal & Partial	Boulder/bedrock chute. Total height of barrier: 4.5 ft Water depth below plunge: 1.8 ft Total cascade length: 6 ft

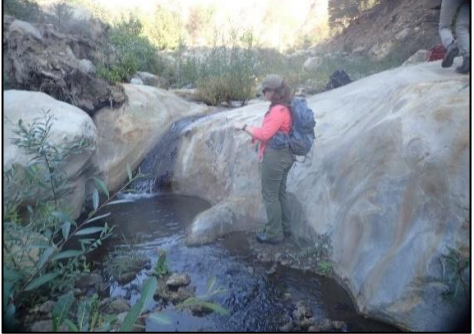
Barrier ID: SYD_011_NR PAD ID: 706512	34.45556, -119.62337	Total	Temporal & Partial	Cascade over bedrock. Total height of barrier: 4.4 ft Water depth below plunge: 1.1 ft Total cascade length: 6.5 ft
