Assessment of Steelhead Habitat and Migration Barriers within Watersheds Impacted by the Thomas, Whitter, and Topanga Wildfires

Pacific States Marine Fisheries Commission

California Department of Fisheries and Wildlife

September 10, 2019

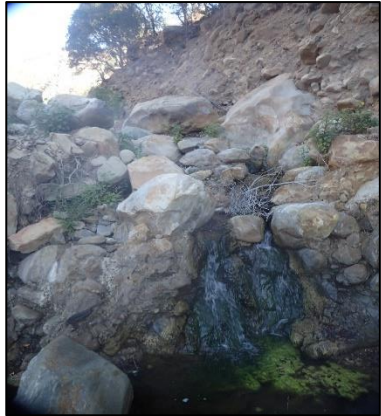
Barrier & PAD ID	Location	Previous Barrier Status	Current Barrier Status	Description and Dimensions	Picture
Barrier ID: SYD_012_NR PAD ID: None Assigned	34.4566, -119.6234	N/A	Temporal & Partial	Cascade over bedrock and boulders. Total height of barrier: 9 ft Water depth below plunge: 0.7 ft

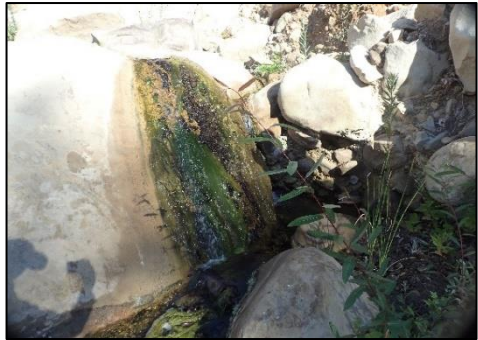
Barrier ID: SYD_013_NR PAD ID: None Assigned	34.45703, -119.62286	N/A	Temporal & Partial	Cascade over bedrock and boulders. Total height of barrier: 5.1 ft Water depth below plunge: 0.7 ft

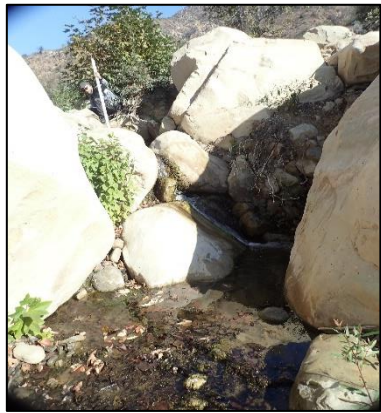
Barrier ID: SYD_014_NR PAD ID: 706249	34.45722, -119.62298	Partial	Temporal & Partial	Boulder cascade/waterfall. Total height of barrier: 8 ft Water depth below plunge: 1.2 ft

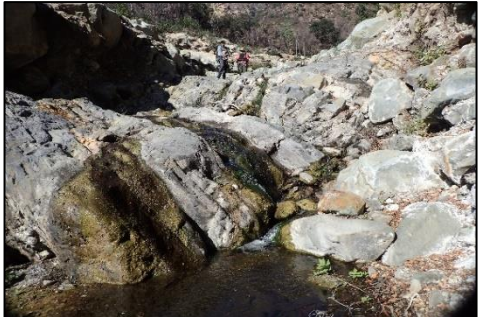
Barrier ID: SYD_016_NR PAD ID: None Assigned	34.46092, -119.62404	N/A	Total	Bedrock chute. Total height of barrier: 12 ft Total cascade length: 37.3 ft

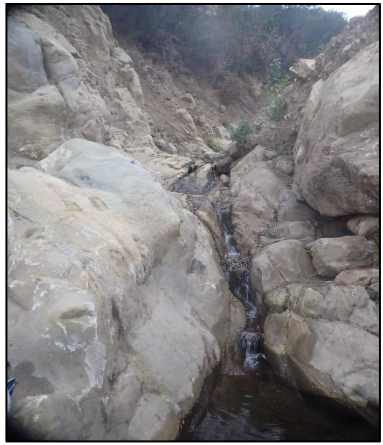
Barrier & PAD ID	Location	Previous Barrier Status	Current Barrier Status	Description and Dimensions	Picture
Barrier ID: ROM_029_NR PAD ID: None Assigned	34.45474, -119.59222	N/A	Total	Bedrock chute. Total height of barrier: 13.5 ft

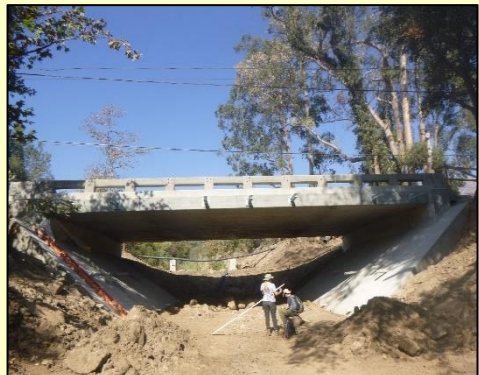
Barrier ID: ROM_012_R PAD ID: 762292	34.43615, -119.59793	N/A	Not a Barrier	Newly constructed free spanning Hwy 192 bridge with concrete channel walls. Post Mile: 10.93

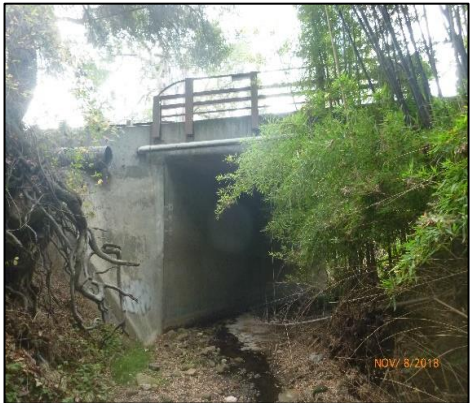
Barrier & PAD ID	Location	Previous Barrier Status	Current Barrier Status	Description and Dimensions	Picture
Barrier ID: BV_001_R PAD ID: None Assigned	34.42678, -119.60976	N/A	Not a Barrier	Free spanning bridge with cemented channel walls and partially cemented channel bottom.

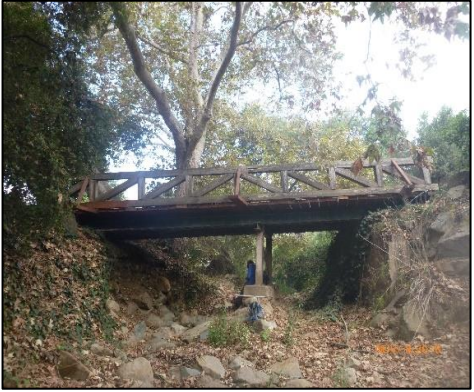
Barrier ID: BV_002_R PAD ID: None Assigned	34.42949, -119.61052	N/A	Not a Barrier	Golf course bridge with one support beam structure in middle of channel and concrete/boulder rip rap channel bottom.

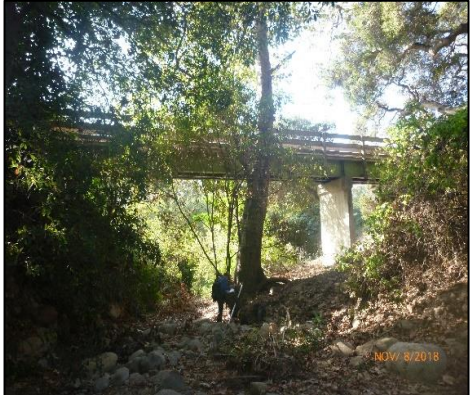
Barrier ID: BV_003_R PAD ID: None Assigned	34.42984, -119.61049	N/A	Not a Barrier	Narrow golf course pedestrian bridge with one support structure near right channel bank.

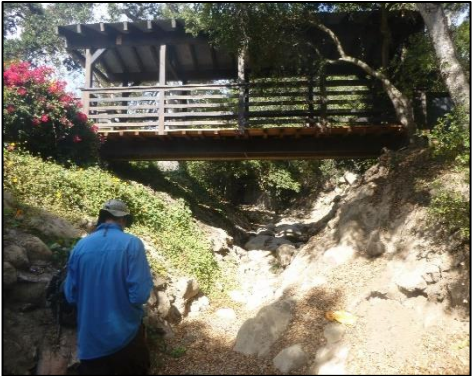
Barrier & PAD ID	Location	Previous Barrier Status	Current Barrier Status	Description and Dimensions	Picture
Barrier ID: BV_015_R PAD ID: None Assigned	34.43844, -119.60594	N/A	Not a Barrier	Free spanning pedestrian golf course bridge with cement/boulder rip rap channel walls.

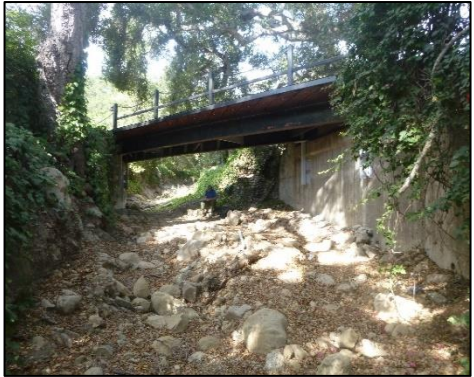
Barrier ID: BV_016_R PAD ID: None Assigned	34.43867, -119.60612	N/A	Not a Barrier	Free spanning private driveway bridge with concrete channel walls.

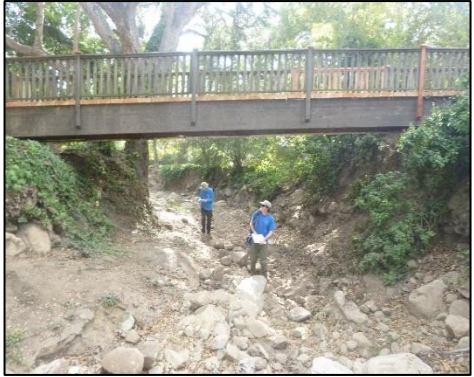
Barrier ID: BV_017_R PAD ID: None Assigned	34.4391, -119.60658	N/A	Not a Barrier	Free spanning private pedestrian bridge.

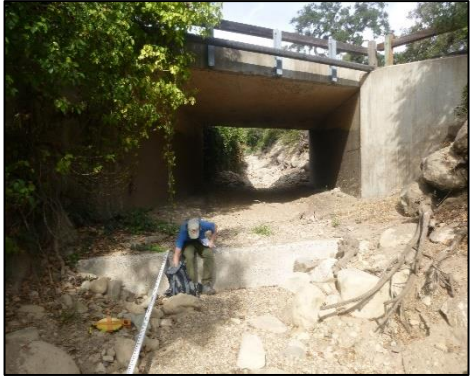
Barrier ID: BV_018_R PAD ID: None Assigned	34.43952, -119.60671	N/A	Not a Barrier	Free spanning bridge with concrete channel walls and wing walls.

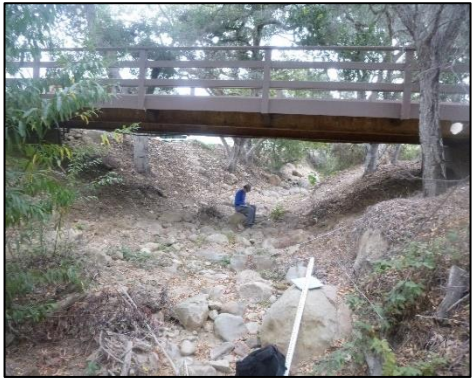
Barrier & PAD ID	Location	Previous Barrier Status	Current Barrier Status	Description and Dimensions	Picture
Barrier ID: PCY_001_R PAD ID: None Assigned	34.43545, -119.59386	N/A	Not a Barrier	Free spanning private bridge over natural streambed substrate.

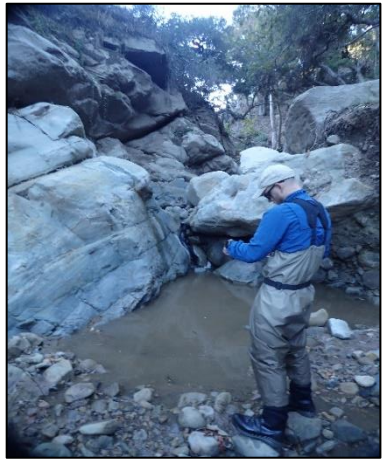
Barrier & PAD ID	Location	Previous Barrier Status	Current Barrier Status	Description and Dimensions	Picture
Barrier ID: AYP_002_NR PAD ID: 706241	34.4295, -119.54433	N/A	Temporal & Partial	Boulder/bedrock cascade. Total height of barrier: 4.5 ft

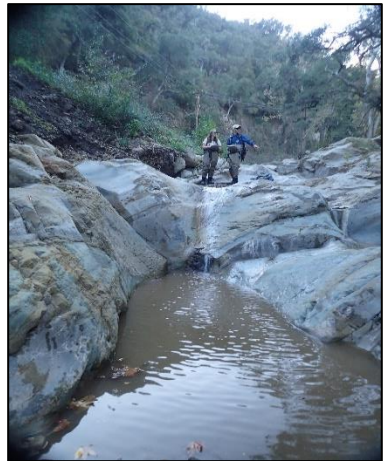
Barrier ID: AYP_003_NR PAD ID: None Assigned	34.4305, -119.54875	N/A	Temporal & Partial	Narrow bedrock chute. Total height of barrier: 6.2 ft Total cascade length: 11 ft

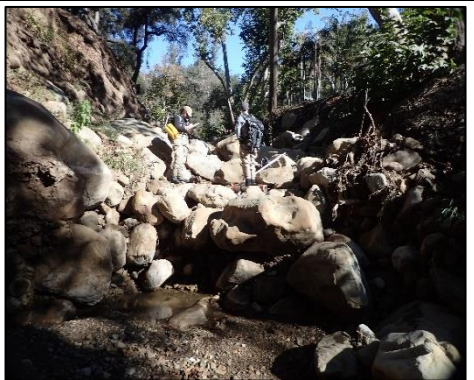
Barrier ID: AYP_004_NR PAD ID: None Assigned	34.43328, -119.55016	N/A	Temporal & Partial	Bedrock/boulder cascade. Total height of barrier: 4 ft

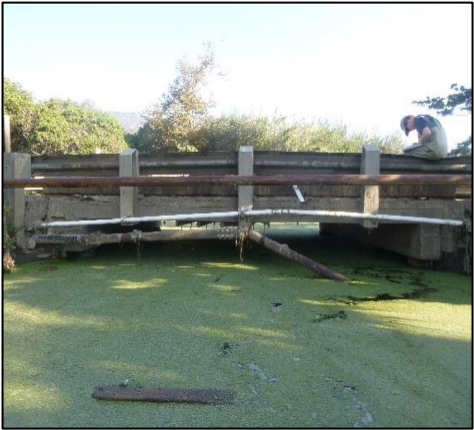
Barrier & PAD ID	Location	Previous Barrier Status	Current Barrier Status	Description and Dimensions	Picture
Barrier ID: AYP_001_R PAD ID: None Assigned	34.41402, -119.55893	N/A	Not a Barrier	Free spanning bridge over stagnant estuary water.

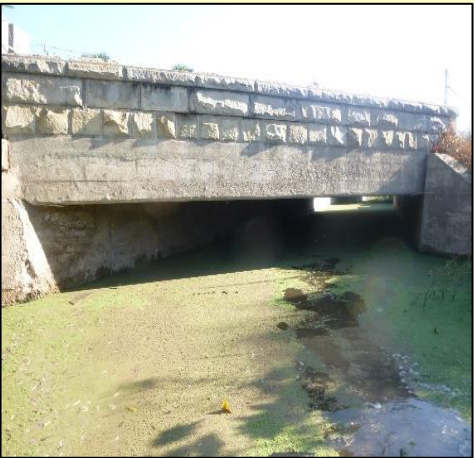
Barrier ID: AYP_002_R PAD ID: 734310	34.41414, -119.55699	Not a Barrier	Not a Barrier	Hwy 101 free spanning north and southbound bridges over concrete channel walls and natural streambed substrate. Post Mile: 5.6

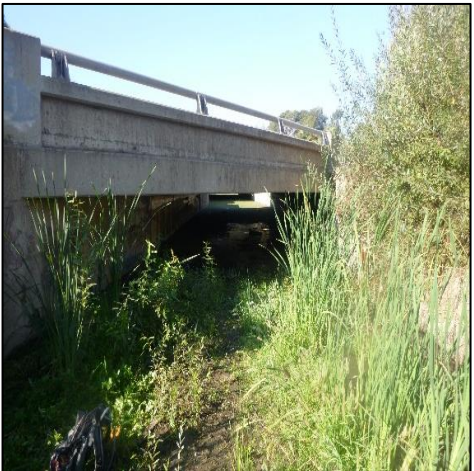
Barrier ID: AYP_003_R PAD ID: None Assigned	34.41405, -119.55666	N/A	Not a Barrier	Free spanning bridge over concrete channel walls and natural streambed substrate.

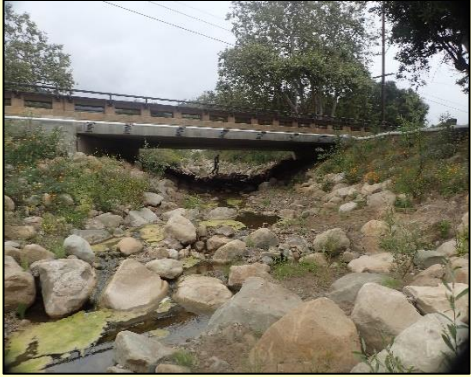
The debris flow event on Arroyo Paredon Creek following the Thomas Fire severely damaged the highway 192 crossing. A new free spanning bridge was constructed and finished in 2019. This new bridge was assessed to be free of *O. mykiss* passage constraints. The previous crossing structure had been assigned a temporal barrier status.

Barrier & PAD ID	Location	Previous Barrier Status	Current Barrier Status	Description and Dimensions	Picture
Barrier ID: AYP_004_R PAD ID: 706239	34.41703, -119.54416	Temporal	Not a Barrier	Newly constructed free spanning Hwy 192 bridge over natural substrate. Post Mile: 15.52

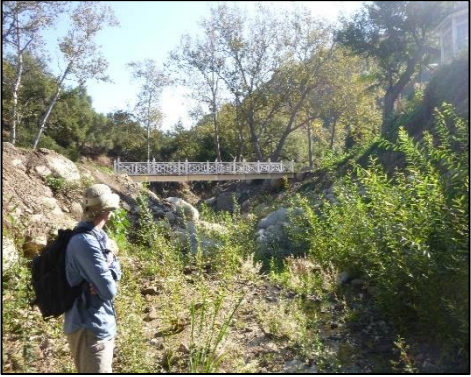
Barrier ID: AYP_006_R PAD ID: None Assigned	34.43156, -119.55042	N/A	Not a Barrier	Free spanning pedestrian bridge.

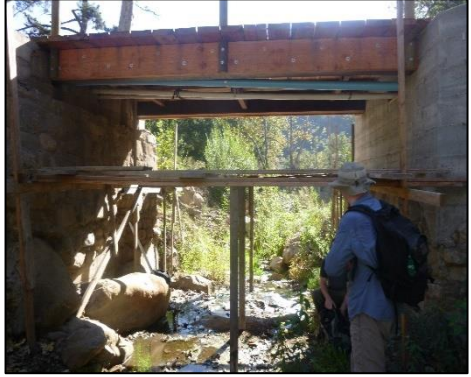
Barrier ID: AYP_007_R PAD ID: 706242	34.4325, -119.55036	N/A	Not a Barrier	Bridge with concrete channel walls.

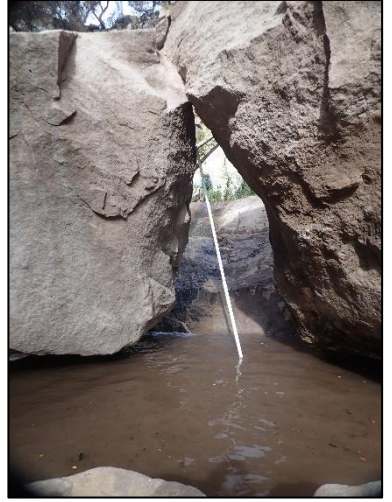
Barrier & PAD ID	Location	Previous Barrier Status	Current Barrier Status	Description and Dimensions	Picture
Barrier ID: CRP_011_NR PAD ID: 706493	34.41819, -119.47913	Temporal	Temporal & Partial	Bedrock chute. Total height of barrier: 9 ft Water depth below plunge: 1.9 ft

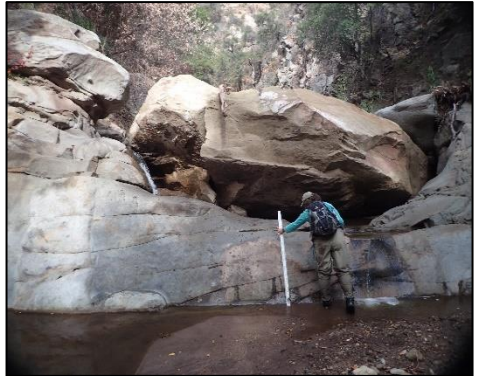
Barrier ID: CRP_012_NR PAD ID: None Assigned	34.41897, -119.47933	N/A	Total	Bedrock/boulder cascade.

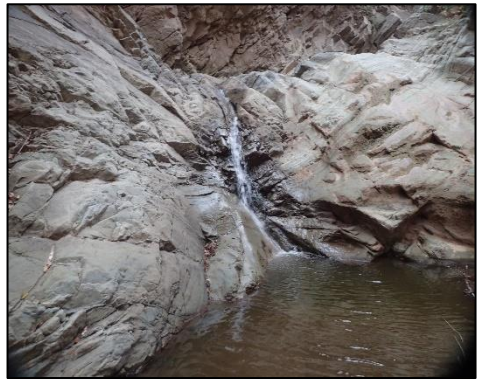
Barrier ID: CRP_013_NR PAD ID: 706494	34.41969, -119.47953	Temporal & Partial	Total	Bedrock waterfall Total height of barrier: 15.2 ft Water depth below plunge: 2.4 ft

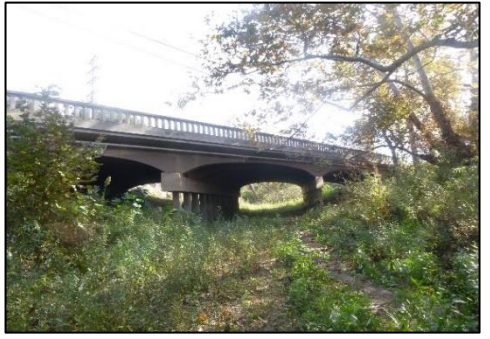
Barrier & PAD ID	Location	Previous Barrier Status	Current Barrier Status	Description and Dimensions	Picture
Barrier ID: CRP_001_R PAD ID: None Assigned	34.39348, -119.51166	N/A	Not a Barrier	Concrete bridge with multiple instream supports.

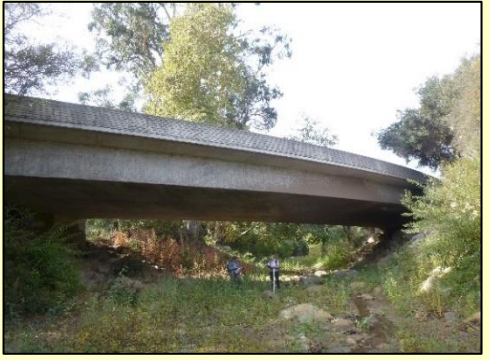
Barrier ID: CRP_002_R PAD ID: 731247	34.40129, -119.48718	Not a Barrier	Not a Barrier	Hwy 192 free spanning concrete bridge over natural streambed substrate. Post Mile: 19.11

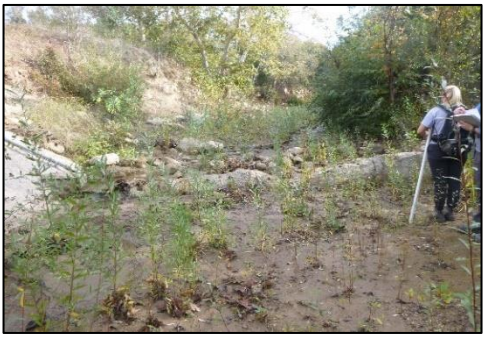
Barrier ID: CRP_003_NR PAD ID: 706231	34.40128, -119.48668	Not a Barrier	Not a Barrier	Grade control structure at utility crossing.

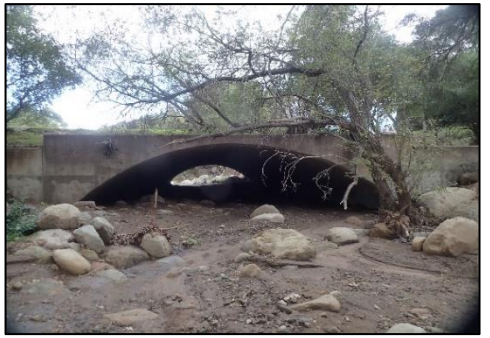
Barrier ID: CRP_004_R PAD ID: None Assigned	34.39348, -119.48586	N/A	Not a Barrier	Open arch culvert under Lilington road.

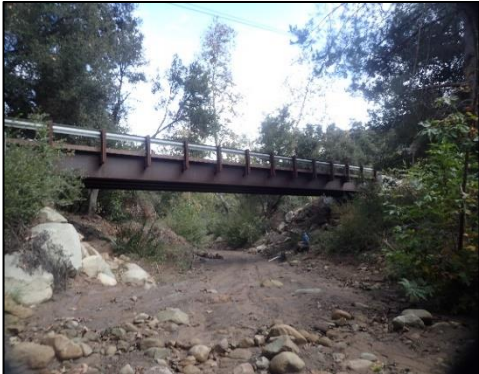
Barrier & PAD ID	Location	Previous Barrier Status	Current Barrier Status	Description and Dimensions	Picture
Barrier ID: CRP_005_R PAD ID: 706489	34.40495, -119.48333	Remediated fish response unconfirmed	Not a Barrier	Free spanning bridge on private property.

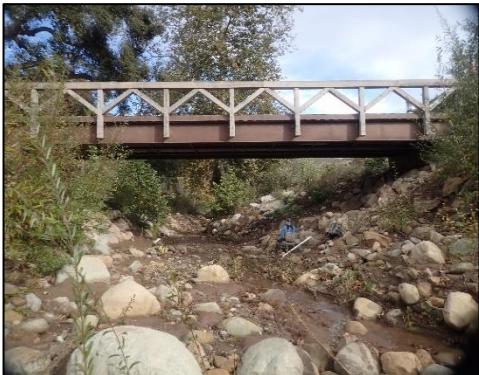
Barrier ID: CRP_006_R PAD ID: 706490	34.40854, -119.4813	Remediated, fish response unconfirmed	Not a Barrier	Free spanning bridge on private property.

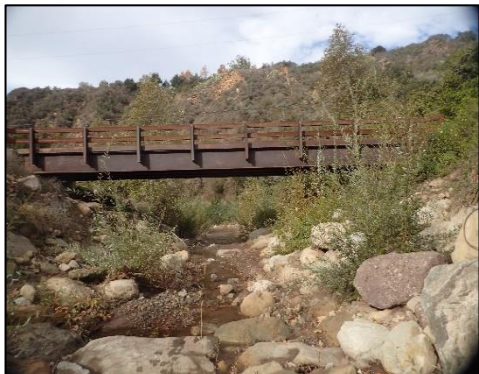
Barrier ID: CRP_007_R PAD ID: 706233	34.41008, -119.48049	Remediated, fish response unconfirmed	Not a Barrier	Free spanning bridge on private property.

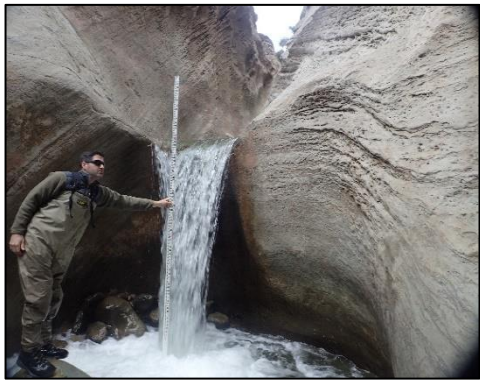
Barrier & PAD ID	Location	Previous Barrier Status	Current Barrier Status	Description and Dimensions	Picture
Barrier ID: GOB_009_NR PAD ID: 706501	34.42077, -119.47244	Total	Total	Total waterfall in bedrock slot canyon. Total height of barrier: 11.6 ft Water depth below plunge: 4 ft

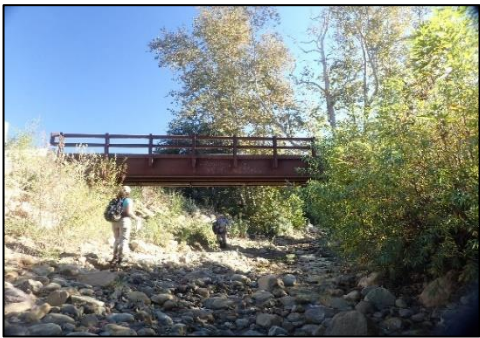
Barrier & PAD ID	Location	Previous Barrier Status	Current Barrier Status	Description and Dimensions	Picture
Barrier ID: GOB_002_R PAD ID: 758784	34.40095, -119.47805	Unassessed	Not a Barrier	Free spanning bridge with no passage constraints.

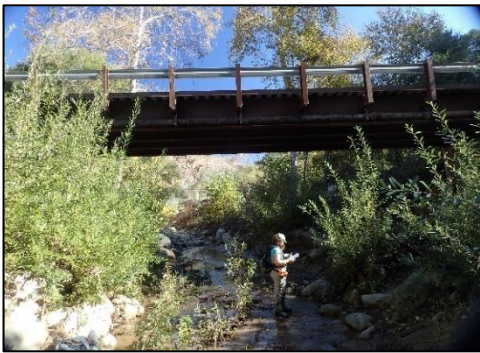
Barrier ID: GOB_005_R PAD ID: 706497	34.40656, -119.46821	Remediated, fish response unconfirmed	Not a Barrier	Free spanning bridge with no passage constraints.

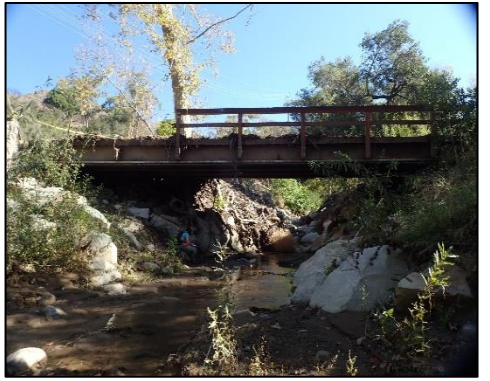
Barrier & PAD ID	Location	Previous Barrier Status	Current Barrier Status	Description and Dimensions	Picture
Barrier ID: GOB_007_R PAD ID: 706499	34.40871, -119.46423	Remediated, fish response unconfirmed	Not a Barrier	Free spanning bridge with no passage constraints.

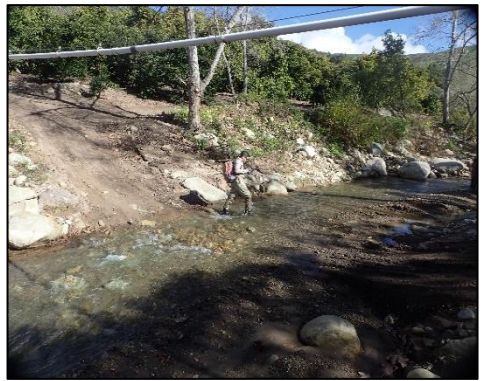
Barrier ID: GOB_010_R PAD ID: None Assigned	34.40629, -119.46888	N/A	Not a Barrier	Low-water crossing with natural streambed substrate.

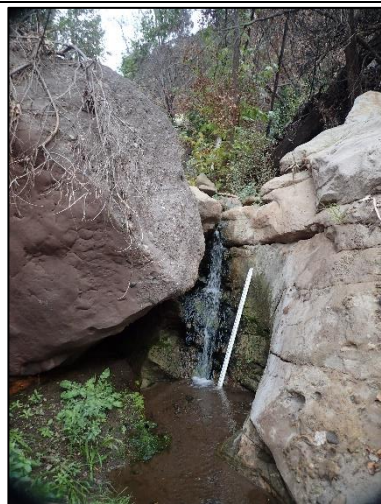
Barrier & PAD ID	Location	Previous Barrier Status	Current Barrier Status	Description and Dimensions	Picture
Barrier ID: RNC_015_NR PAD ID: 706222	34.43328, -119.55016	Temporal	Temporal	Plunge over bedrock. Total height of barrier: 7.1 ft Water depth below plunge: 0.4 ft

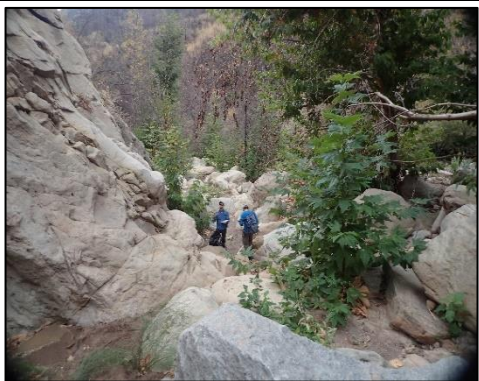
Barrier ID: RNC_016_NR PAD ID: 707369	34.41265	Total	Total	Boulder cascade. Total height of barrier: 7 ft Total cascade length: 9 ft

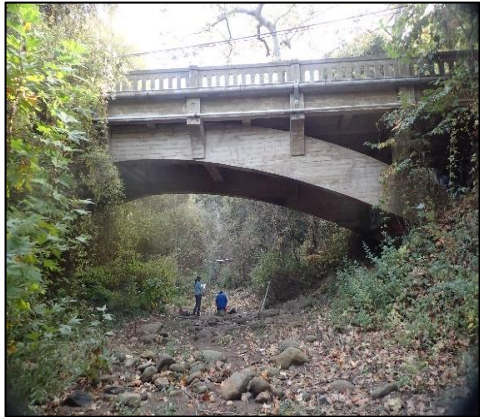
Barrier & PAD ID	Location	Previous Barrier Status	Current Barrier Status	Description and Dimensions	Picture
Barrier ID: RNC_002_R PAD ID: None Assigned	34.38708, -119.47533	N/A	Not a Barrier	Free spanning bridge over natural streambed.

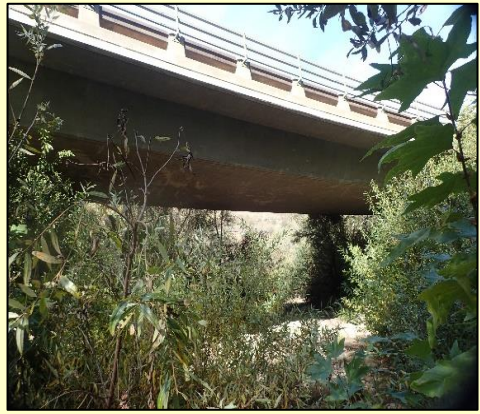
Barrier ID: RNC_003_R PAD ID: 706212	34.38806, -119.46881	Remediated, fish response unconfirmed	Not a Barrier	Free spanning Hwy 150 bridge over natural streambed substrate with concrete and boulder riprap channel walls. Post Mile: 1.12

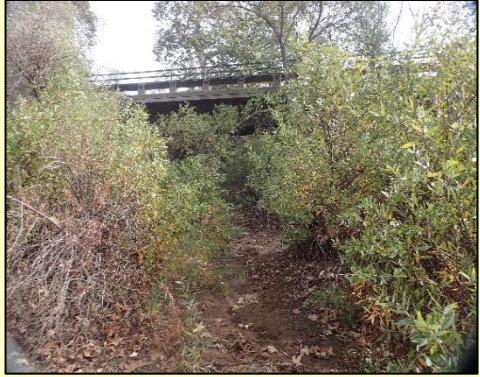
Barrier ID: RNC_004_R PAD ID: 706213	34.39051, -119.46314	Remediated, fish response unconfirmed	Not a Barrier	Free spanning Hwy 150 bridge over natural streambed substrate with concrete and boulder riprap channel walls. Post Mile: 1.5

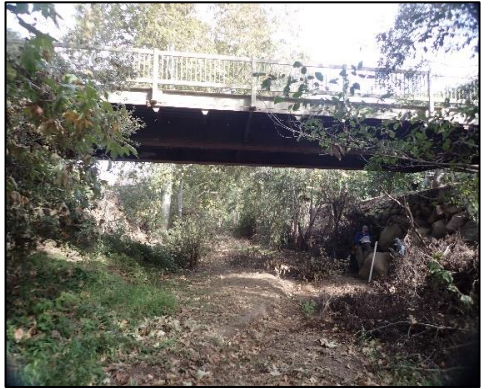
Barrier ID: RNC_005_R PAD ID: None Assigned	34.39411, -119.45723	N/A	Not a Barrier	Free spanning bridge over natural streambed substrate with concrete and boulder riprap channel walls.

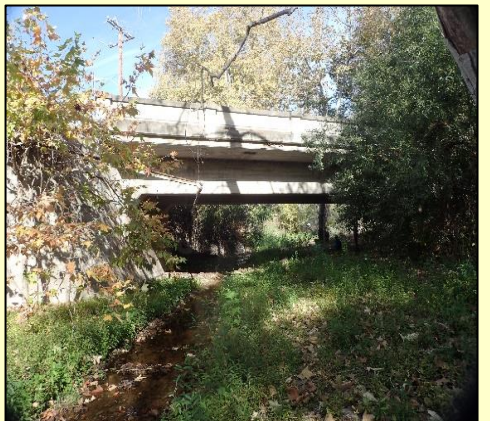
Barrier ID: RNC_006_R PAD ID: 732269	34.39608, -119.45359	Not a Barrier	Not a Barrier	Free spanning Hwy 150 bridge over natural streambed substrate with concrete channel walls. Post Mile: 0.006

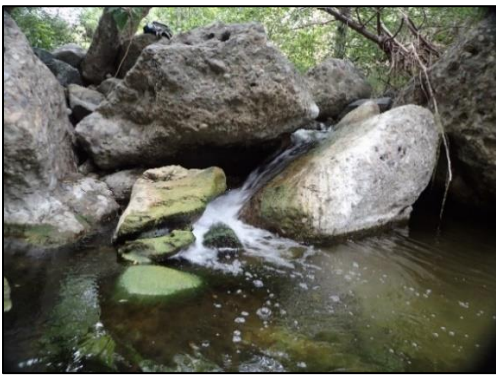
Barrier & PAD ID	Location	Previous Barrier Status	Current Barrier Status	Description and Dimensions	Picture
Barrier ID: TPC_002_NR PAD ID: 723593	34.05085, -118.58158	Partial	Partial	Natural bedrock chute with shallow jump pool. Total height of barrier: 3.2 ft Water depth below plunge: 0.8 ft Total cascade length: 12.6 ft

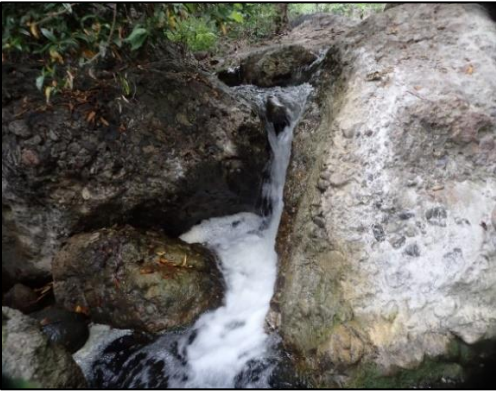
Barrier ID: TPC_003_NR PAD ID: 723594	34.05311, -118.58189	Partial	Temporal & Partial	Natural boulder cascade with bedrock chute. Potentially passable at high flows. Total height of barrier: 4.2 ft Water depth below plunge: 1.7 ft

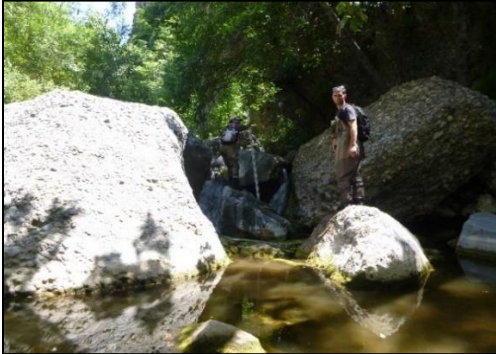
Barrier ID: TPC_005_NR PAD ID: None Assigned	34.0699, -118.58702	N/A	Temporal & Partial	Bedrock chute/fall. Total height of barrier: 5.5 ft Water depth below plunge: 2.5 ft

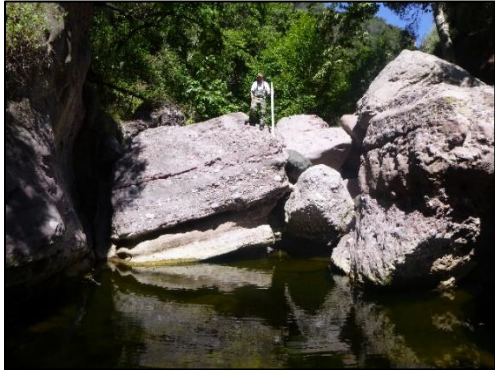
Barrier & PAD ID	Location	Previous Barrier Status	Current Barrier Status	Description and Dimensions	Picture
Barrier ID: TPC_006_NR PAD ID: None Assigned	34.07548, -118.58987	N/A	Total	Bedrock chute/fall with extremely constricted plunge. Total height of barrier: 12.5 ft Water depth below plunge: 1.1 ft

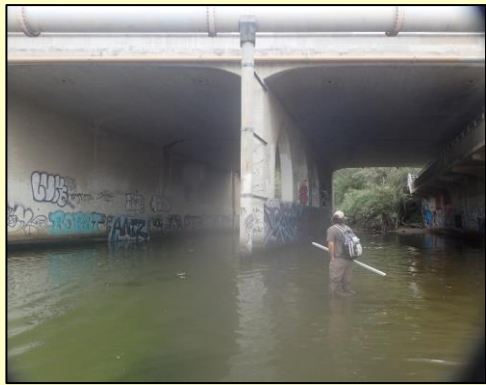
Barrier & PAD ID	Location	Previous Barrier Status	Current Barrier Status	Description and Dimensions	Picture
Barrier ID: TPC_001_R PAD ID: 716891	34.03932, -118.58303	Partial	Not a Barrier	Hwy 1 bridge with in stream concrete supports and concrete walls over natural streambed substrate. Post Mile: 40.99

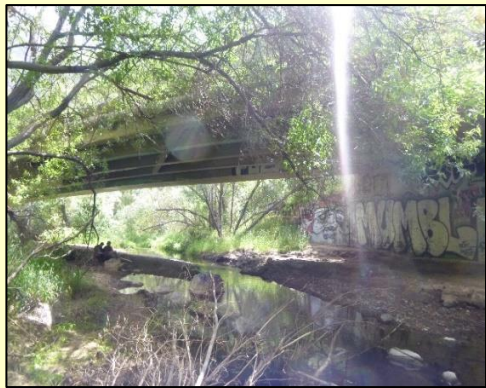
Barrier ID: TPC_004_R PAD ID: 716894	34.06429, -118.58785	Not a Barrier	Not a Barrier	Hwy 27 free spanning bridge over natural streambed substrate. Post Mile: 2.04
